AIRCRAFT ACCIDENT REPORT

SOUTHERN AIRWAYS, INC. DC-9, N971S

To State Airport

November 14, 1970

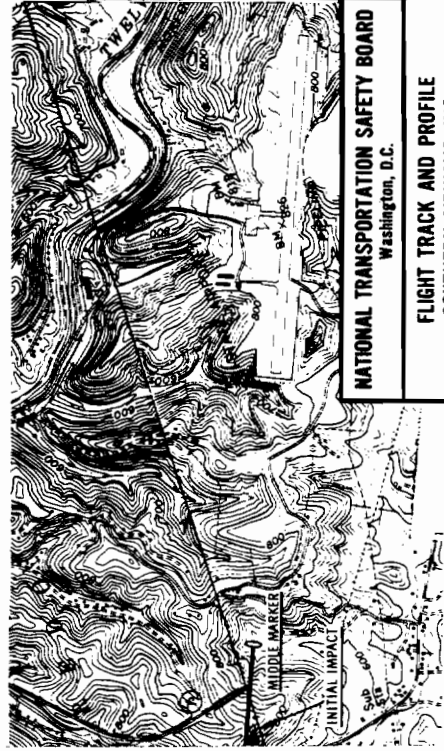
FLIGHT TRACK AND PROFILE
 SOUTHERN AIRWAYS, INC.
 DC-9-31, N97S
 HUNTINGTON, WEST VIRGINIA
 November 14, 1970

● FLIGHT TRACK AND ALTITUDE DATA POINTS DERIVED FROM FLIGHT RECORDER AND WEATHER DATA
 NOTE: FLIGHT TRACK IS DRAWN AS STRAIGHT LINE CONNECTING FIRST DATA POINT AND IMPACT

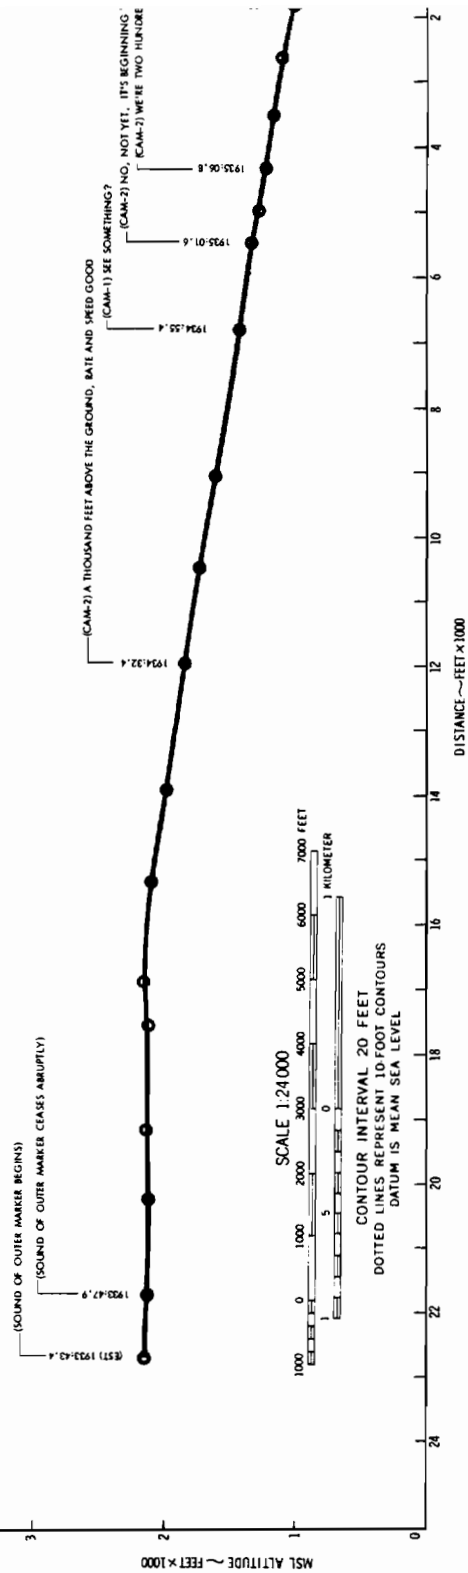
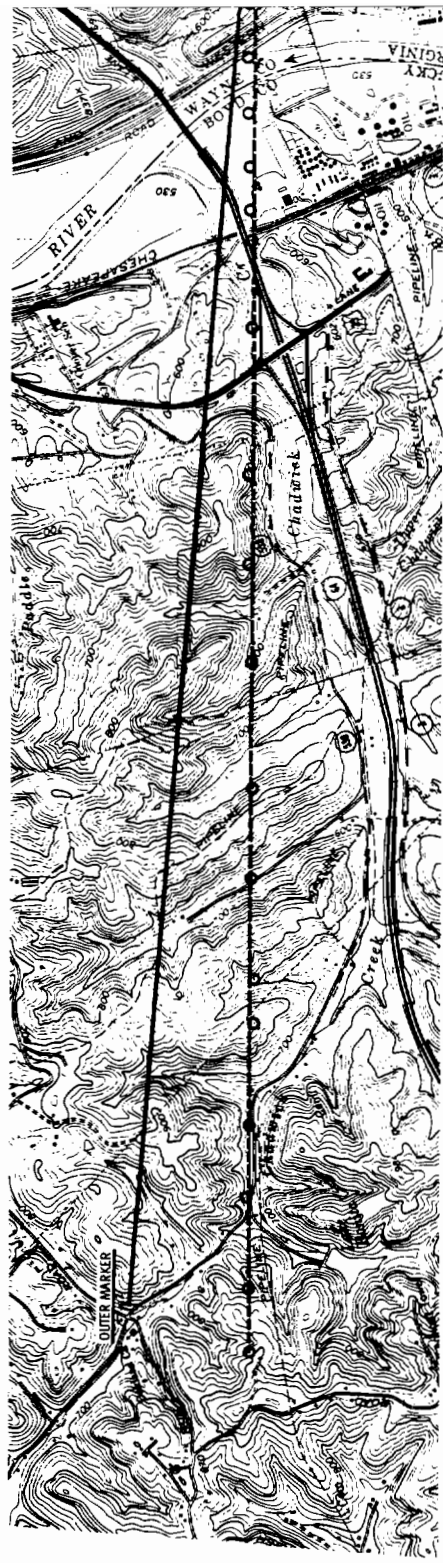
COMPARISON OF DESCENT PROFILE AND 3° GLIDE SLOPE
SOUTHERN AIRWAYS, INC.
DC-9-31, N97S
HUNTINGTON, WEST VIRGINIA
November 14, 1970

NOTE: Glide Path intercepts runway 960 feet beyond
runway threshold.
Vertical Scale distorted by ratio of 5:1.
