# Service Bulletin

Bulletin No.: 17-NA-166

**Subject:** Rough Idle in Drive

Brand:	Model:	Model Year:		VIN:		Engine:	Transmission:
		from	to	from	to		
Cadillac	Escalade Models	2015	2021				
Chevrolet	Silverado	2014	2018			L83, L84, L86, L87, LV1, LV3 (4.3L, 5.3L, 6.2L)	
	Silverado 1500 (New Model)	2019	2021				
	Silverado LD	2019	2019				
	Suburban	2015	2021				
	Tahoe						
GMC	Sierra	2014	2018				
	Sierra 1500 (New Model)	2019	2021				
	Sierra Limited	2019	2019				
GMC	Yukon Models	2015	2021

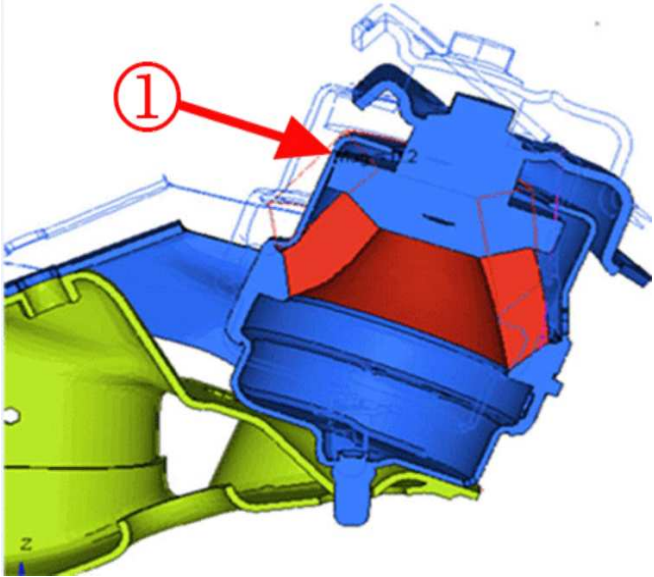
<p style="text-align: right;">4787059</p> <p>This concern may be caused by ground out (1) within one or both engine mounts.</p>
<p>Correction</p>	<p><b>Important:</b> Familiarize yourself with this entire bulletin before proceeding to ensure you are diagnosing and focusing on the correct issue by frequency measured with Pico scope.</p> <p>Perform PICO analysis, refer to the Service Procedure section below.</p> <p>⇒ If the rough idle / vibration concern frequency is E1.5 in the horizontal / lateral direction with Pico sensor mounted in seat track as indicated below – continue with steps to install updated design engine mounts and settle both engine and trans mounts to reduce amplitude (mg) / eliminate ground out within the engine mounts for vehicles built prior to engine mount breakpoint. For vehicles built after breakpoint, follow Shimming Procedure for Engine Mount Vibration/Grounding after Mount Replacement.</p> <p><b>Important:</b> The updated engine mounts are designed to reduce internal ground out, primarily E1.5. These mounts along with engine and trans mount settling will typically reduce amplitude at the seat track to 2 mg or less.</p> <p><b>Note:</b> The 6.2L engine has a characteristic E1 which can be felt and may be described as a lopey idle. V-8 engine firing frequency produces E4 which will typically be very low frequency at the seat track. Do not confuse 6.2L E1 characteristic (not caused by mount ground-out), with E1.5 normal idle characteristics being transmitted into the truck via ground-out through the engine mounts.</p>

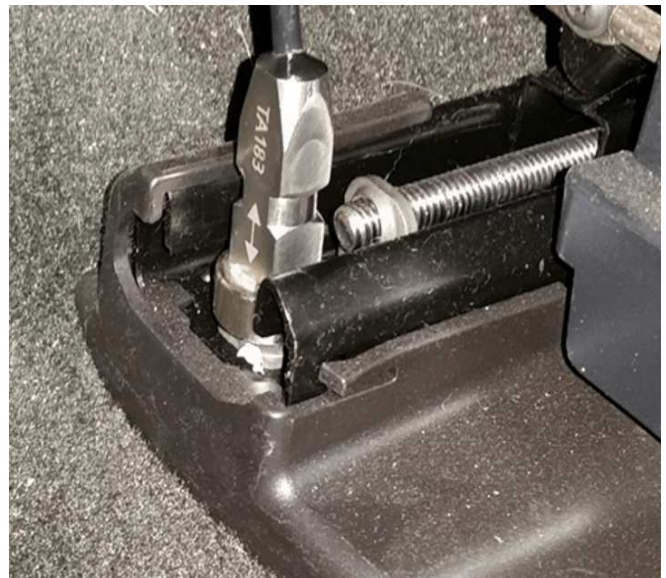
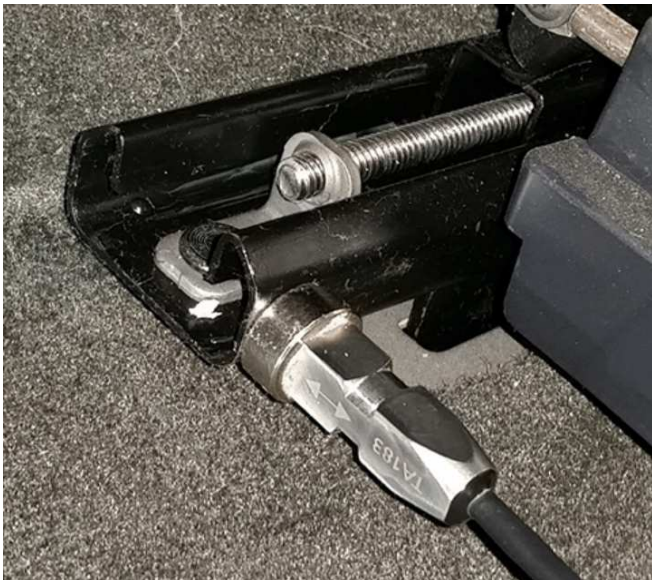
4532456

(TA183 single axis pico sensor shown / TA143 is tri-axis sensor)

Measure the vibration disturbance using the vibration analyzer, CH-51450-A (Pico Oscilloscope), to qualify whether the issue frequency is E1.5 as opposed to E1 or E4.

**Note:** If using a single-axis pico sensor, mount and test both vertically and horizontally – E1.5 rough idle vibration will usually be horizontal / lateral at the seat track.

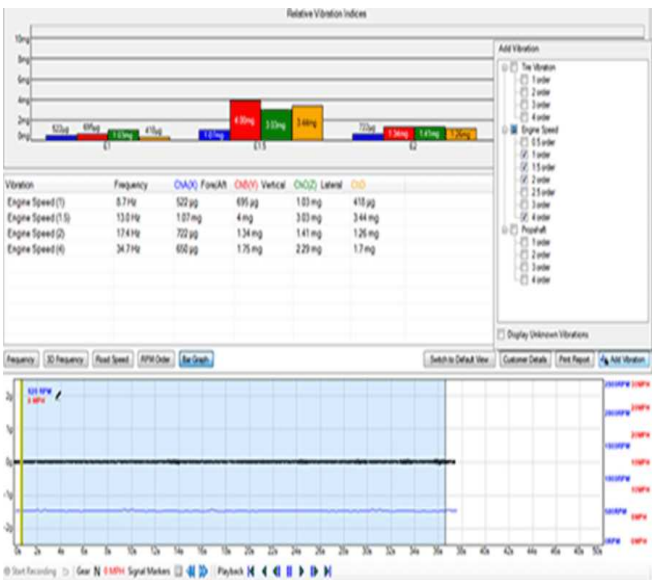
4534309

Add E1.5 to the displayed data and turn Off T and P related data (under Add Vibration in Pico) since issue occurs with vehicle stationary.

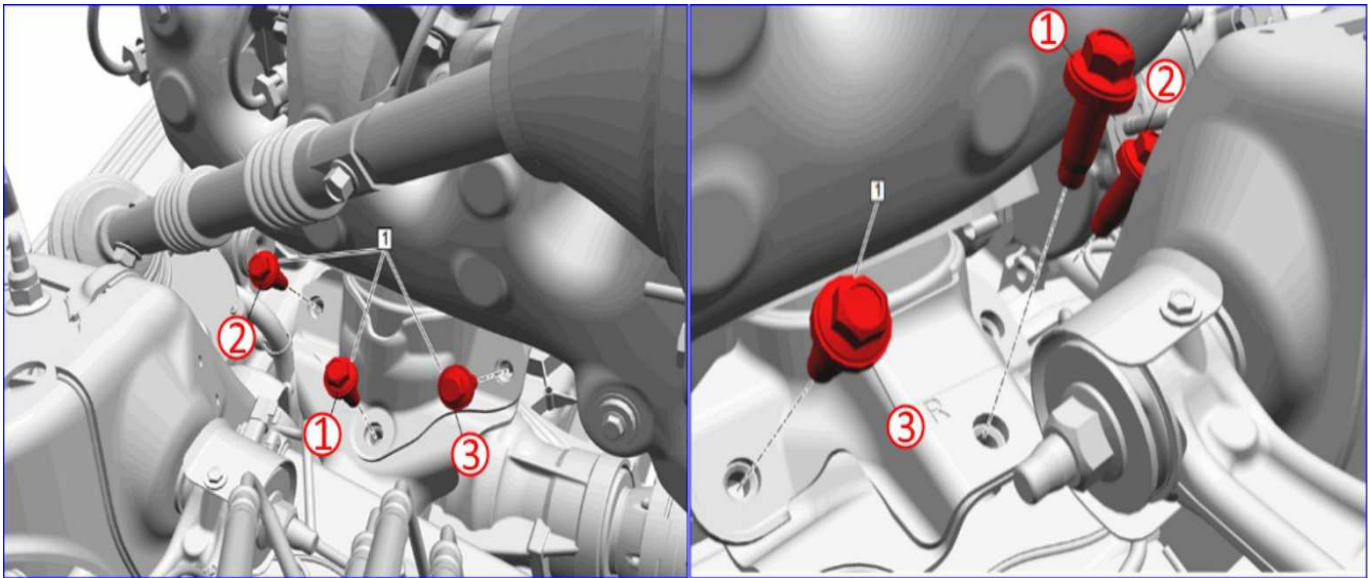
5318277

**Note:** Idle vibration caused by ground-out within an engine mount may be able to be turned off/on with a single bolt location. Shimming that bolt location may greatly reduce the vibration. In some cases, a combination of bolt location shimming may be needed.

2. Beginning with RH side, loosen the engine mount to frame bolts one at a time a few turns to release clamp load beginning with rear bolt at position 6, front bolt at position 5 and the middle bolt at position 4.
  - ⇒ Verify if idle vibration was significantly reduced or eliminated when the bolts were loosened.
3. Torque bolts to specifications in order and validate if the vibration returns.
4. Repeat the process on the LH mount starting at the rear bolt at position 3, front bolt at position 2 and the middle bolt at position 1.
  - If idle vibration **Does Not** return when the RH or LH engine mount bolts are re-torqued to specifications, remove the old bolts and discard. Replace the bolts with new ones.
  - If idle vibration **Does** return, proceed with procedure.
