Aircraft Accident Report - L and J  
Company, Convair 240, N55VM,  
Gillsburg, Mississippi, October 20, 1977

U.S. National Transportation Safety Board, Washington, D C

1. Report No. NTSB-AAR-78-6	2. Government Accession No.	3. Recipient's Catalog No.	
4. Title and Subtitle Aircraft Accident Report -- L & J Company, Convair 240, N55VM, Gillsburg, Mississippi, October 20, 1977		5. Report Date June 19, 1978	
		6. Performing organization Code	
7. Author(s)		8. Performing Organization Report No.	
9. Performing Organization Name and Address National Transportation Safety Board Bureau of Accident Investigation Washington, D.C. 20594		10. Work Unit No. 2365	
		11. Contract or Grant No.	
12. Sponsoring Agency Name and Address  NATIONAL TRANSPORTATION SAFETY BOARD Washington, D. C. 20594		13. Type of Report and Period Covered Aircraft Accident Report October 20, 1977	
		14. Sponsoring Agency Code	
15. Supplementary Notes

L & J COMPANY  
CONVAIR 240, N55VM  
GILLSBURG, MISSISSIPPI  
OCTOBER 20, 1977

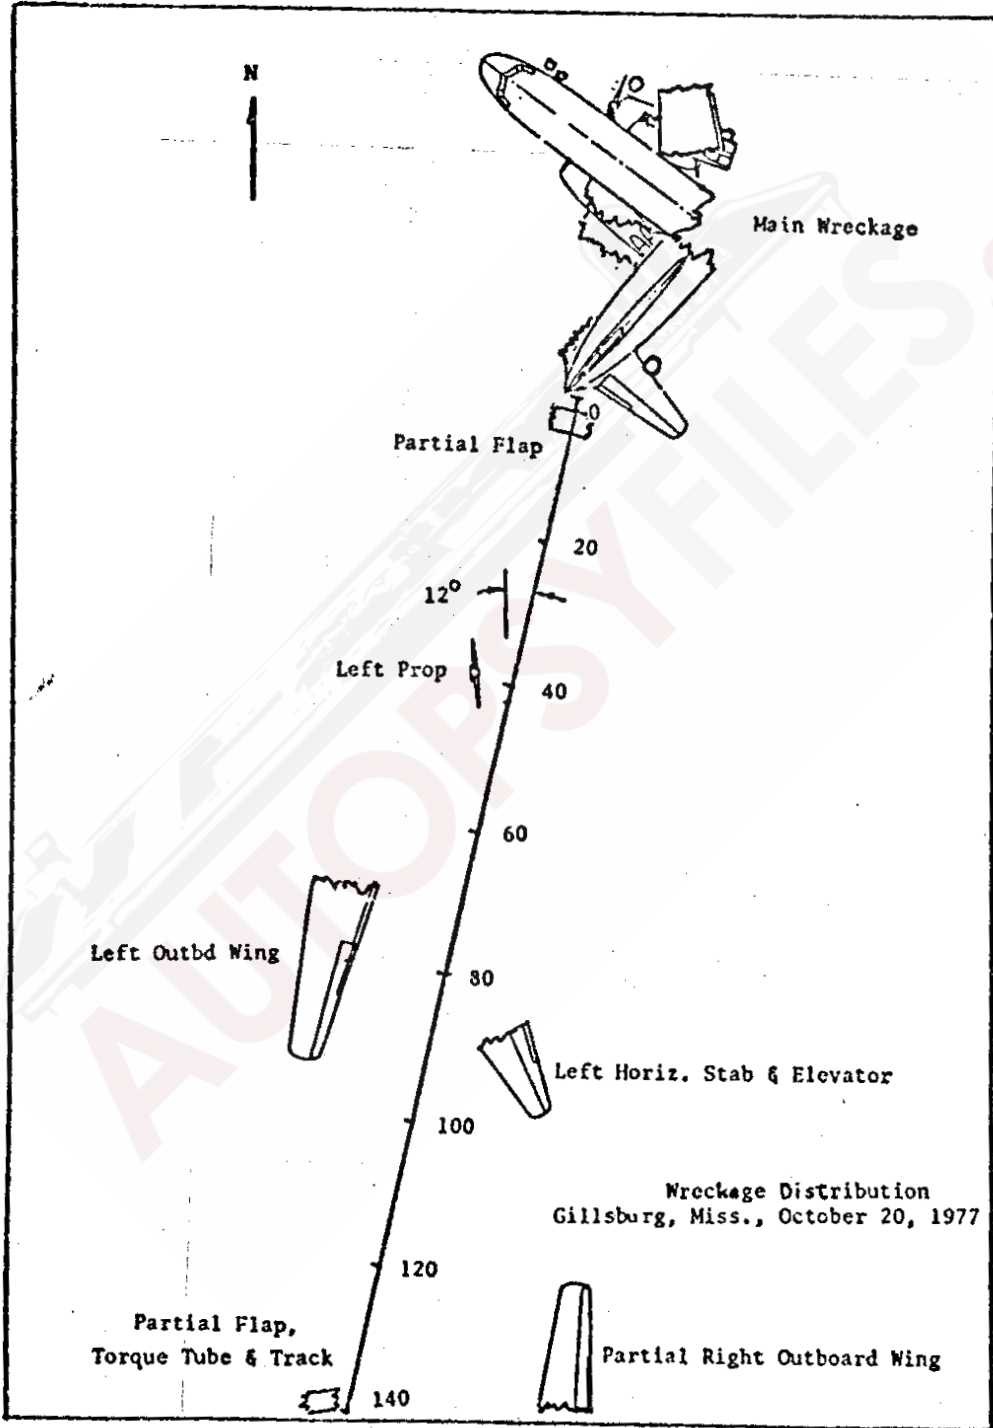
APPENDIX D

after the aircraft hit the second tree and continued the steeper angle until it hit the ground. The wreckage path was about 495 ft long. Trees as high as 80 ft and as large as 3 ft in diameter were struck during the final 300 ft of flight. The left horizontal Stabilizer and the outboard section of both wings were torn from the aircraft and found 100 ft from the main wreckage along the wreckage path. The right outboard wing pane' separated from the aircraft after initial contact with trees. The left horizontal stabilizer and the left outboard wing panel also struck trees and separated along the wreckage path. The wreckage distribution was on a magnetic heading of 012'. The fuselage continued forward on that heading and came to rest about 140 ft from the point of initial impact. The fuselage separated forward of the bottom leading edge of the vertical stabilizer. The center wing and engine nacelles were twisted to the left of the forward fuselage. The cockpit structure was crushed against trees. Cabin seats separated during the impact sequence. (Pee. Appendix D.)
