**NATIONAL
TRANSPORTATION
SAFETY
BOARD**

AIRCRAFT ACCIDENT REPORT

**DELTA AIR LINES, INC.,
LOCKHEED L-1011-385-1, N726DA
DALLAS/FORT WORTH -
INTERNATIONAL AIRPORT, TEXAS
AUGUST 2, 1985**

NTSB/AAR-86/05

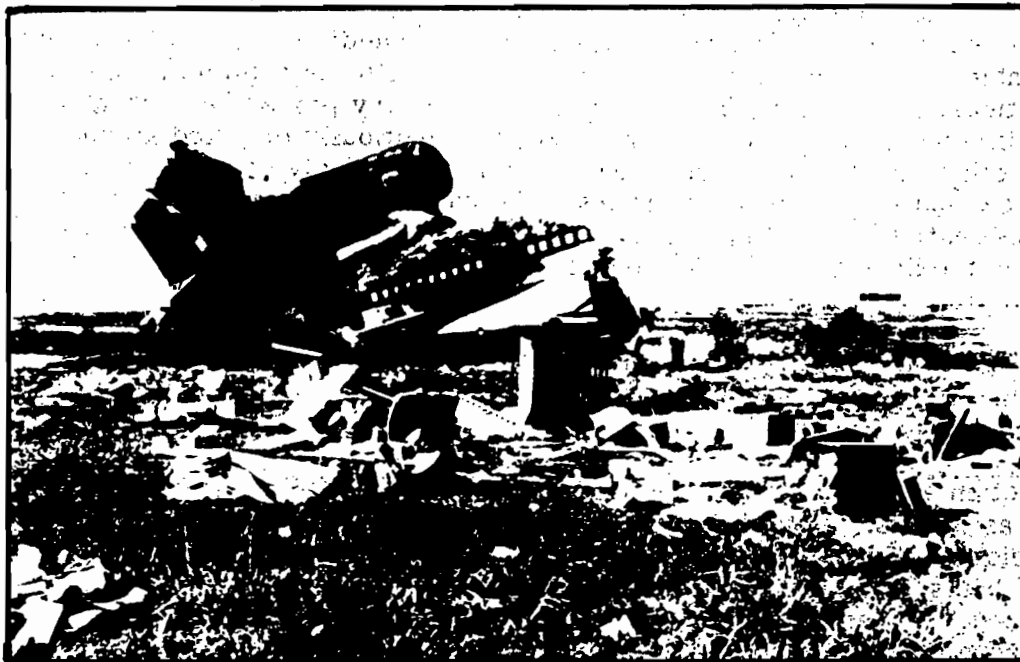
Figure 2.--The aft section of the airplane's fuselage.

The investigation team found the aft fuselage section containing the rear cabin and the empennage was in an upright position. Passengers and flight attendants reported that this section came to rest on its left side and was rolled to the upright position by wind gusts after the arrival of the rescue personnel. The section was relatively intact and included the No. 2 engine and associated ducting, the right stabilizer and elevator, and the base of the vertical stabilizer and rudder. The upper 12 feet of the vertical stabilizer and rudder had separated as a unit during the impact sequence and was found about 100 feet north of the aft fuselage section.

The No. 2 engine remained in position in the aft section of the fuselage, but its left side was damaged significantly by impact forces. The engine inlet and fan section, which had been protected by the fuselage structure during the crash, exhibited minor damage from the ingestion of miscellaneous debris, such as airplane seat cushions, seat sections, and other pieces of the airplane's interior furnishings. This debris was found as far back as the high-pressure compressor. Examination of the engine's rotating and thrust reverser components indicated that the engine was capable of producing power at impact and that it was in the full reverse thrust position, but that it had been commanded to the stow or forward thrust position.

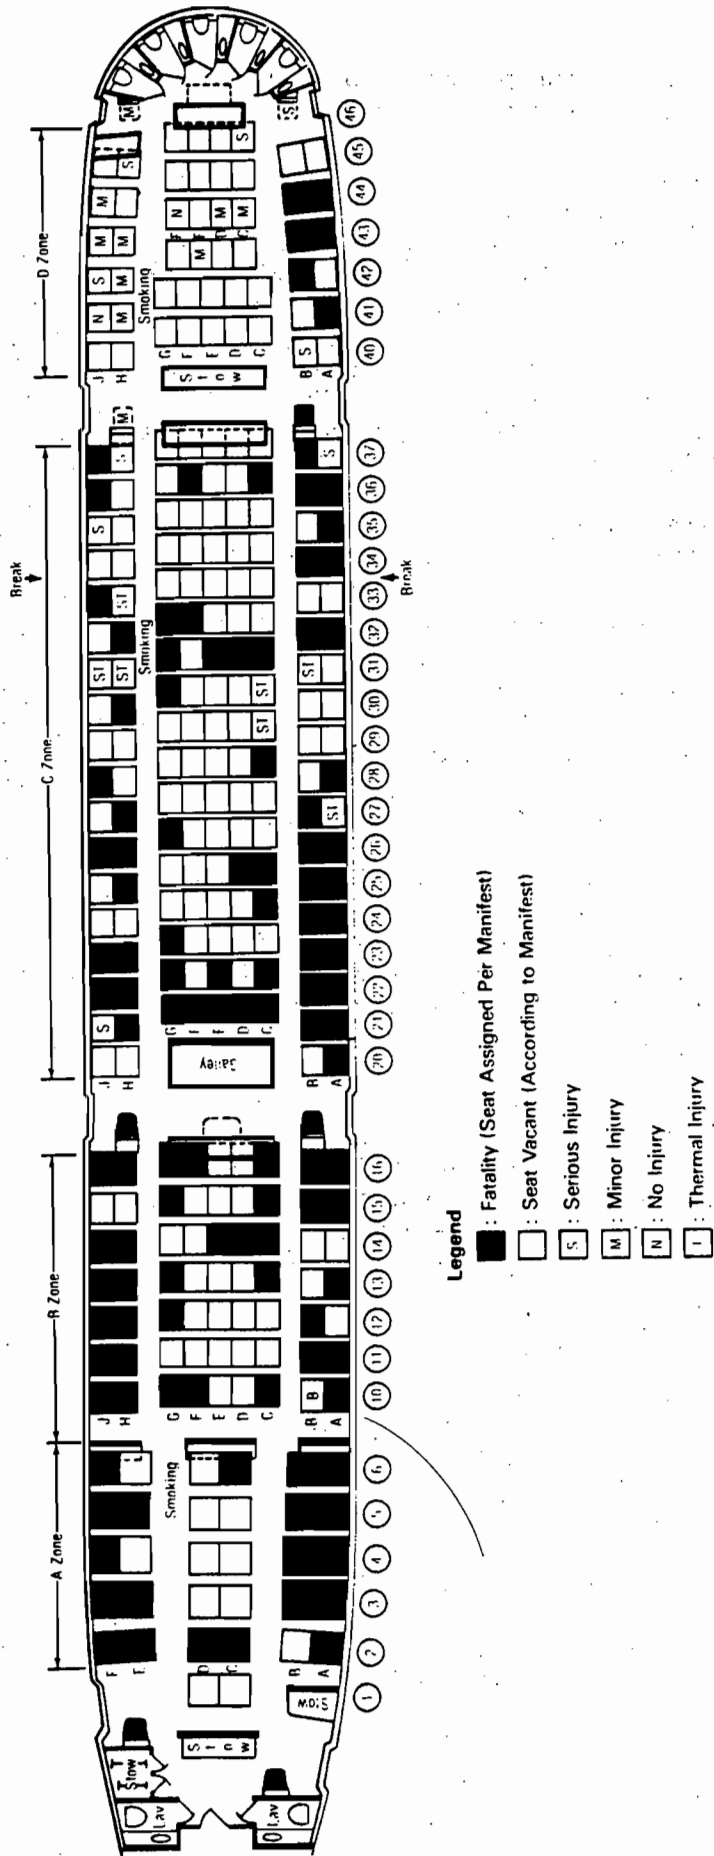
Figure 3.--L-1011 cabin seat diagram.

Except for the left cabin wall, which was missing, the remainder of the separated rear cabin section from row 40 aft to row 46 was relatively undamaged. Six passengers seated along the missing left cabin wall were killed. The remaining 16 occupants of this cabin section, including 2 flight attendants, sustained serious and minor injuries, and 2 passengers were not injured.

The rear cabin section came to rest on its left side. The survivors were either flung from the airplane in their seats or released themselves from their seats and exited at the forward end of the separated fuselage section or through the missing left wall. One flight attendant and three passengers could not escape from the cabin because of injuries and were removed by fellow passengers and rescue personnel. Two other flight attendants had only minor injuries and were able to escape unaided after shouting commands to the passengers to get out of the cabin. The flight attendant seated at the right rear (R-4) exit had difficulty releasing her seatbelt because the buckle was located on her left hip and her weight was on the buckle. The passengers and flight attendants were covered with fuel and some had fuel on their hands and in their eyes, which caused difficulties in climbing down the cabin to the hole created by the missing left cabin wall. Some persons were able to climb downward to the hole over seats while others fell the width of the cabin to the ground.

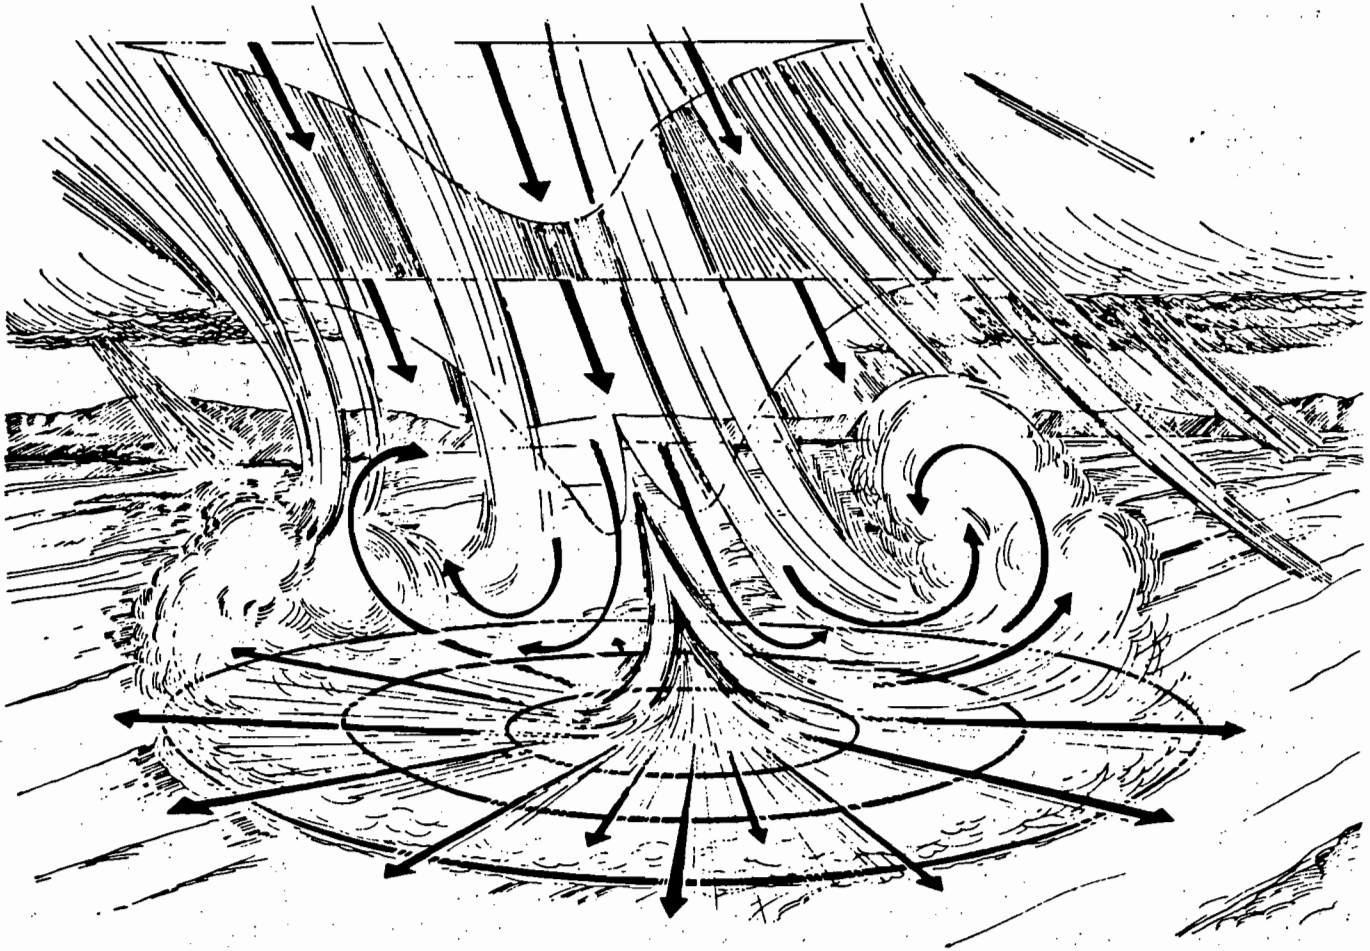
Figure 4.--Typical microburst wind field.

When a microburst is encountered during a landing approach, the airplane will typically experience an increasing headwind, a downdraft, and a decreasing headwind in rapid succession as it passes beneath the outflow and descending air column. The increasing headwind will be recognized as the indicated airspeed increases suddenly and the airplane tends to rise above the glidepath. However, this apparent increase in airplane performance is shortlived as the airplane enters the downdraft and encounters the decreasing headwind caused by the reversal in the direction of the outflow. The rapid reversal of wind direction and speed produces sudden changes in the airplane's angle of attack and airspeed, which may reduce the airspeed far below the initial stabilized airspeed. The reduced airspeed will result in reduced vertical lift, causing the airplane to accelerate downward. Furthermore, the airplane's longitudinal stability will cause the airplane to pitch nose downward as it attempts to reacquire its trim speed equilibrium. The extent to which the airplane's flight path changes depends upon the severity of the wind shear and the pilot's reaction with flight controls and engine thrust. The microburst might also create horizontal vortices which produces sudden changes of vertical wind speeds to further upset the longitudinal stability and perhaps the lateral and vertical stability of the airplane, exacerbating the pilot's control task.
