YOUR Inspection Report

443 Madison St.
Chicago, IL

HORIZON Professional Inspections
120 King St, Suite 418
Toronto, ON 60640

RE: Report No. 1366, v.39
443 Madison St.
Chicago, IL

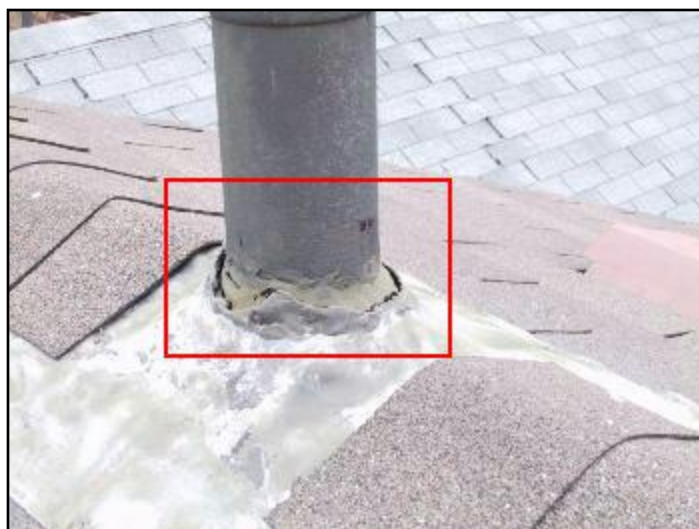
3. Condition: • [Leak](#)

Implication(s): Chance of water damage to contents, finishes and/or structure

Location: North

2. Leak

Task: Repair, immediate

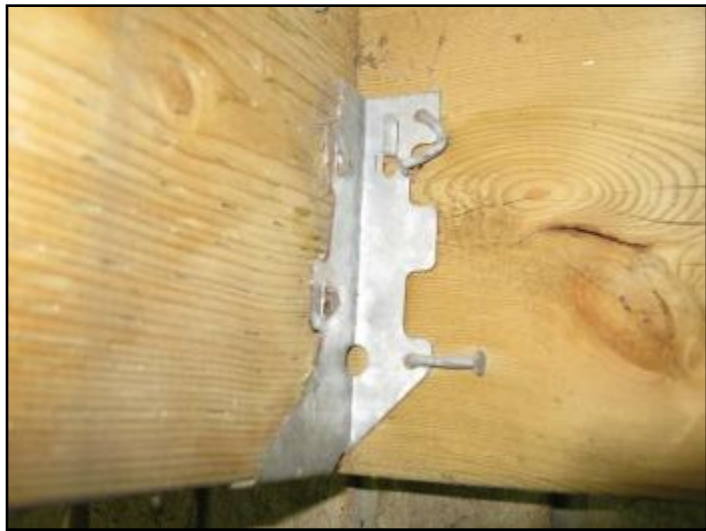
5. Condition: • [Fastener problems](#)

Joist hangers for wood deck are not properly nailed.

Implication(s): Weakened structure | Chance of movement

4. Poor end bearing, joist hanger connections

Task: Improve

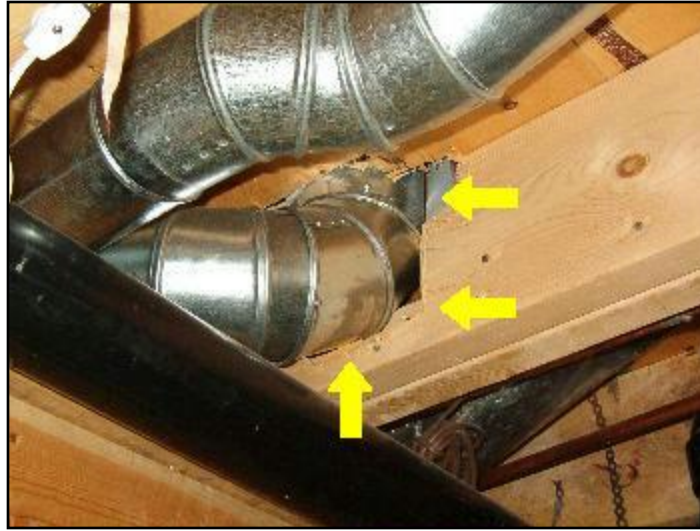
6. Condition: • [Notches or holes](#)

Implication(s): Weakened structure

Location: West

5. Joists are notched and weakened

Task: Repair

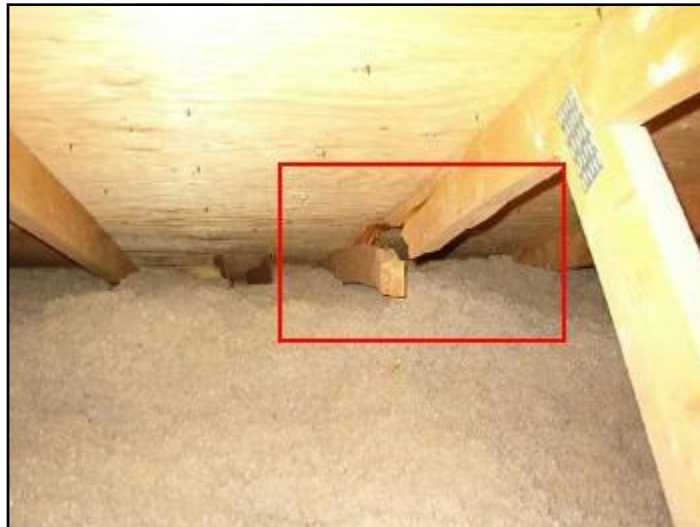
7. **Condition:** • Top chord of truss is broken

Location: North Attic

6. Top chord of truss is broken

Task: Replace

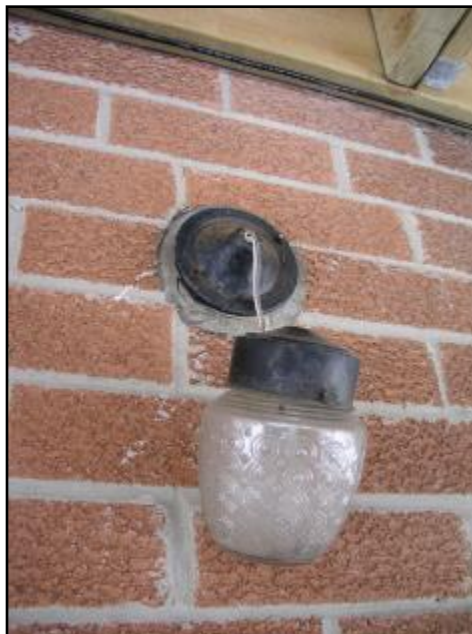
12. Condition: • [Loose](#)

Location: East Exterior wall

8. *Light fixture is not well secured*

Task: Repair or replace

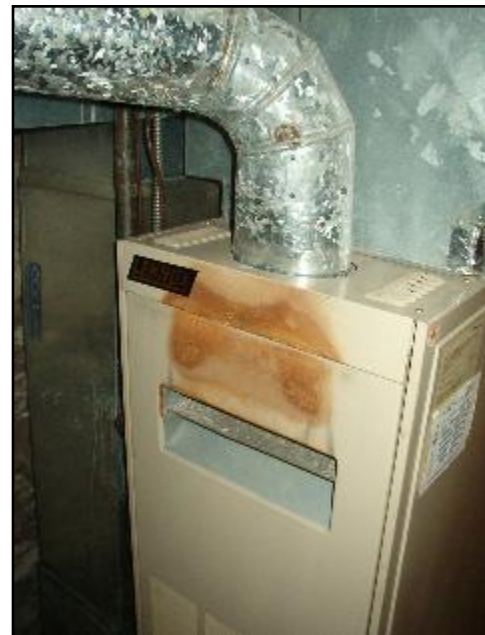
14. **Condition:** • [Draft hood spillage or backdraft](#)

This suggests a back-drafting problem, with combustion products entering the home.

10. Evidence of furnace backdrafting

Task: Correct

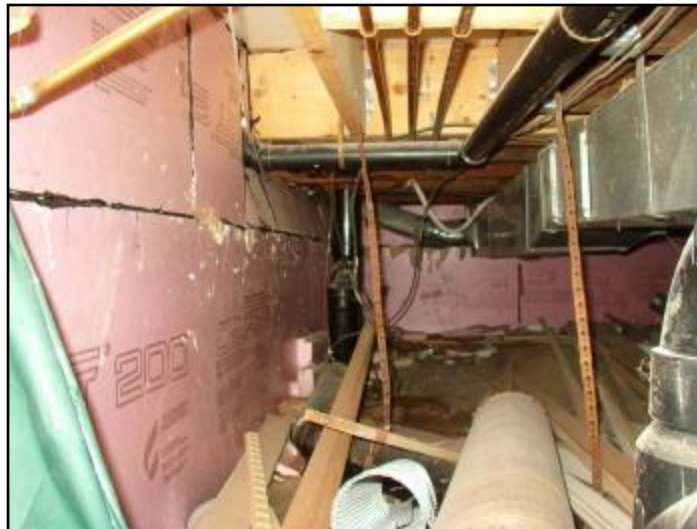
16. Condition: • [Exposed combustibile insulation](#)

Implication(s): Fire hazard

Location: West Crawl space

12. Exposed polystyrene insulation is fire hazard

Task: Remove or cover with drywall

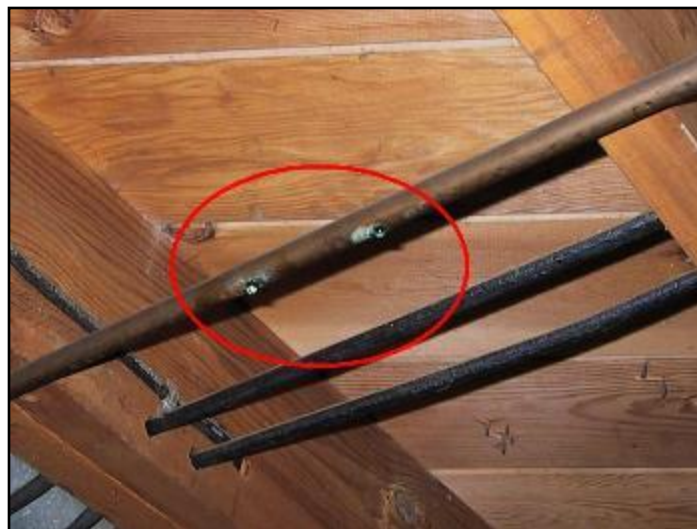
17. Condition: • [Leak](#)

Implication(s): Chance of water damage to contents, finishes and/or structure | System inoperative

Location: Northeast Basement

13. *Leaking copper supply pipe*

Task: Replace

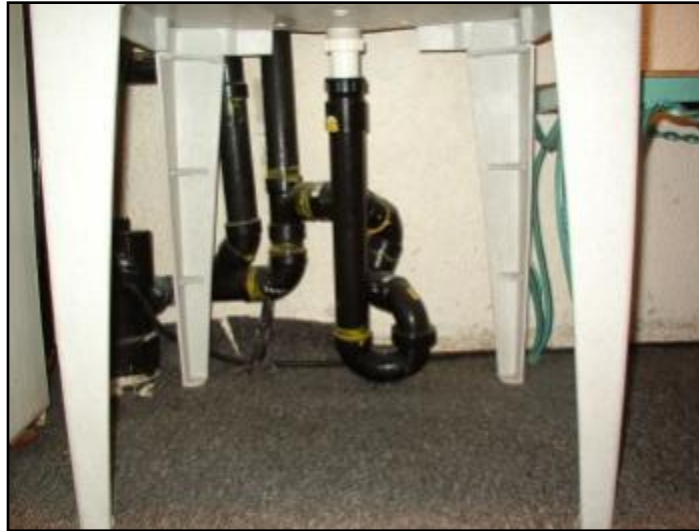
18. Condition: • [Nonstandard shape or material](#)

Implication(s): Reduced operability | Fixtures slow to drain

Location: Basement Laundry area

14. Poor trap arrangement

Task: Improve
Time: Immediate

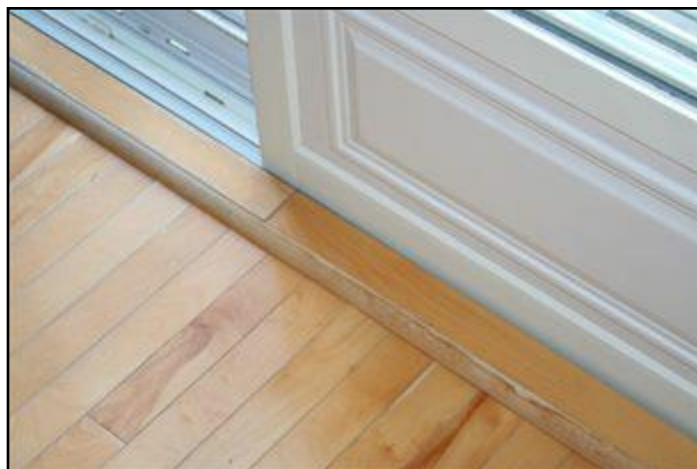
20. Condition: • [Stained](#)

Implication(s): Cosmetic defects

Location: North First Floor Family Room

16. Stained

Task: Repair
