MARINE OCCURRENCE REPORT

Report 05-201, passenger ferry *Quickcat* and restricted passenger vessel *Doctor Hook*, collision, Motuihe Channel

4 January 2005

TRANSPORT ACCIDENT INVESTIGATION COMMISSION
NEW ZEALAND

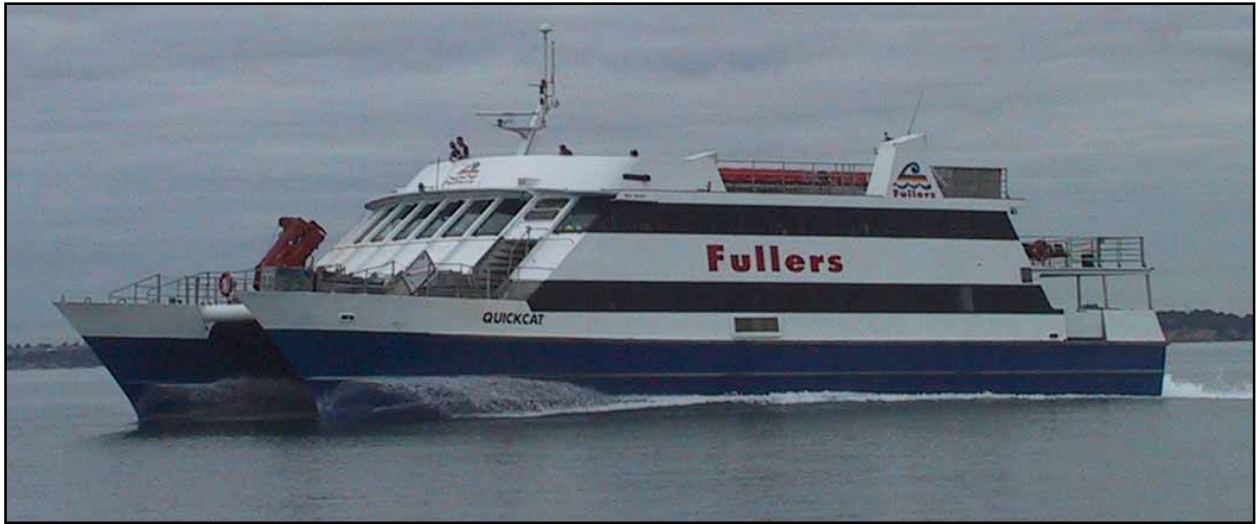
The *Quickcat* under way after the accident

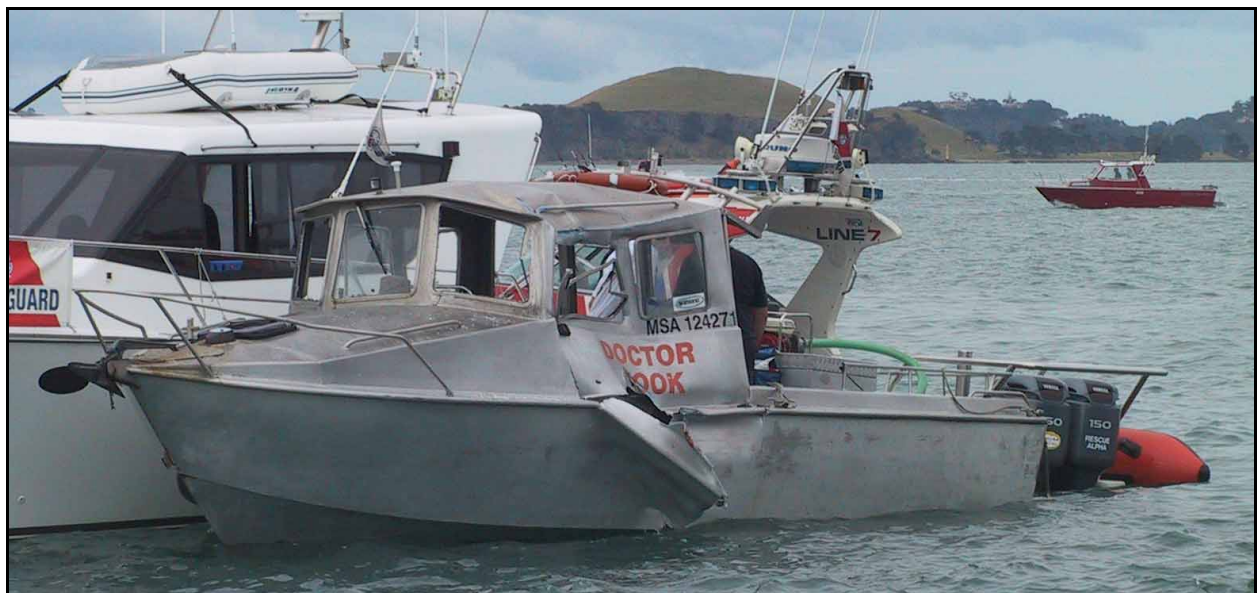
The *Doctor Hook* with 2 rescue boats alongside after the accident

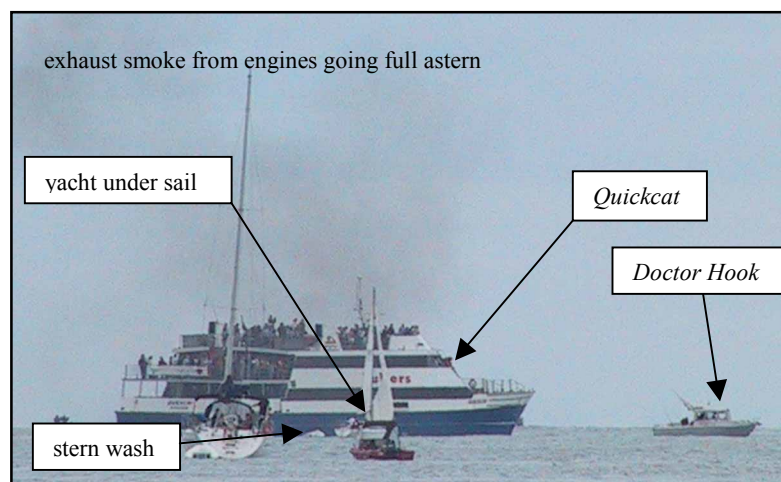
Figure 2
Accident scene just after the collision

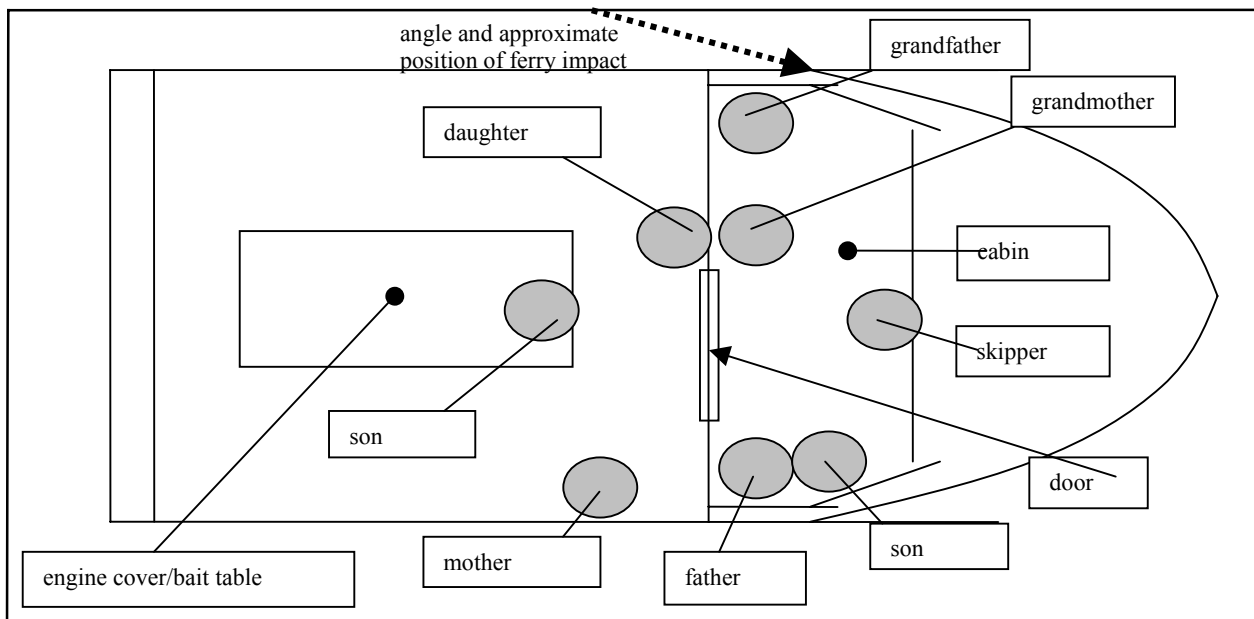
Figure 4
Passenger and crew positioning on board the *Doctor Hook* just prior to impact

- 1.1.16 Seeing the ferry at what he thought was about 200 m to 300 m away, the father asked the skipper if he was aware of the ferry astern. The skipper turned in his chair and looked aft and the father thought he had seen it. However, the skipper later recollected that he had glanced aft but could not see the ferry through the windows as the grandmother obscured his view.

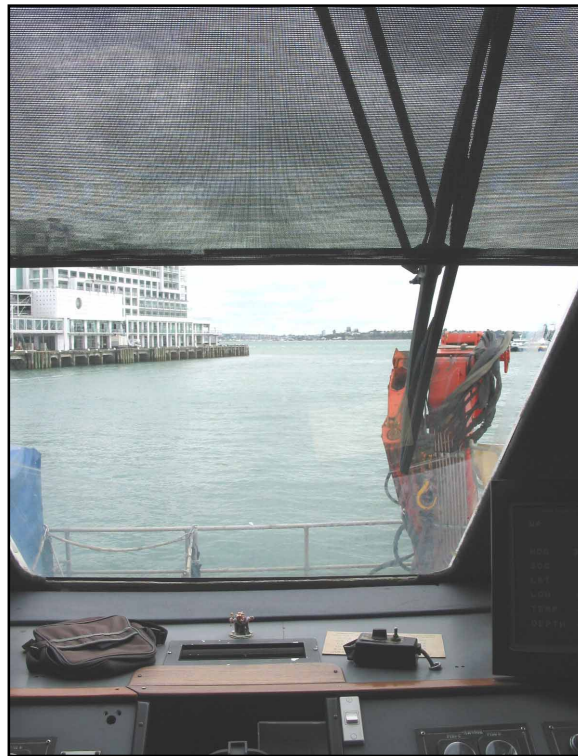
- 1.2.5 In the stowed position the crane stood 2.8 m high, restricting the forward view to the starboard side from the conning position (see Figure 5). The restriction was such that a small platform had been provided for the Master to stand on to see over the crane and it was common practice for the Master to stand up or lean over to starboard to see around the crane.

Figure 5
View from conning position on board the *Quickcat*

- 2.10 It is probable that the angle of closure of the 2 vessels was such that the smaller *Doctor Hook* was masked in the blind spot caused by the freight crane on the foredeck of the *Quickcat* (see Figure 5). As a risk of collision existed, the bearing would have remained steady and the *Doctor Hook* remained hidden behind the crane. The Master would have had to move from the conning position to see around the crane to have seen the *Doctor Hook*.

- 2.15 Although there was no recorded evidence of the poor visibility caused by the crane being a hazard, it may have been aired anecdotally; but this could not be substantiated. However, the restriction in visibility was known about, as unwritten procedures such as leaning to the starboard side or standing on a specially constructed box had evolved to enable the Master to see around the obstruction and maintain his lookout.

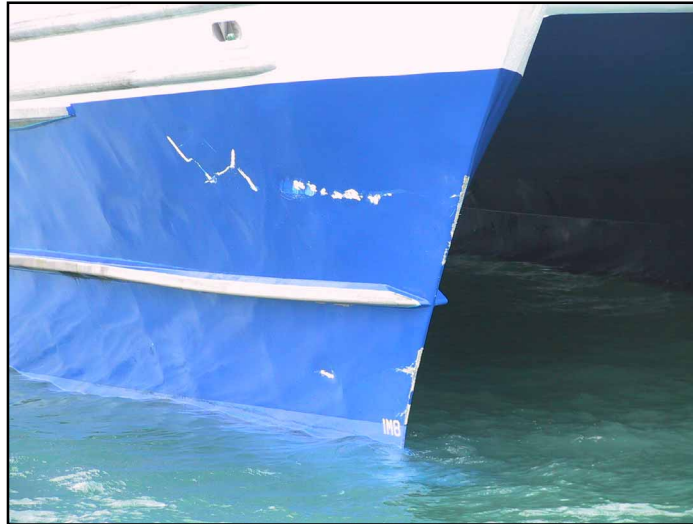
- 1.3.1 The *Quickcat* sustained only superficial damage to the paintwork on the starboard side of the starboard hull (see Figure 6).

Figure 6
Damage to the *Quickcat*'s hull

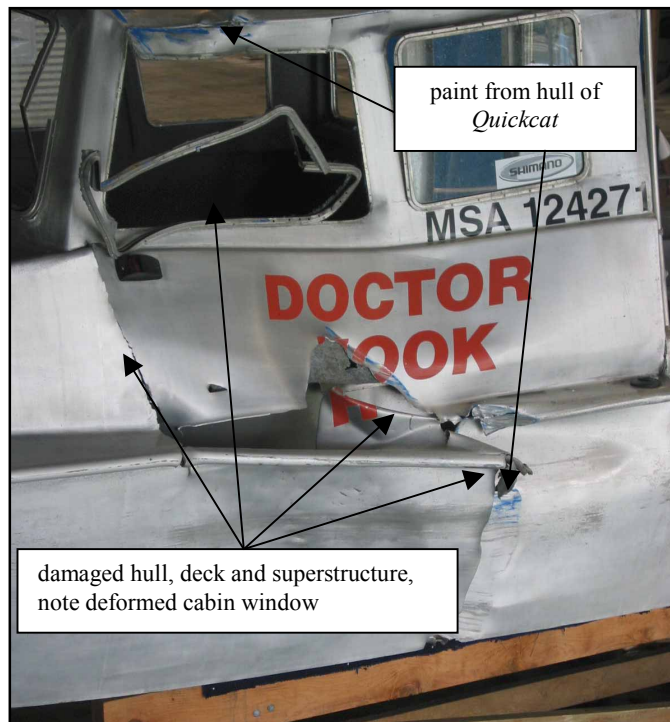
- 1.3.2 The *Doctor Hook*'s hull was torn midway along the port hull from near the waterline to the top of the sheerstrake. The deck was torn and the cabin superstructure torn and displaced in the area of the impact. The whole cabin superstructure was deformed towards the forward end, and most of the windows were displaced or broken except along the rear cabin bulkhead (see Figure 7).
- 1.3.3 The *Doctor Hook* was declared a constructive total loss.

Figure 7
Damage to the port side of the *Doctor Hook*

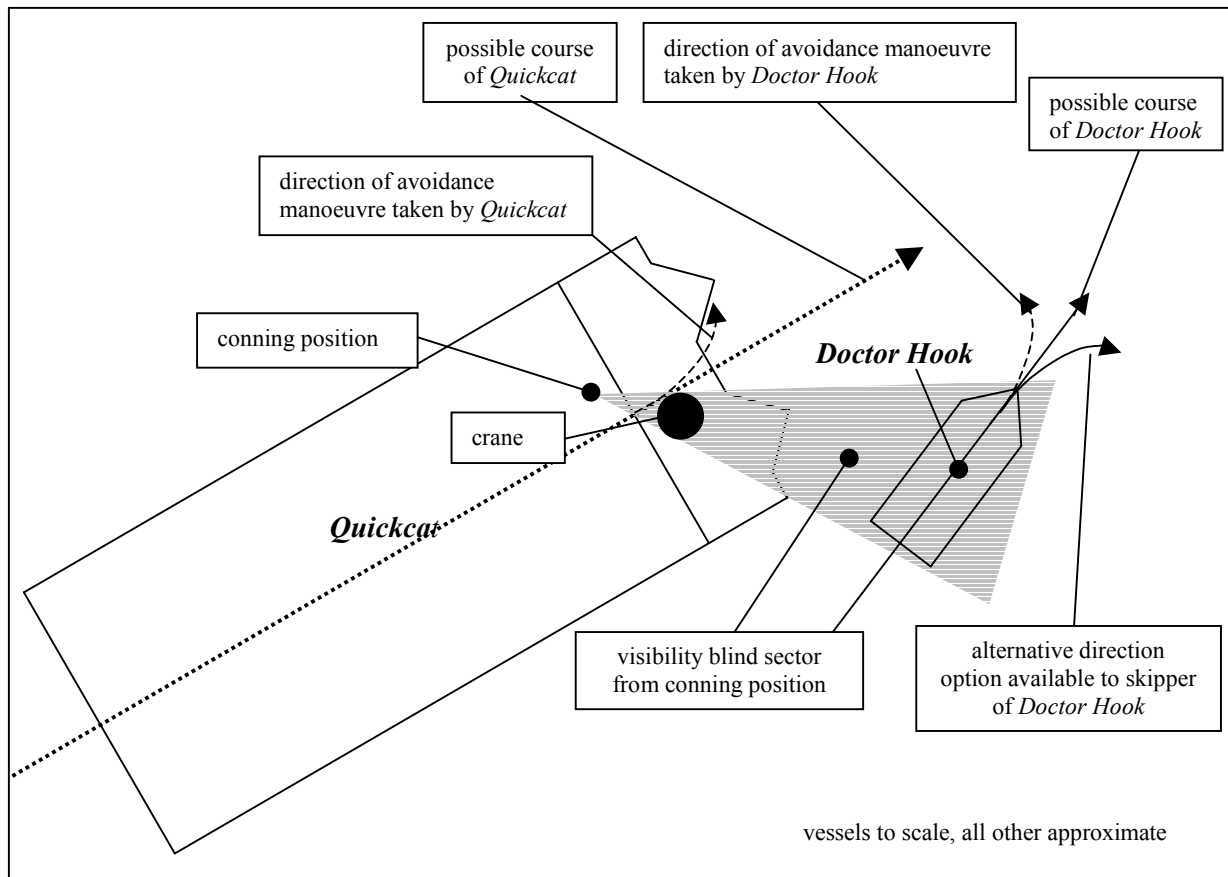
Figure 8
Plan of emergency manoeuvres taken by the *Quickcat* and the *Doctor Hook*

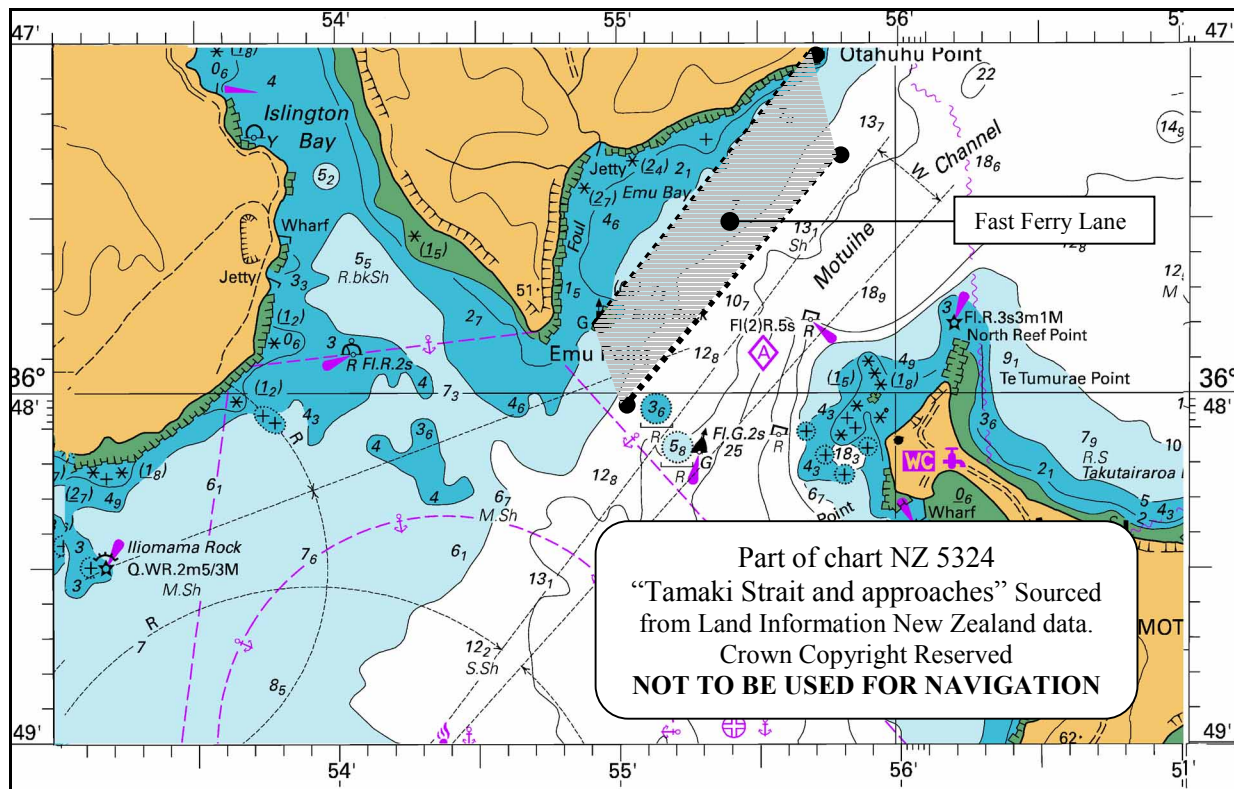
Figure 9
Chart showing Fast Ferry Lane as directed by the Auckland Regional Harbourmaster

- 4.3 In view of the safety actions taken by Fullers, no further safety recommendations covering these aspects have been made to Fullers.
- 4.4 After the accident, the Auckland Regional Council Harbourmaster undertook a review of the area of the accident. After the review and consultation with interested parties, he issued the Harbourmaster's Direction 1-05. It stated, in part:

- 1) Preamble**
- These directions are issued under section 650C(3)(a) of the Local Government Act 1974. They:
- Define the limits of the "Motuihe Channel Fast Passenger Ferry Lane".

- Prescribe the manner in which vessels must navigate within this lane.
- Prescribe activities, which are prohibited within this lane...
- 4.5 In view of the safety actions taken by Auckland Regional Council, no safety recommendations covering these aspects have been made to Auckland Regional Council.
