TMS-NTC-14022 February 26, 2014

Re: Toyota Safety Recall 13V-396 Dealer Notification (Remedy)

Subject: Safety Recall D0M – Remedy Available

Intelligent Power Module (IPM) Replacement

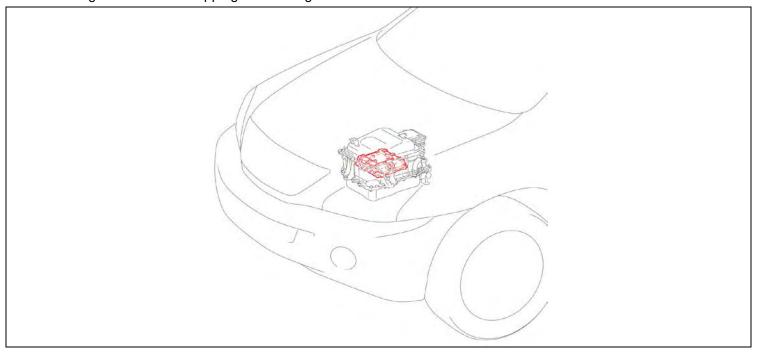
II. BACKGROUND

Within the vehicle, inside the inverter assembly is an Intelligent Power Module (IPM) which contains a control board equipped with transistors. The solder underneath these transistors could degrade and eventually cause damage to them, illuminating various warning lights on the instrument panel. In most cases, the vehicle will enter a fail-safe mode, resulting in reduced motive power in which the vehicle can still be driven for short distances. In limited instances, the fuse of the power supply circuit could blow, causing the hybrid system to shut down and resulting in the vehicle stopping while being driven.

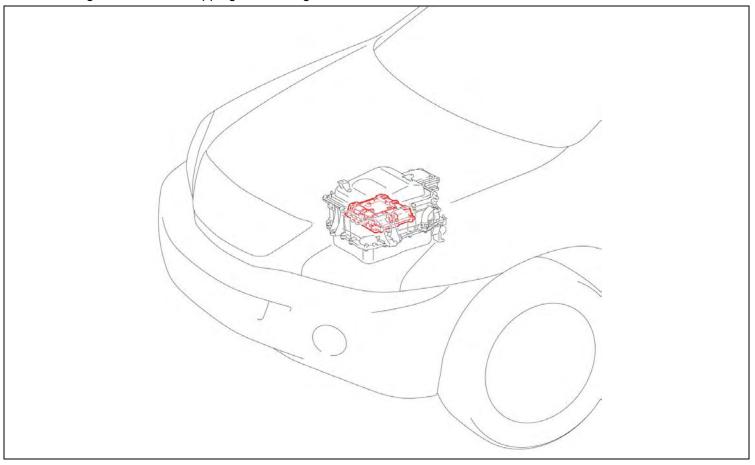
II. BACKGROUND

Within the vehicle, inside the inverter assembly is an Intelligent Power Module (IPM) which contains a control board equipped with transistors. The solder underneath these transistors could degrade and eventually cause damage to them, illuminating various warning lights on the instrument panel. In most cases, the vehicle will enter a fail-safe mode, resulting in reduced motive power in which the vehicle can still be driven for short distances. In limited instances, the fuse of the power supply circuit could blow, causing the hybrid system to shut down and resulting in the vehicle stopping while being driven.
