# Property Condition Report

## Sample – Commercial Building Inspection Report

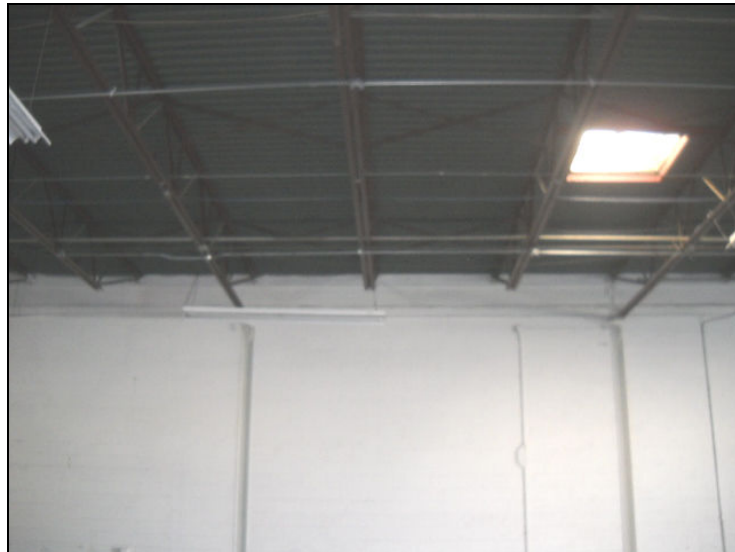
View of structural components and build methodology.

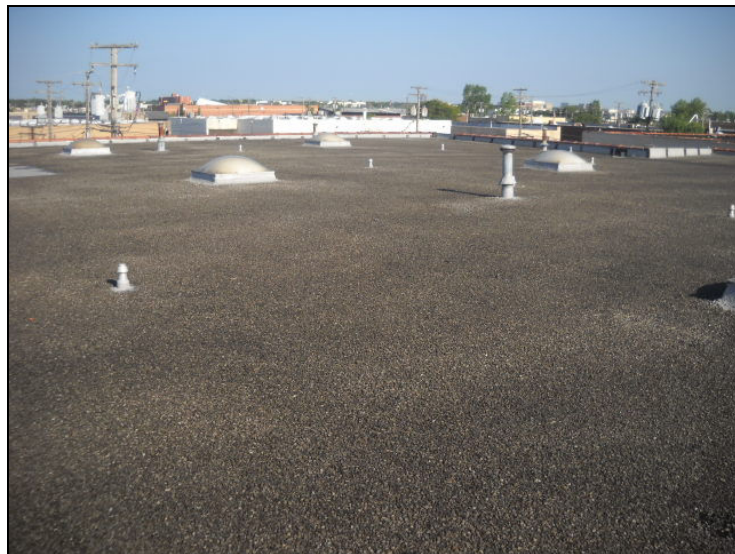
View of roof surface.

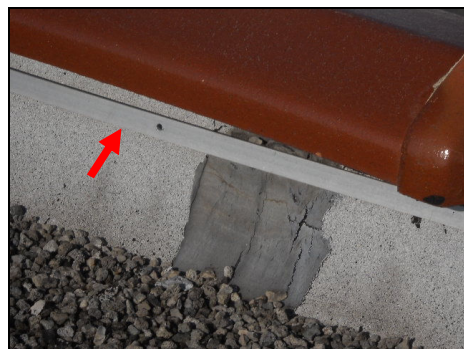
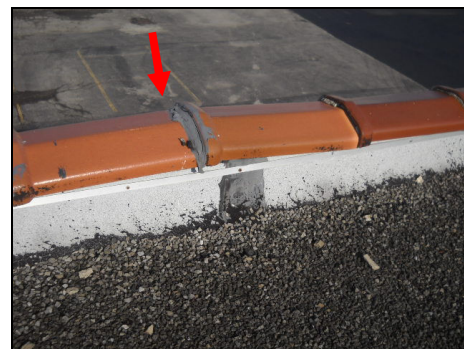
Loose support bands and coping observed at multiple areas.

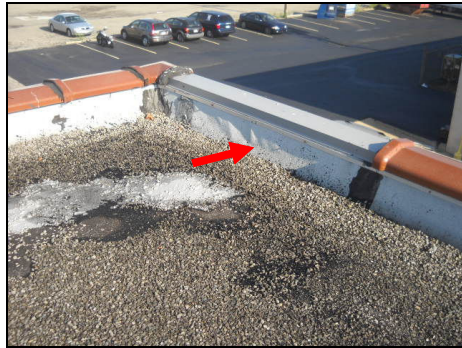
Loose material at parapet wall.

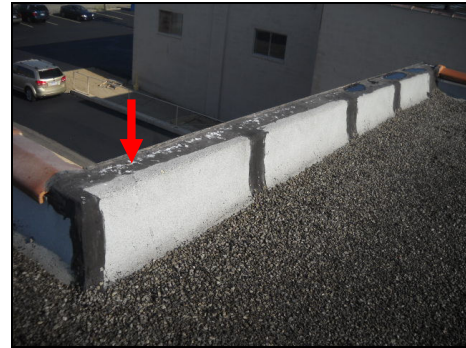
Missing coping on parapet wall.

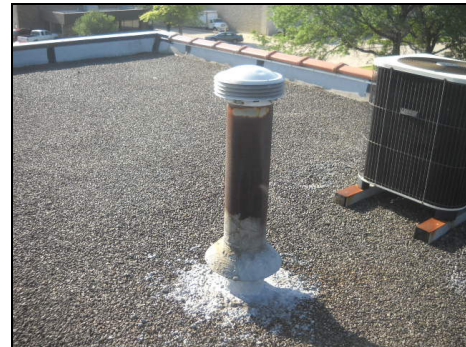
Surface corrosion on chimneys.

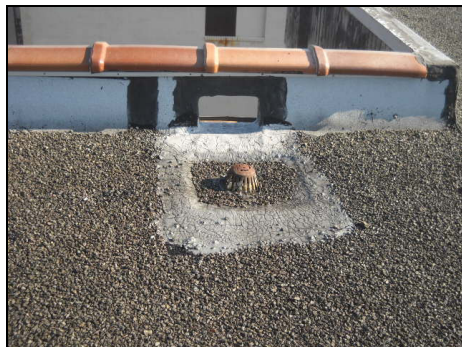
Roof drains need to be cleared of debris.

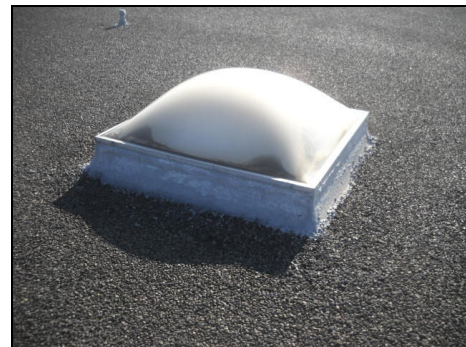
Skylight flashing needs caulking.

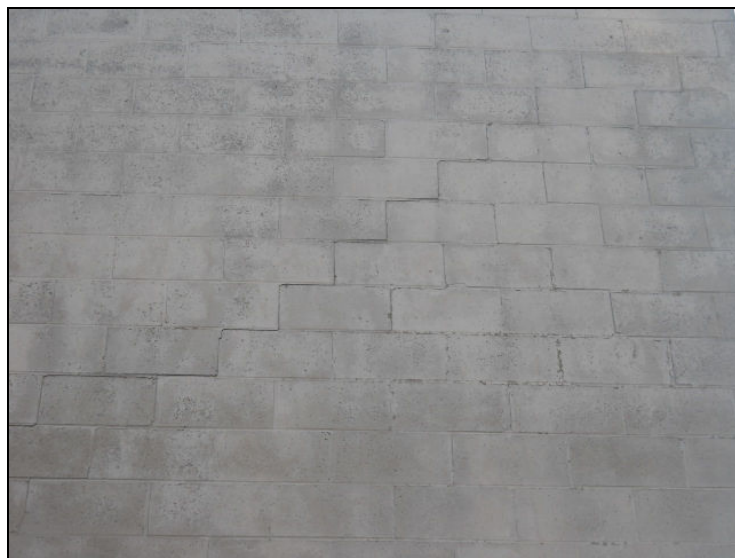
General condition of block exterior wall.

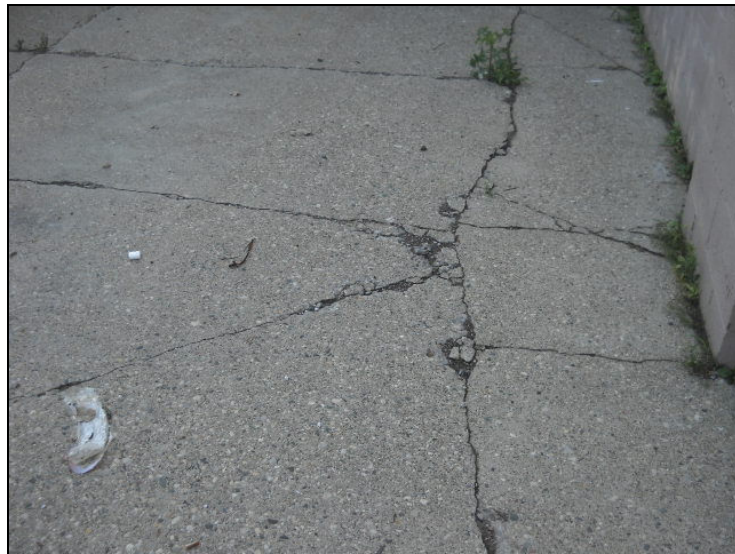
General condition of concrete serving the truck well.

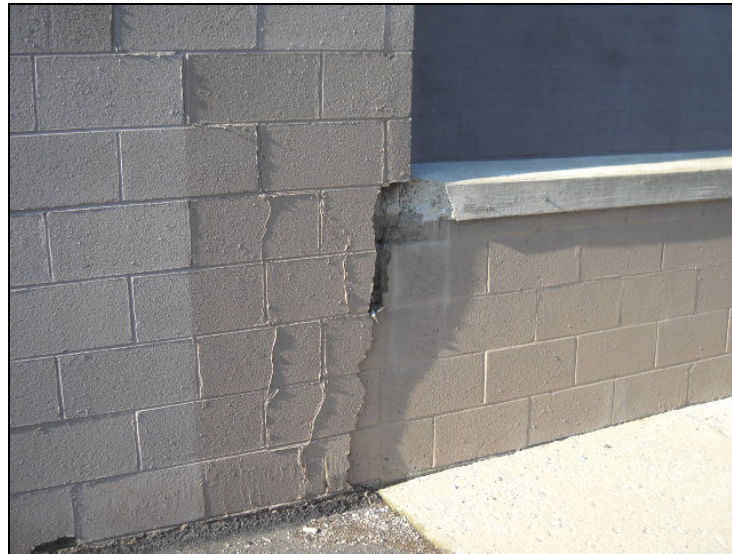
Block and cap damage at retaining wall for truck well.

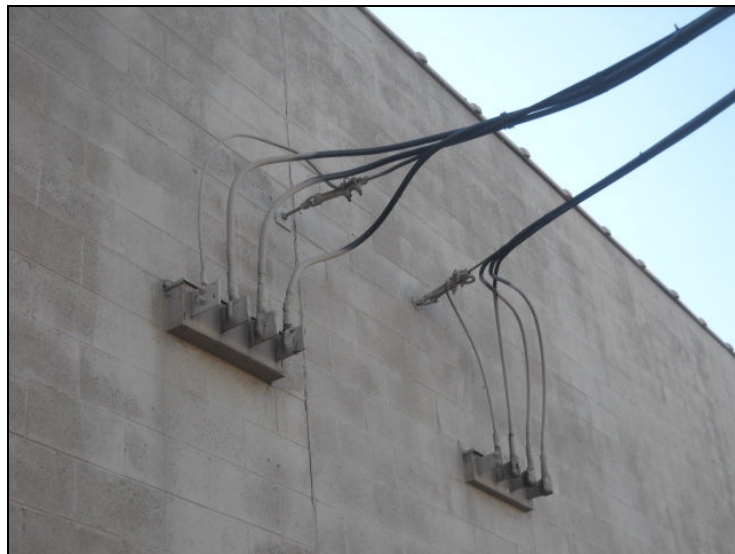
Input lines for both sections of the building.

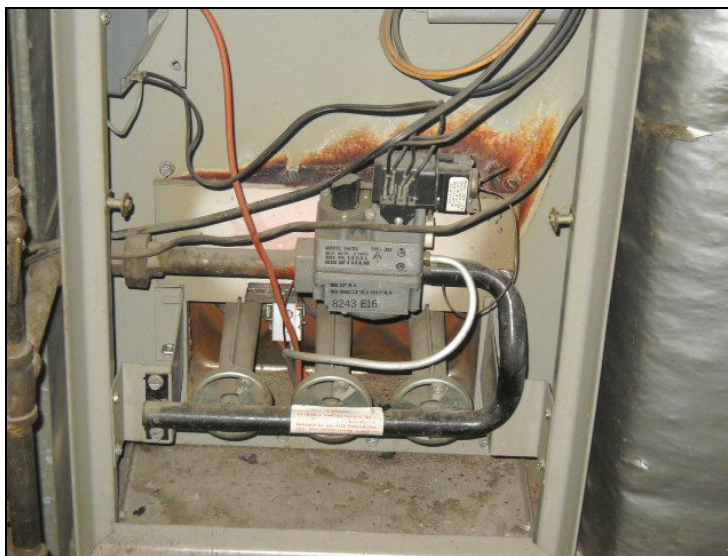
Representative views of furnace systems.

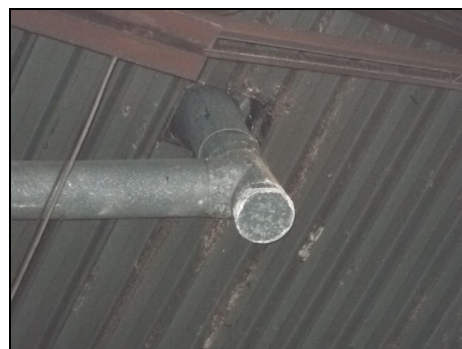
Evidence of roof leakage at chimney protrusion.

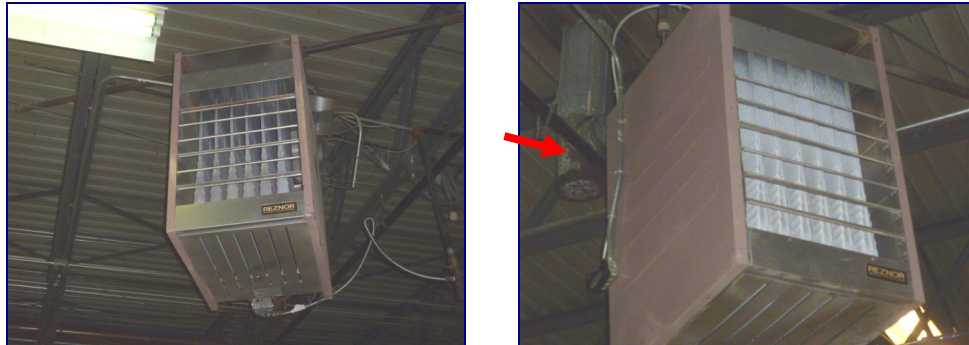
Representative view of warehouse units. Note the corrosion on the vent stack – probable flashing leak at roof.

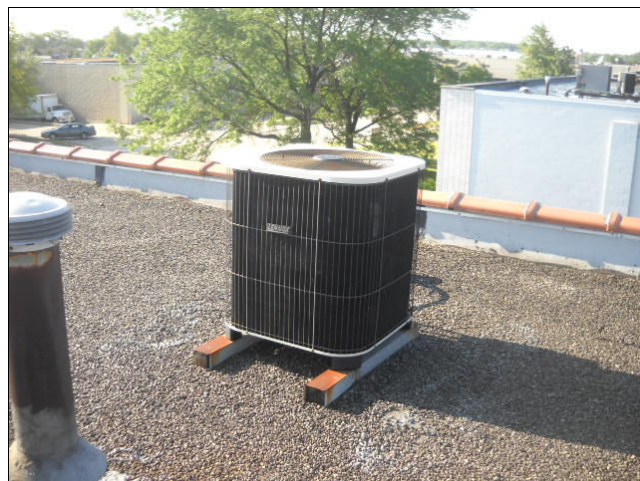
Older condenser unit serving west side.

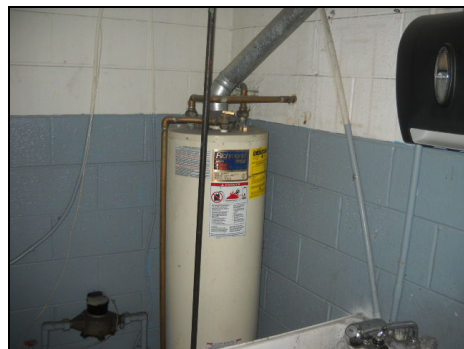
Representative hot water tank.

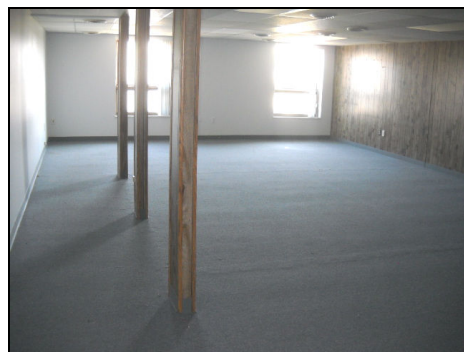
View of interior office space.

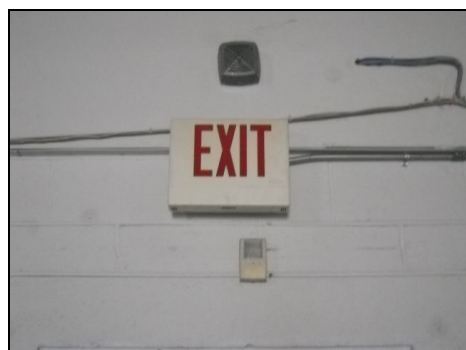
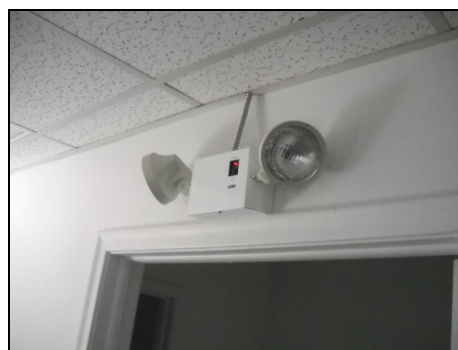
Representative view of installed fire protection equipment.

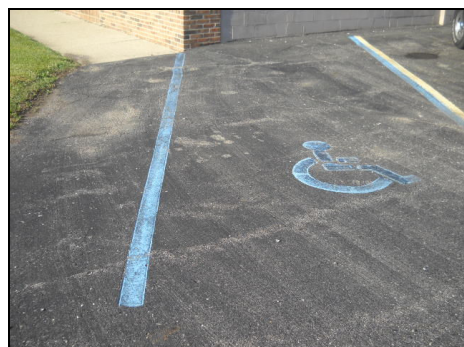
Present, yet insufficient ADA parking.

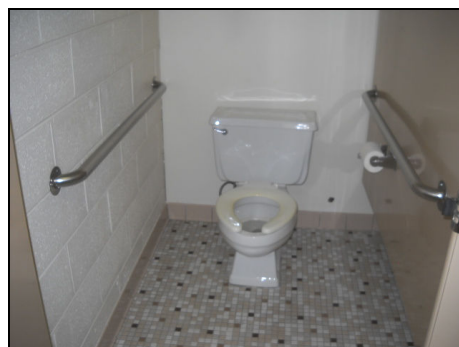
Wheelchair accessible bathroom stall.
