# Service Bulletin

Bulletin No.: 18-NA-183

**Subject: Squeak and/or Clunking Noise from Rear of Vehicle**

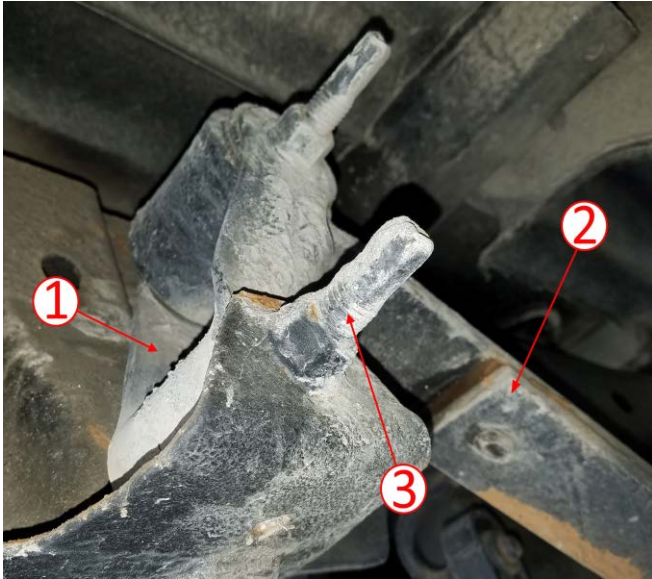
5084560

- If squeak noise is coming from the rear Spring Shackle (1) lower bolt area (3), jump ahead to step #11.
- If the noise is coming from the leaf springs (2), proceed to the next step.

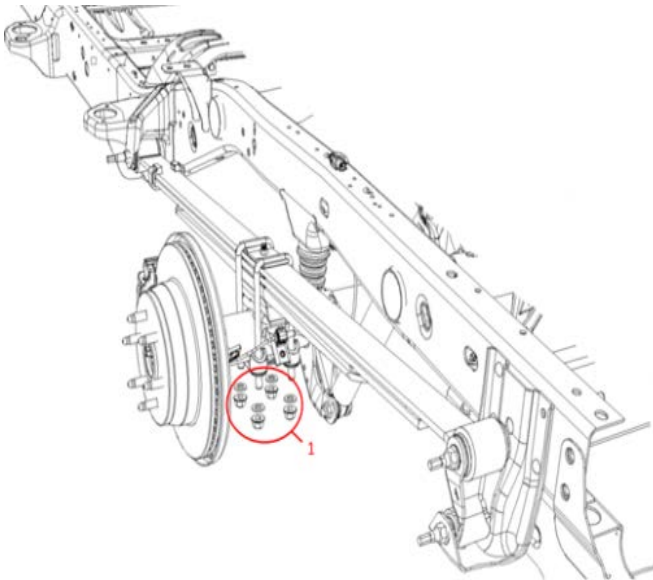
5344028

4. Loosen the anchor plate U-bolts (1).
5. Re-torque the anchor plate U-bolts (1). Refer to Fastener Specifications in SI.
6. Repeat steps # 2 – 5 for the opposite side leaf spring.

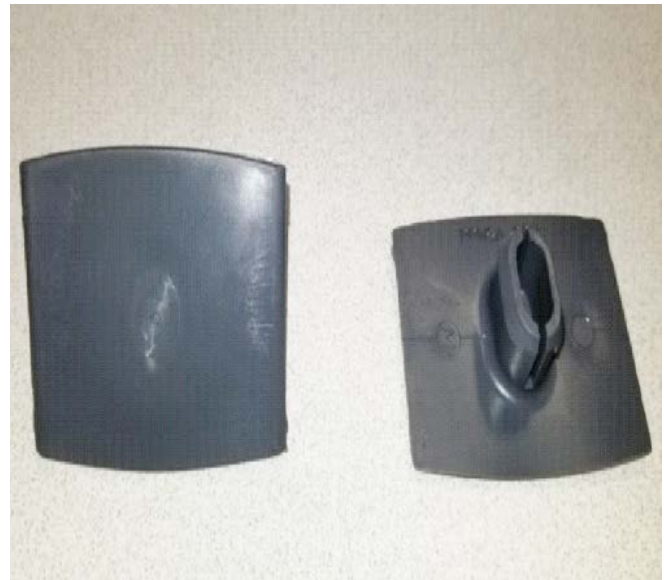
5341853

7. Install new Rear Leaf Spring Inserts using the following procedure:

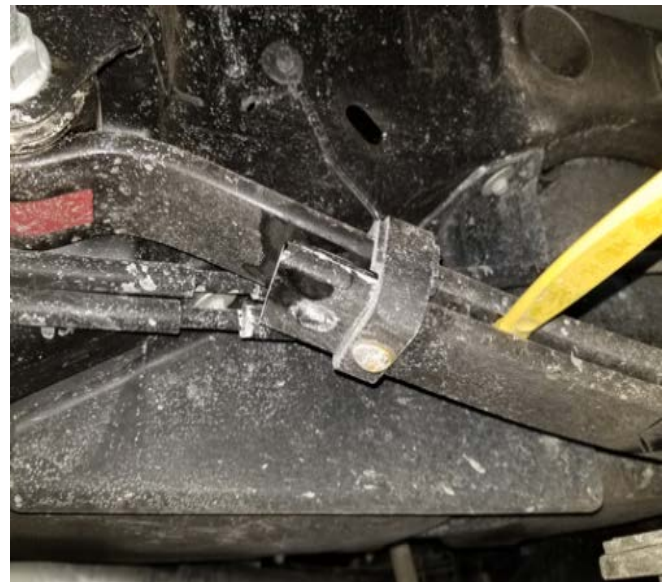
5341854

- 7.1. On the forward side of the spring assembly, insert a plastic trim tool or plastic wedge in between the #1 and #2 leaf springs, to access the old insert.

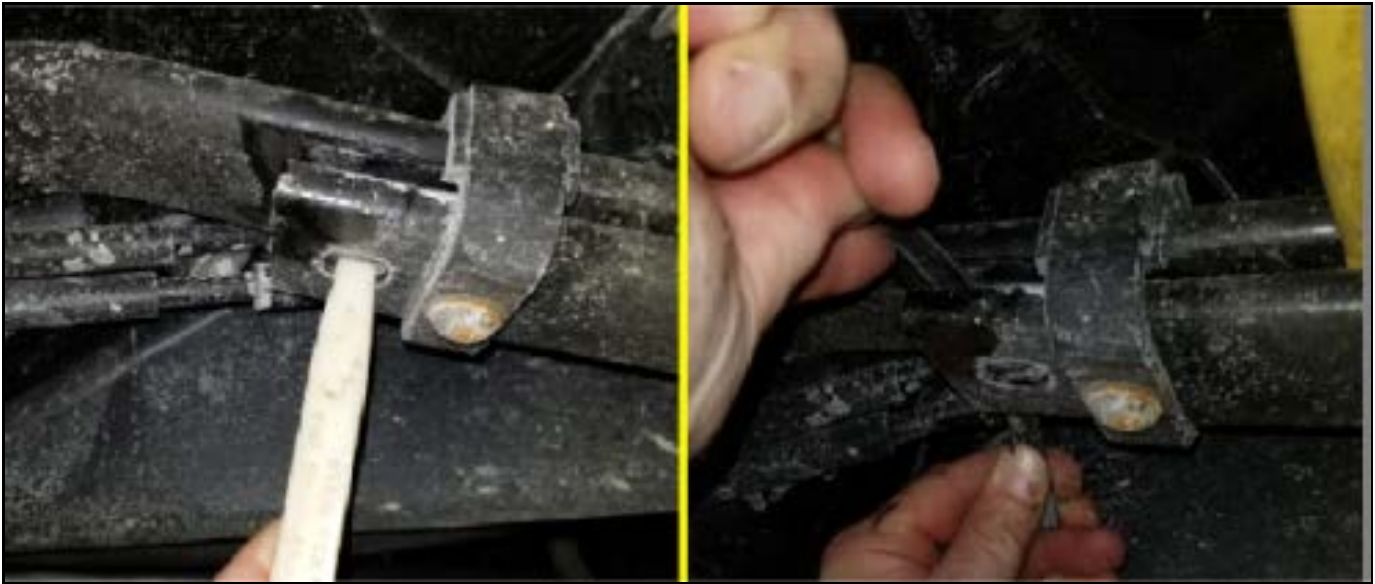
5341855

7.2. Push up on insert until it hits the bottom of the spring above it. Then use a suitable cutting tool to cut the stem off from the insert.

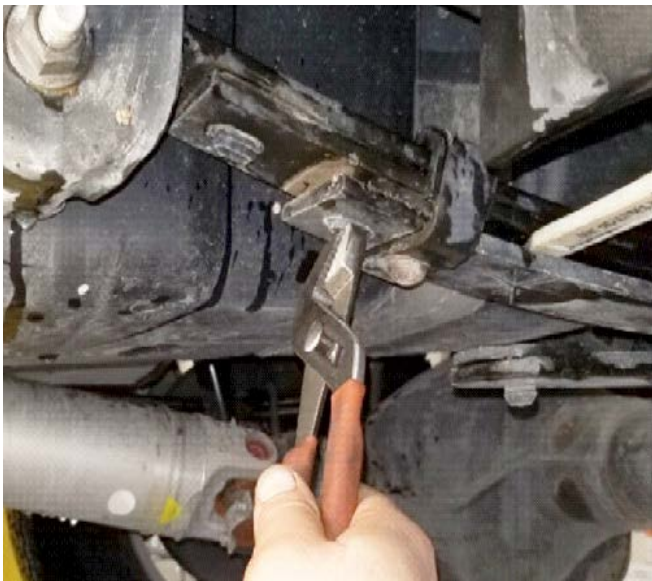
5341856

7.3. Remove the top portion of the insert, and then remove the bottom portion of the remaining stem.

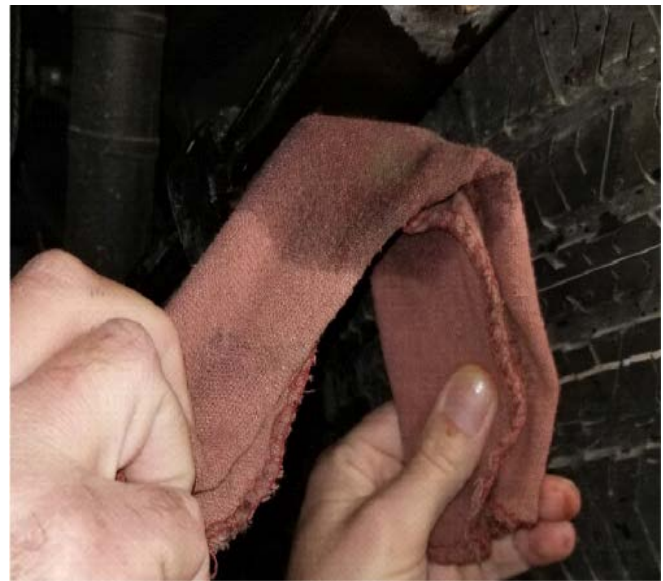
5341857

7.4. Using a rag and degreaser, clean any dirt or grease from between the leaf springs at the insert location.

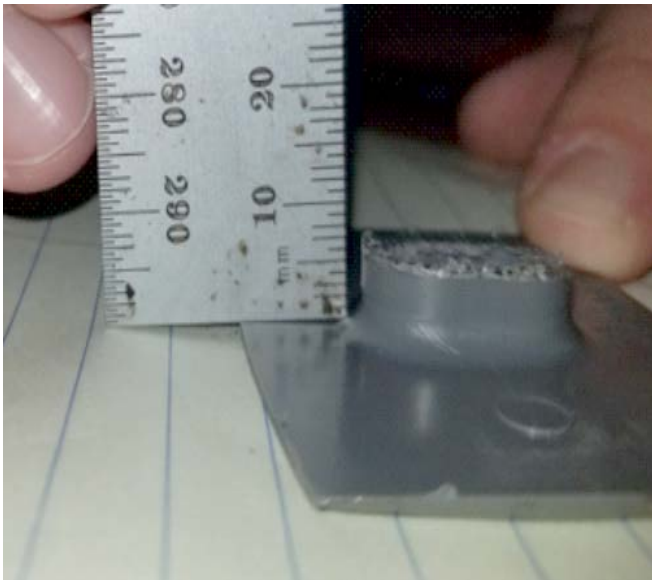
5341859

- 7.5. Cut the stem of the new insert with a hacksaw or suitable cutting tool. Make sure to leave 6 mm (0.240 in) of the stem.

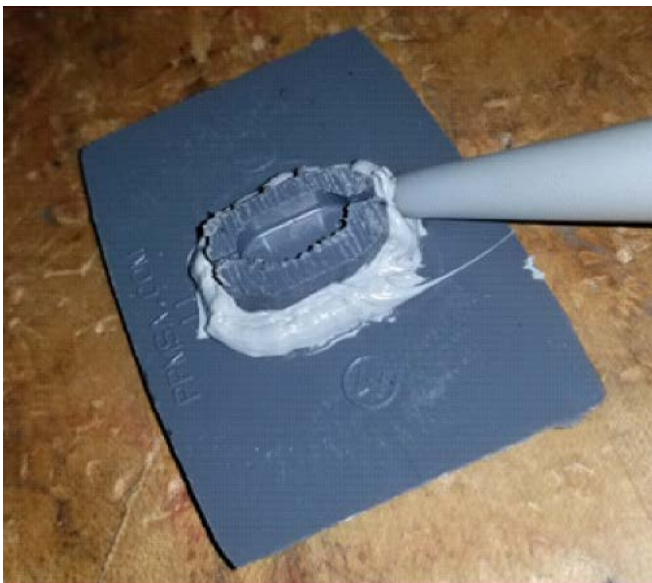
5341861

- 7.6. Apply a small amount of RTV sealer around the remaining portion of the stem.
- 7.7. Install the new insert into the leaf spring. Make sure the stem portion lines up with the slot in the spring. Remove the plastic trim tool or plastic wedge to close the spring and seat the new insert.

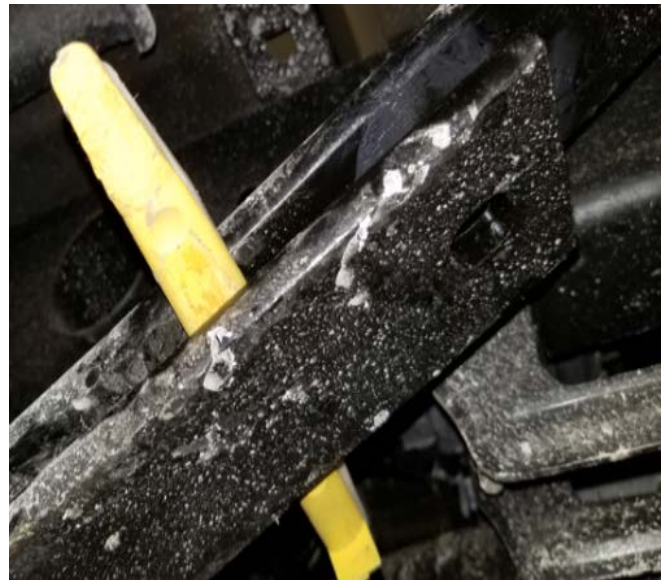
5341863

**Note:** On the rearward side of the leaf spring, DO NOT trim/cut the new replacement insert.

8. On the rearward side of the spring assembly, insert a plastic trim tool or plastic wedge in between the #1 and #2 leaf springs to access the old insert.
  - 8.1. Remove the old insert.

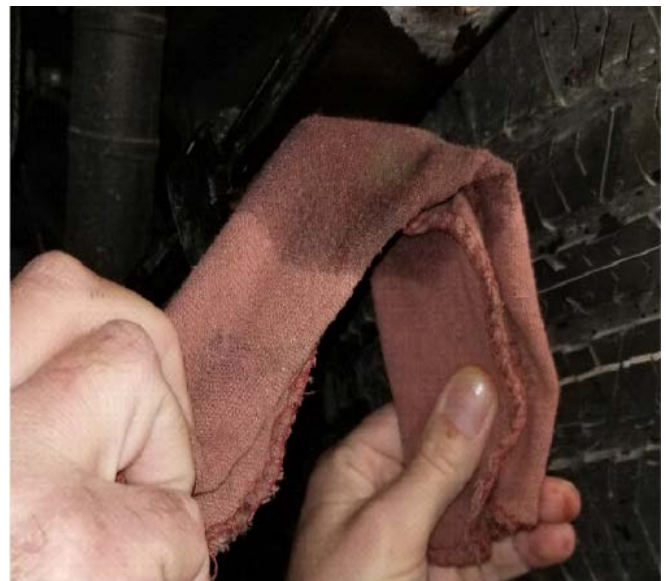
5341857

- 8.2. Using a rag and degreaser, clean any dirt or grease from between the leaf springs at the insert location.
