Applies To: **2001–03 3.2CL (including Type S) – ALL**
2000–03 3.2TL (including Type S) – ALL
2004 TL – From VIN 19UUA66..4A000001 thru 19UUA66.4A014224

April 8, 2005

Safety Recall: CL and TL Automatic Transmission 2nd Gear Inspection

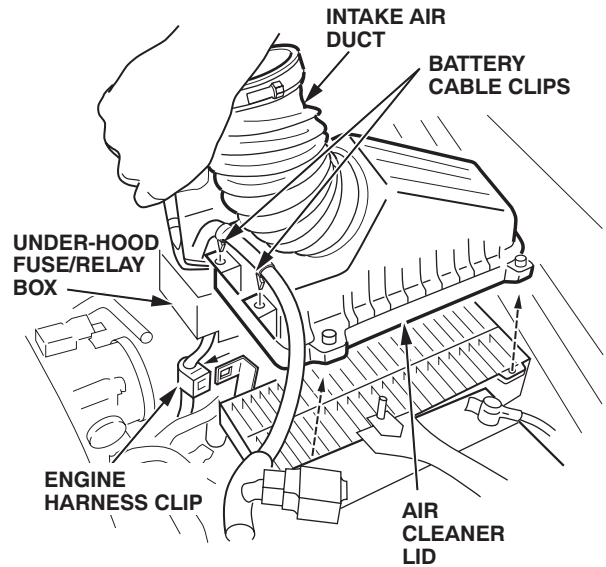
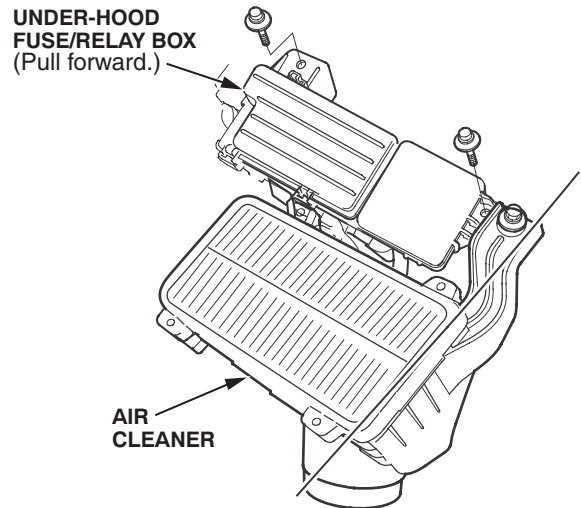
4. *'04 TL models:* Remove the two 10 mm bolts from the under-hood fuse/relay box. Then detach the engine harness clip from the fuse/relay box, and pull the fuse/relay box forward.

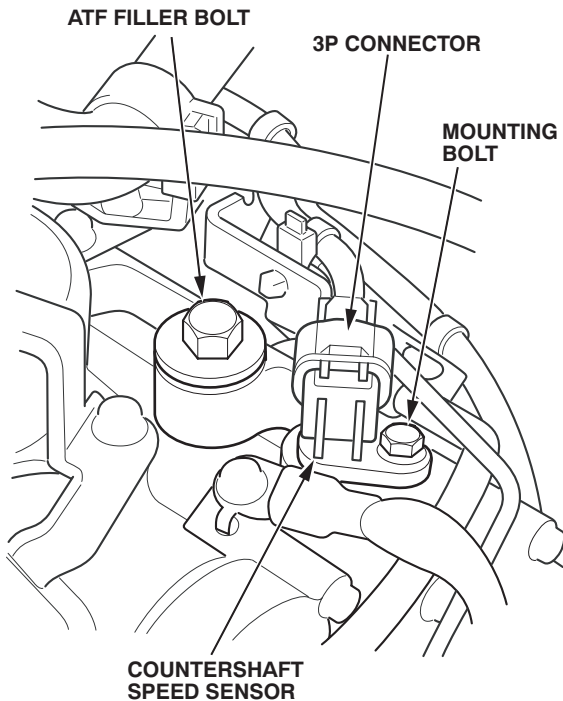
6. Unplug the countershaft speed sensor 3P connector, and remove the sensor mounting bolt. Gently twist the sensor left and right until it loosens, then remove the sensor and its O-ring.

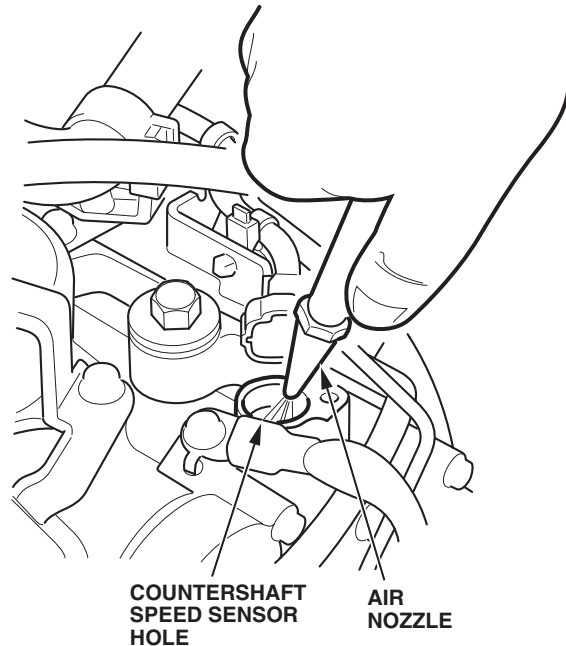
8. Use a clean shop towel to wipe the sensor hole bore.

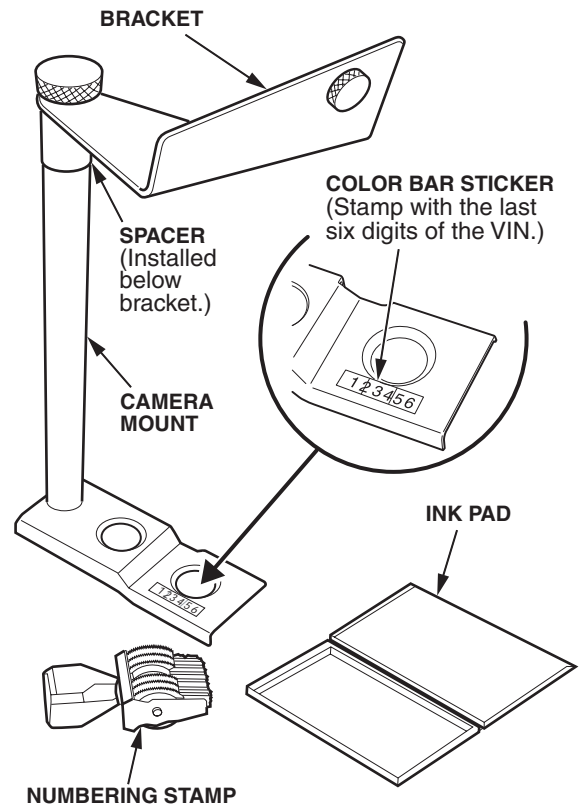
12. On the camera mount, position the spacer below the bracket.
13. Remove the ATF filler bolt.

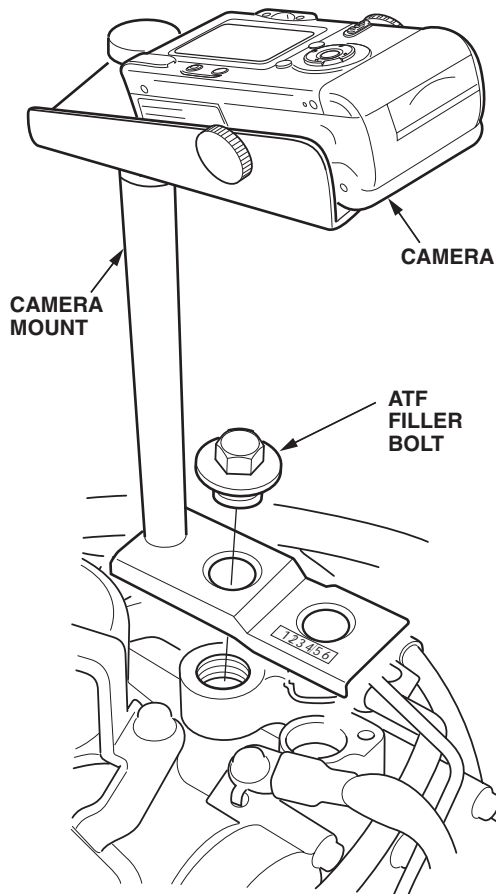
15. Attach the camera to the camera mount. Be careful not to damage the plastic threads in the bottom of the camera.
16. *3.2CL and 3.2TL models:* Detach the throttle cable from the cable bracket on the driver's side of the bulkhead. Before taking any photos, move the throttle cable and the purge control hose out of the way.

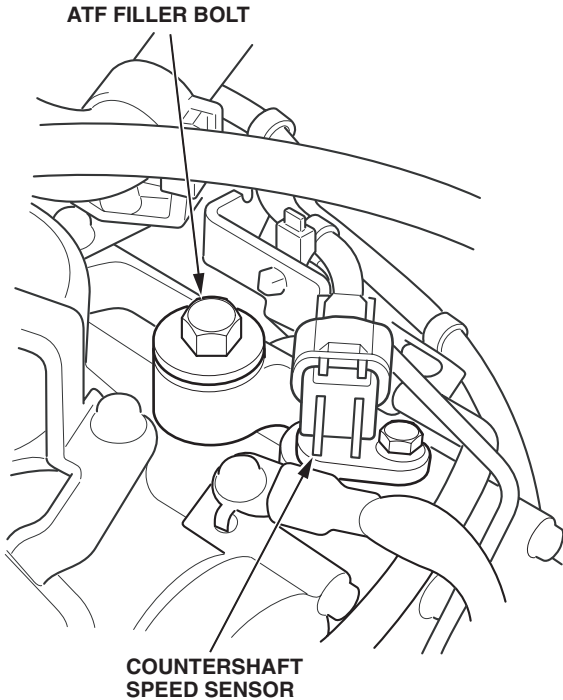
1. *3.2CL and 3.2TL models:* Detach the engine harness clips from the ATF oil line.
2. *3.2CL and 3.2TL models:* Clean the area around the ATF filler bolt, the countershaft speed sensor, and the ATF filter lines. Go to step 11.

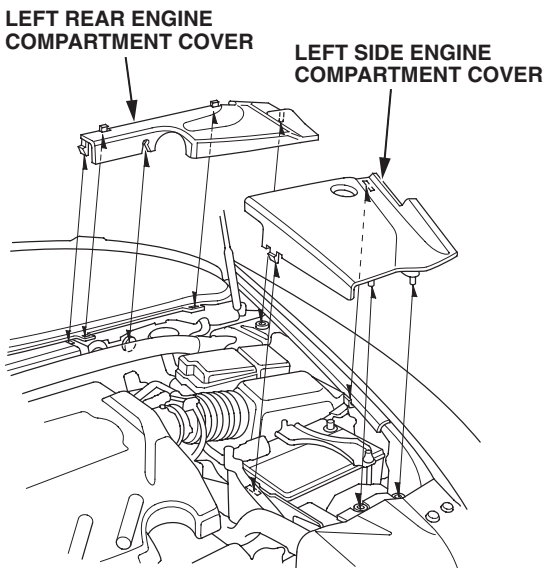
3. *'04 TL models:* Remove the left side and left rear engine compartment covers.

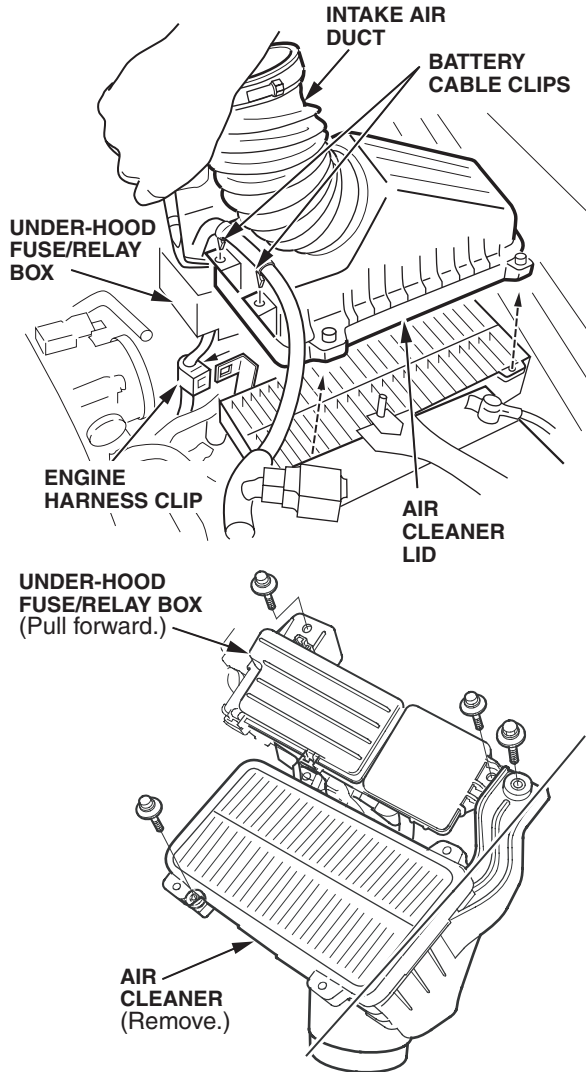
4. *'04 TL models:* Unbolt the air cleaner lid, detach the battery cable clips from the lid, then remove the air cleaner lid, the intake air duct, and the air cleaner.

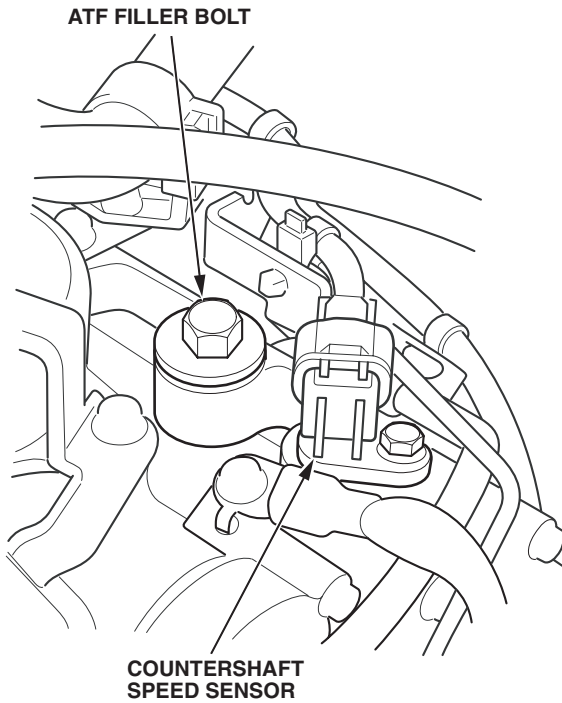
- '04 TL models: Clean the top of the A/T around the ATF filler bolt, the countershaft speed sensor, and the ATF lines.

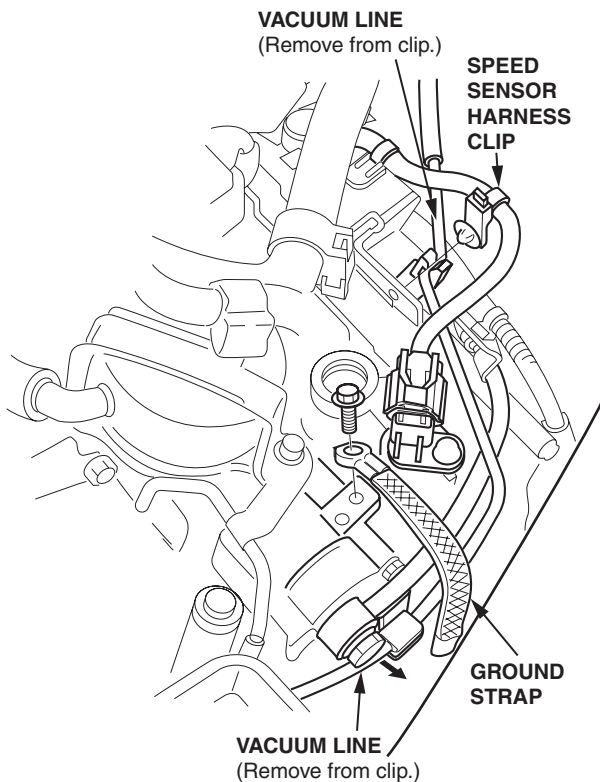
- '04 TL models: Remove the A/T ground strap.
- '04 TL models: Detach the wire harness from the ATF filter line bracket.
- '04 TL models: Remove the metal vacuum lines from the two clips on the A/T cooler hose assembly.

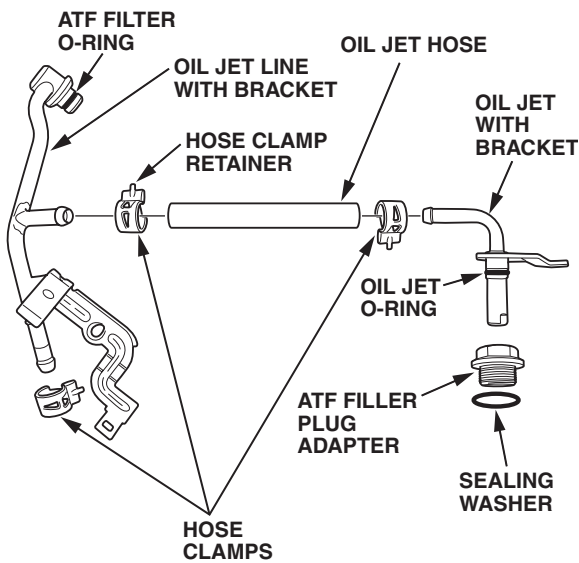
3.2 CL and 3.2 TL

13. Assemble the A/T Oil Jet Kit outside the vehicle, but *do not attach the oil jet onto the oil jet hose yet.*

- Each hose clamp has a retainer to hold it in its spread position. To install a hose clamp, slide it into position (7 mm from the end of the hose), and use pliers to pull off the retainer.
- Use clean ATF to assemble all metal-to-rubber lines and hoses. *Do not use grease or any other lubricants.*
- Make sure you slide the oil jet hose onto the T-fitting on the oil jet line.

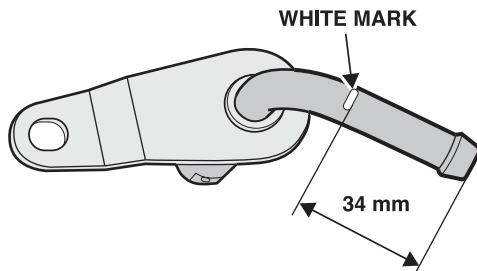
15. Install the other end of the oil jet line onto the ATF filter. For 3.2CL and 3.2TL models, torque the filter line bracket bolts to **12 N·m (8.7 lb-ft)**; for '04 TL models, torque the filter line bolt to **28 N·m (21 lb-ft)**.
16. Remove the harness bracket bolt.
17. If not already done, remove and discard the ATF filler bolt.
18. Install the ATF filler plug adapter with a new sealing washer. Torque the adapter to **44 N·m (33 lb-ft)**.
19. Insert the oil jet into the filler plug adapter, making sure the oil jet is flush. Position the oil jet bracket over the harness bracket bolt hole. Reinstall the harness bracket bolt. Torque the bolt to **27 N·m (20 lb-ft)**.
20. Check if the oil jet has a white mark **34 mm** from the end of the pipe. If it does not have this mark, measure **34 mm** from the end of the pipe, and use a paint pen or marker to mark the spot.

21. Slide the new hose clamp onto the oil jet hose, and then slide the hose onto the oil jet tube up to the mark on the tube. Make sure the hose is not kinked. Position the clamp **7 mm** from the end of the hose, and release the clamp retainer.
22. Attach the oil jet line bracket. Torque the bolt to **12 N·m (8.7 lb-ft)**.
23. Attach the wire harness to the oil jet line bracket.
24. Clean up any residual ATF that spilled when you installed the kit.
25. Start the engine. Move the shift lever to **D**, and then to **R**. Move the shift lever to **D** and then to **P**. Raise the engine speed to **1,500 rpm**, keep it there for several minutes, then turn off the engine.
26. Check for leaks where you installed the kit. If you find any leaks, make sure the ATF filler plug adapter, the oil jet, and all hose clamps are correctly installed.
27. Check the ATF level, and add ATF if needed.
