## **TECH NOTES IMPORTANT HEAT** TAB INFORMATION

### **Important Heat Tab Information**

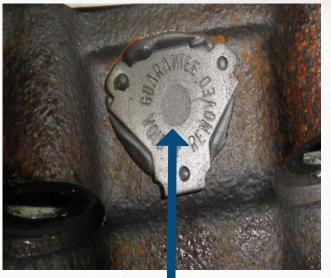
HEAT TAB CENTER IS NOT MELTED

THIS IS A "GOOD" HEAT TAB

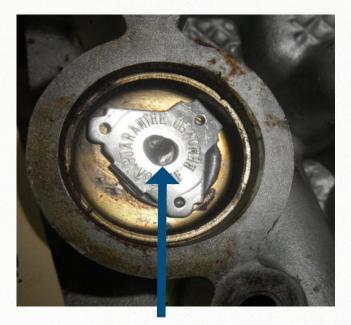
HEAT TAB CENTER IS BEGINNING TO MELT The engine coolant has reached a temperature above 250° Warranty is Void

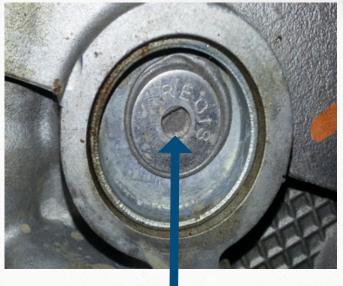
#### HEAT TAB CENTER IS COMPLETELY MELTED OUT

The engine coolant has reached a temperature above 250° Warranty is Void
