Colorado Cultural Resource Survey **Architectural Inventory Form**

1. Resource Number: 5PT991

5. Historic Building Name: Mountain Rescue Aspen Building

7. Building Address: 630 W. Main St.

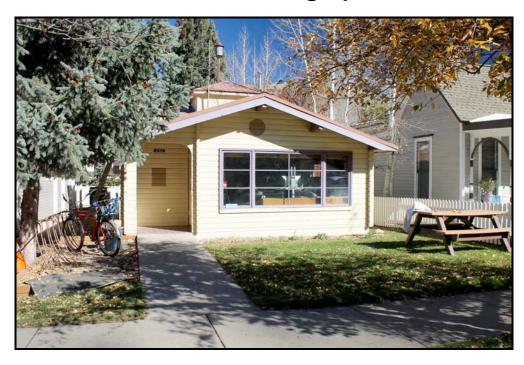
<u>South (front)</u>: The front of the building holds the main entry, which is located in an open cutaway porch on the southwest corner. The entrance faces west and contains a wood panel door with an X-pattern in the lower half and nine lights in the upper. The 5' x 5' porch is open to the south and west, although the west side has a half wall formed by a closed rail of milled logs. The floor is of wood planks, and the openings are arched overhead. A large window dominates the front wall. This consists of a central fixed six-light window flanked by what appear to be three-light casements, all set in wood framing.

View of the Property from Main Street View to the North

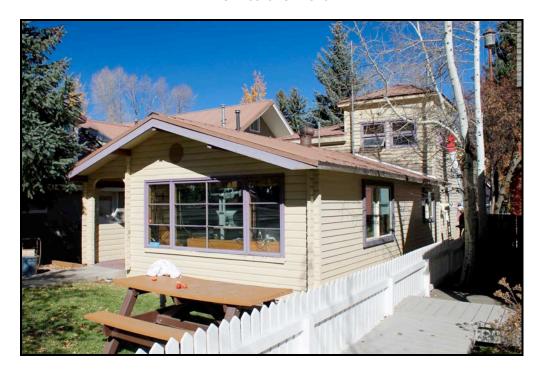
<u>East (side)</u>: This side of the building holds no entries. The front one-story area contains two pairs of sliding windows with wood frames. As on the west, the original milled logs that form the walls have been clad in clapboard siding. The rear two-story area has a pair of single-light fixed windows on the main floor. The cupola holds a pair of what appear to be casement windows set in wood frames.

View of the Property from the Southeast View to the Northwest

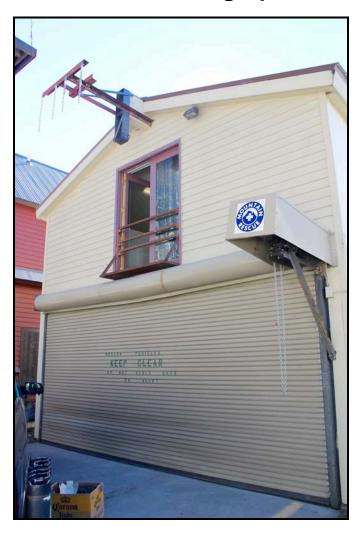
North (rear): The two-story rear of the building is dominated by a full-width overhead metal garage door on the main floor. A chain-operated door control projects from the building's northwest corner. Centered in the upper wall is a pair of glass doors set in wood framing. These provide access to a small unadorned metal balconet that allowed personnel to participate in loading and

unloading activities on the ground below and to engage in rope climbing practice associated with a metal frame system that projects from the ridge beam above.

North (rear) Wall of the Building View to the Southeast
