AIRCRAFT ACCIDENT REPORT

SOUTHERN AIRWAYS, INC. DC-9, N971S

To State Airport

November 14, 1970

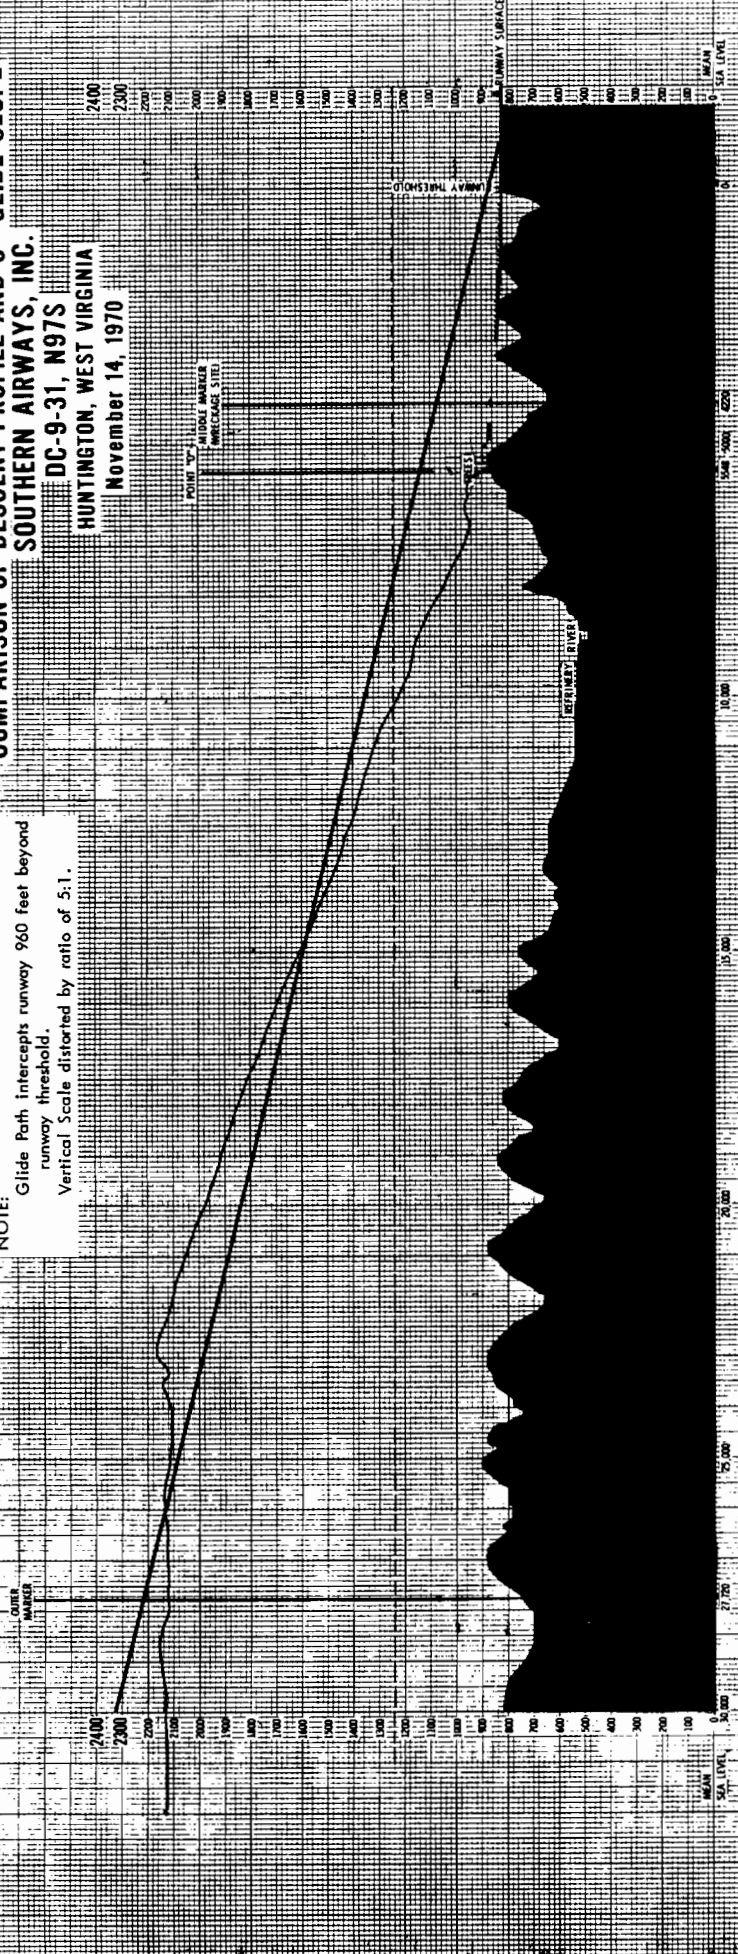
BASIC TERRAIN PROFILE
LOC COURSE RUNWAY II

--- MINIMUM DESCENT ALTITUDE
--- 3° GLIDE PATH
--- DESCENT PROFILE

NOTE: Glide Path intercepts runway 960 feet beyond
runway threshold.
Vertical Scale distorted by ratio of 5:1.
