**NATIONAL
TRANSPORTATION
SAFETY
BOARD**

AIRCRAFT ACCIDENT REPORT

**DELTA AIR LINES, INC.,
LOCKHEED L-1011-385-1, N726DA
DALLAS/FORT WORTH -
INTERNATIONAL AIRPORT, TEXAS
AUGUST 2, 1985**

NTSB/AAR-86/05

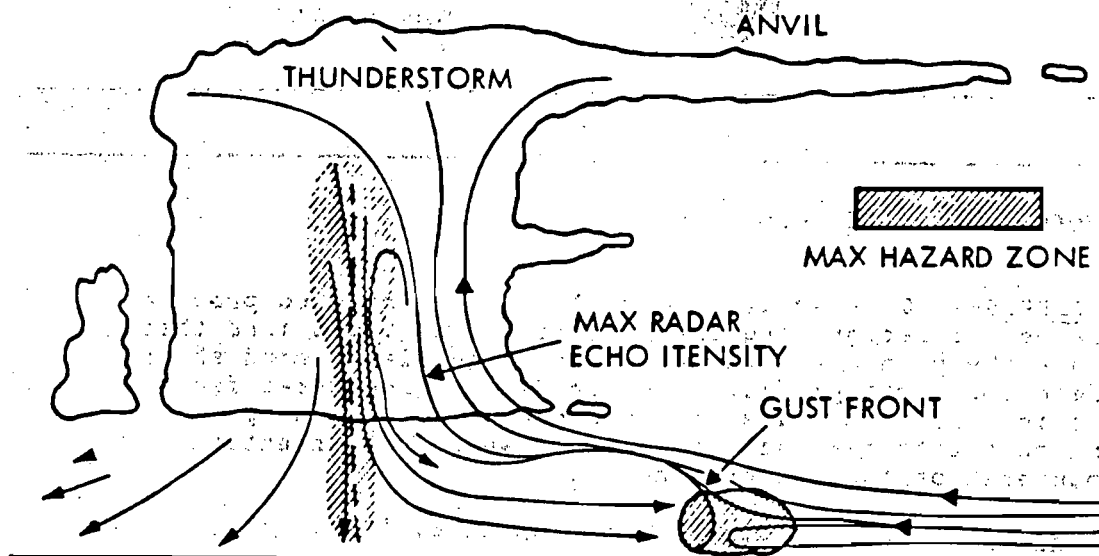
FIGURE 1. THUNDERSTORM HAZARD ZONES

a. Thunderstorms. The winds around a thunderstorm are complex (Figure 1). Wind shear can be found on all sides of a thunderstorm cell and in the downdraft directly under the cell. The wind shift line or gust front associated with thunderstorms can precede the actual storm by 15 nautical miles or more. Consequently, if a thunderstorm is near an airport of intended takeoff or landing, low level wind shear hazards may exist:

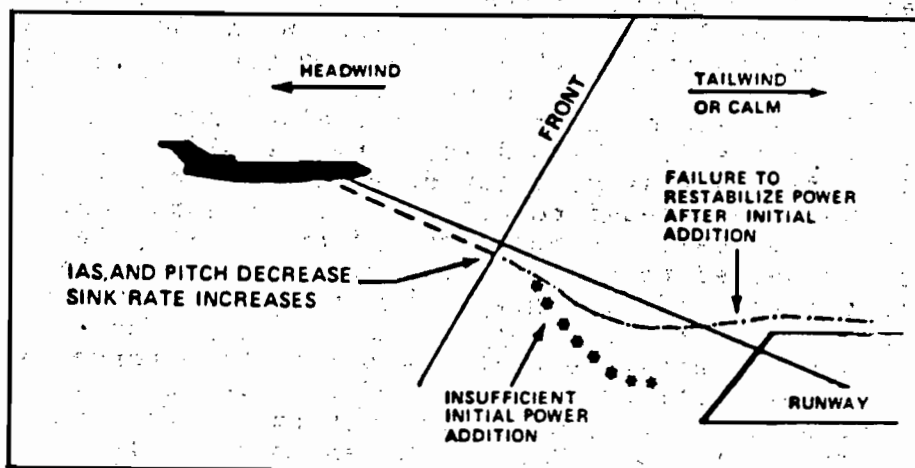
FIGURE 2. HEADWIND SHEARING TO TAILWIND OR CALM

(1) Consider an aircraft flying a 3° ILS on a stabilized approach at 140 knots indicated airspeed (IAS) with a 20-knot headwind. Assume that the aircraft encounters an instantaneous wind shear where the 20-knot headwind shears away completely. At that instant, several things will happen; the airspeed will drop from 140 to 120 knots, the nose will begin to pitch down, and the aircraft will begin to drop below the glide slope. The aircraft will then be both slow and low in a "power deficient" state. The pilot may then pull the nose up to a point even higher than before the shear in an effort to recapture the glide slope. This will aggravate the airspeed situation even further until the pilot advances the throttles and sufficient time elapses at the higher power setting for the engines to replenish the power deficiency. If the aircraft reaches the ground before the power deficiency is corrected, the landing will be short, slow, and hard. However, if there is sufficient time to regain the proper airspeed and glide slope before reaching the ground,

then the "double reverse" problem arises. This is because the throttles are set too high for a stabilized approach in a no-wind condition. So, as soon as the power deficiency is replenished, the throttles should be pulled back even further than they were before the shear (because power required for a 3° ILS in no wind is less than for a 20-knot headwind). If the pilot does not quickly retard the throttles, the aircraft will soon have an excess of power; i.e., it will be high and fast and may not be able to stop in the available runway length (Figure 2).

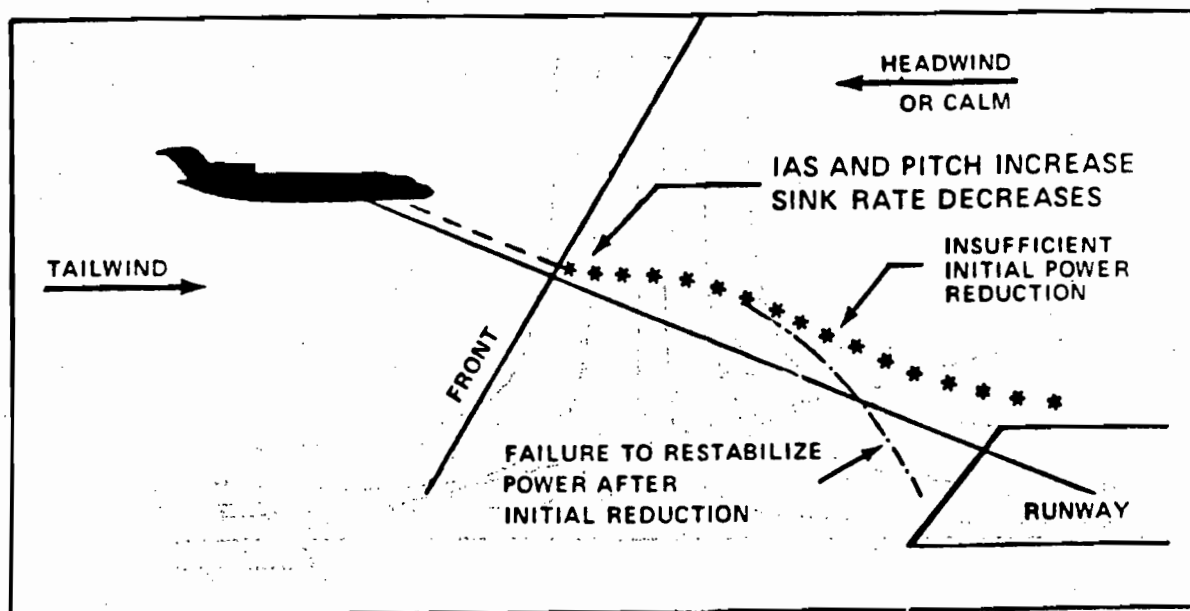
FIGURE 3. TAILWIND SHEARING TO HEADWIND OR CALM

(2) When on approach in a tailwind condition that shears into a calm wind or headwind, the reverse of the previous statements is true. Initially, the IAS and pitch will increase and the aircraft will balloon above the glide slope. Power should initially be reduced to correct this condition or the approach may be high and fast with a danger of overshooting. However, after the initial power reduction is made and the aircraft is back on speed and glide slope, the "double reverse" again comes into play. An appropriate power increase will be necessary to restabilize in the headwind. If this power increase is not accomplished promptly, a high sink rate can develop and the landing may be short and hard (Figure 3). The double reverse problem arises primarily in downdraft and frontal passage shears. Other shears may require a consistent correction throughout the shear.

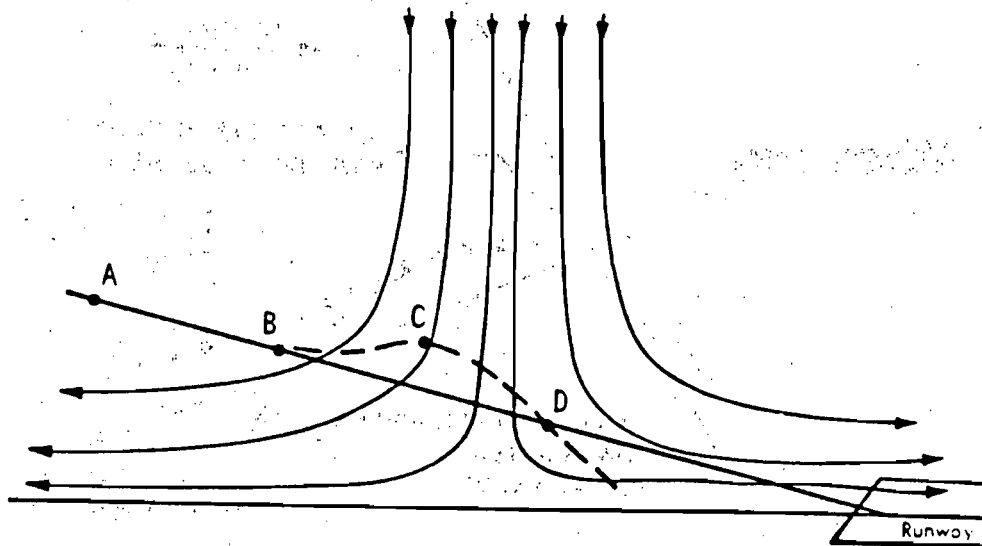
FIGURE 4. DOWNDRAFT SHEAR

(3) The classic thunderstorm "downburst cell" accident is illustrated in Figure 4. There is a strong downdraft in the center of the cell. There is often heavy rain in this vertical flow of air. As the vertical air flow nears the ground it turns 90 degrees and becomes a strong horizontal wind, flowing radially outward from the center. Point A in Figure 4 represents an aircraft which has not entered the cell's flow field. The aircraft is on speed and on glide slope. At Point B the aircraft encounters an increasing headwind. Its airspeed increases, and it balloons above the glide slope. Heavy rain may begin shortly. At Point C the "moment of truth" occurs. If the pilot does not fully appreciate the situation, he may attempt to regain the glide slope and lose excess airspeed by reducing power and pushing the nose down. Then in the short span of time between Points C and D the headwind ceases, a strong downdraft is entered and a tailwind begins increasing. The engines spool down, the airspeed drops below V_{ref} , and the sink rate becomes excessive. A missed approach initiated from this condition may not be successful. Note that a missed approach initiated at Point C (or sooner) would probably be successful since the aircraft is fast and high at this point. Note also that the pilot of an aircraft equipped with a groundspeed readout would see the telltale signs of a downburst cell shortly after Point B; i.e., rapidly increasing airspeed with decreasing groundspeed.
