MARINE OCCURRENCE REPORT

Report 05-201, passenger ferry *Quickcat* and restricted passenger vessel *Doctor Hook*, collision, Motuihe Channel

4 January 2005

TRANSPORT ACCIDENT INVESTIGATION COMMISSION
NEW ZEALAND

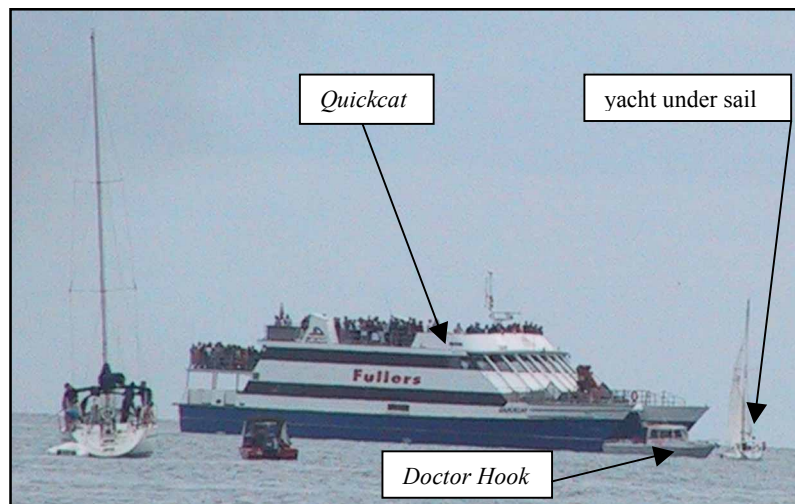
Figure 3

1.5.5 From examination of photographs taken shortly after the collision (Figures 2 and 3) submissions were made to the Commission that the yacht under sail may possibly have crossed between the *Quickcat* and the *Doctor Hook* prior to the collision.

- 2.6 From close examination of the photographs taken just after the accident (Figures 2 and 3) and from the information provided by the witnesses on the 2 vessels it is unlikely that the yacht passed between the *Quickcat* and the *Doctor Hook* because:

- the yacht appears to be closer to the photographer than the *Quickcat* or the *Doctor Hook* in Figure 2
 - the yacht appears to be paralleling the course of the *Quickcat* and then crossing the bows of the 2 vessels in order to proceed seaward
