# AIRCRAFT ACCIDENT REPORT

PIEDMONT AIRLINES  
FAIRCHILD-HILLER 2276, N712U  
CHARLESTON, WEST VIRGINIA  
AUGUST 10, 1968

NATIONAL TRANSPORTATION SAFETY BOARD  
DEPARTMENT OF TRANSPORTATION  
WASHINGTON D.C. 20591

Piedmont Airlines, Flight 230, Fairchild Hiller 227B, N712U, a regularly scheduled passenger flight, crashed and burned while on an approach to the Kanawha County Airport, Charleston, West Virginia, at approximately 0857 e.d.t., on August ~~10, 1968~~ <sup>11, 1970</sup>. The three crewmembers and 32 of the 34 passengers were fatally injured in the accident. The aircraft was "destroyed by impact and subsequent fire."

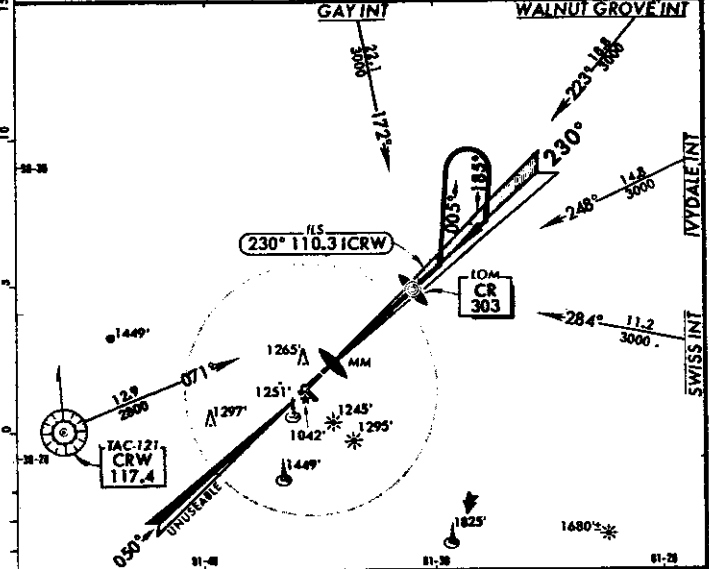
**CHARLESTON, W. VA.**

CHARLESTON Tower 120.3 122.4G 126.2 257.8	Apt. Elev. 982' Var. 03° W GS 335.0	KANAWHA ILS Rwy 23 NDB (ADF) Rwy 23 LOC 110.3 ICRW
Approach(R) 119.2	Departure(R) 124.1	Ground 121.9 348.6

PULL UP STRAIGHT AHEAD TO 3000 feet, then direct to CRW VOR and hold WEST on R-261, RIGHT turns.

A	STRAIGHT-IN LANDING RWY 23			CIRCLE-TO-LAND
	MDA 1382'(400')	MDA 1582'(600')	MDA 1582'(600')	
B	1	1	1	1582'(600')-1
C	1	1	1	1582'(600')-1 1/2
D	1	1	1	1582'(600')-2
MDA	1382'(400')	1382'(400')	1582'(600')	1582'(600')-2
End	1	1	1	1682'(600')-2

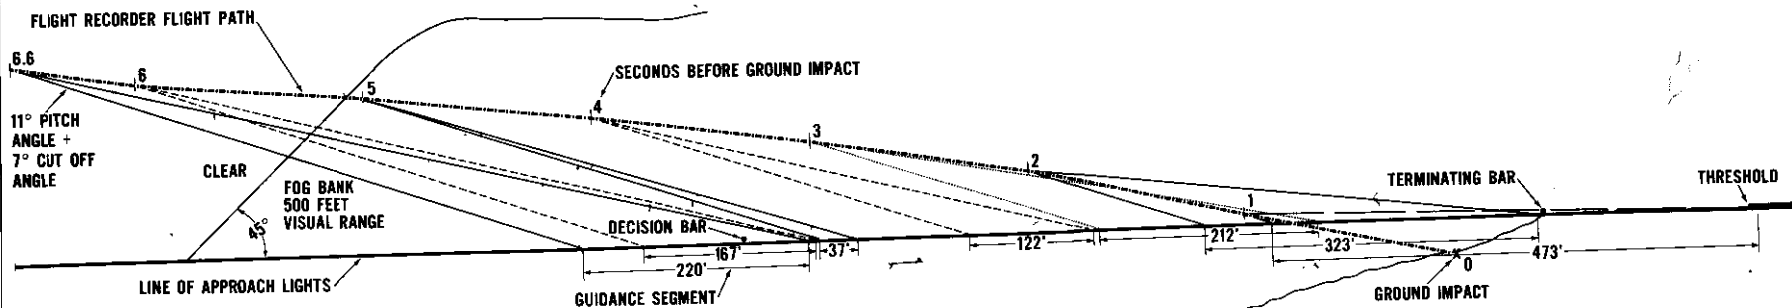
ATTACHMENT NO. 4

# GUIDANCE SEGMENT STUDY

SCALE 0 50 100  
FEET
