Safety Recall: 2019 CR-V Fuel Tank

Supersedes 19-090, dated August 2, 2019, to revise the information highlighted in **yellow**

During manufacturing, the vent pipe on the evaporative return line was not properly welded to the fuel tank and may separate. Customers may notice a fuel smell or a leak. A fuel leak in the presence of an ignition source could result in a fire.

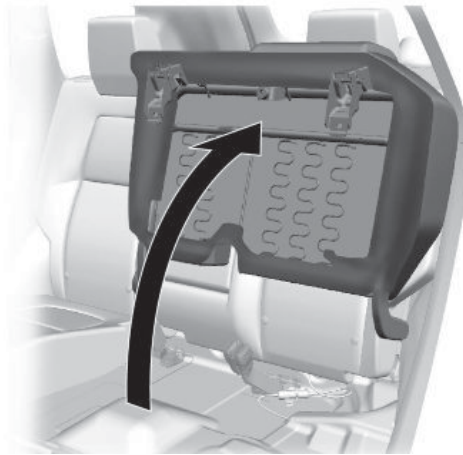
REAR SEAT FOOT COVERS

3.1. Remove the rear seat foot covers, then remove the bolts.

24 N·m (18 lb-ft)

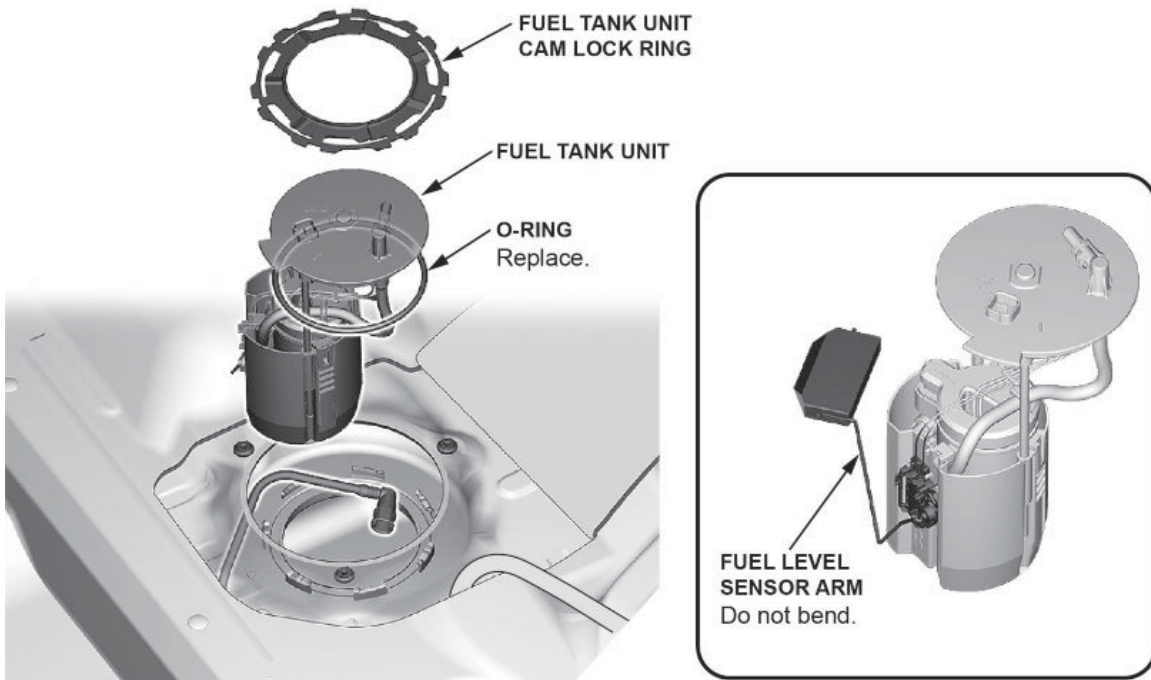
3.7. Remove the fuel tank unit.

The new fuel tank comes with a tank unit O-ring.

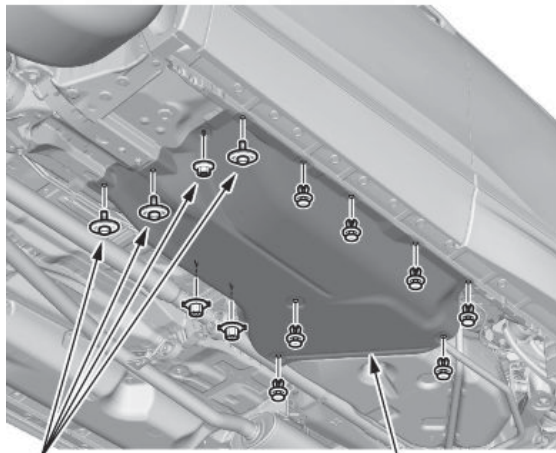
AWD Models:

BOLTS AND NUT
9.4 N·m (6.9 lb-in)
LEFT MIDDLE FLOOR UNDERCOVER

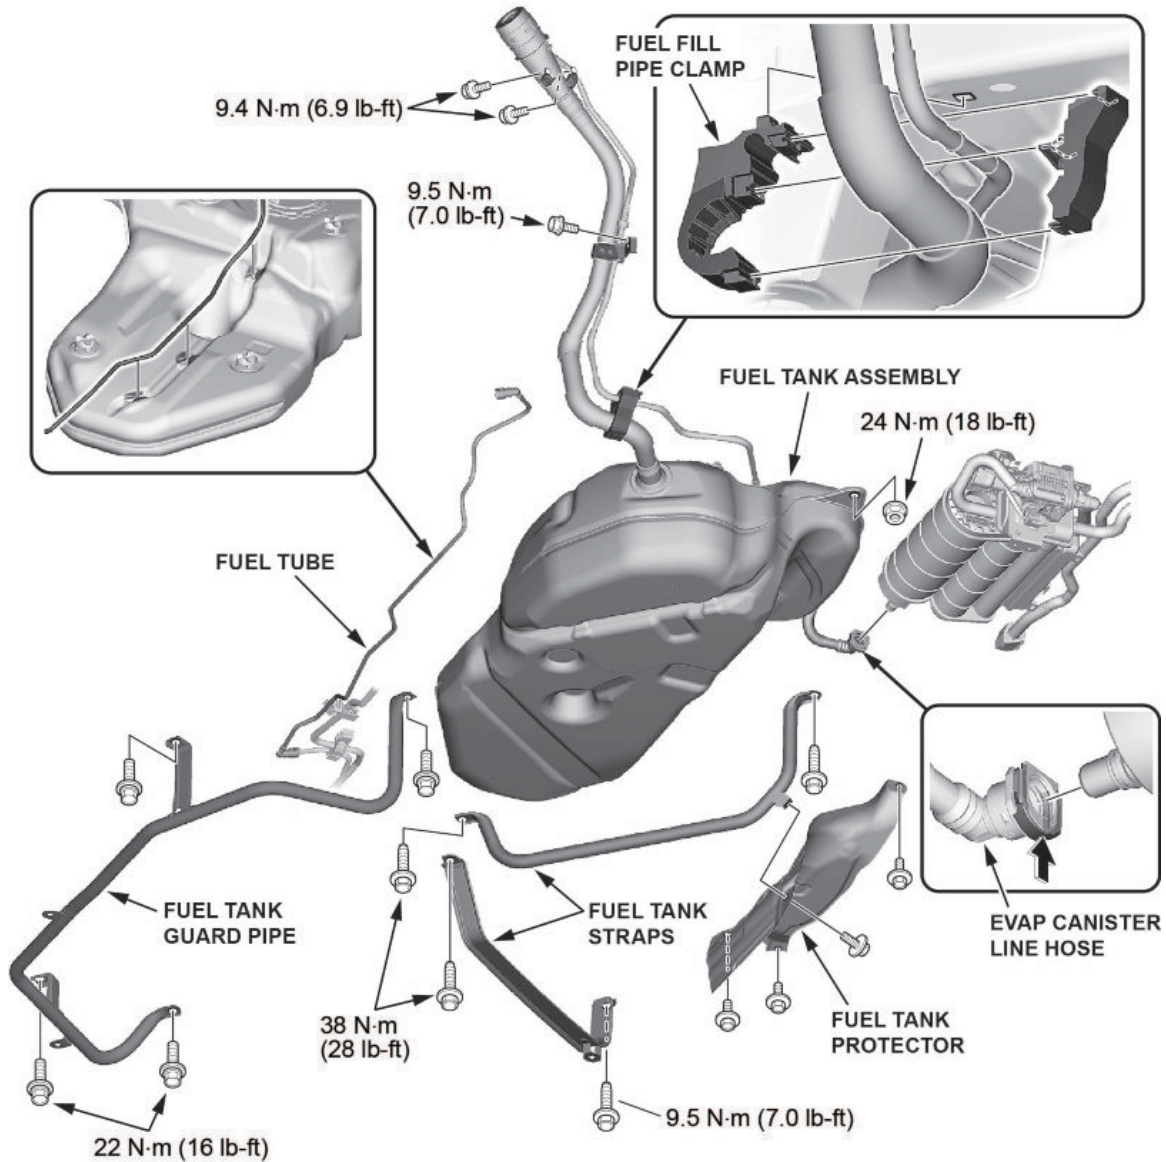
8. Remove the fuel tank.
 - 8.1. Remove the fuel tank protector.

- 8.2. Remove the fuel tank guard pipe (if needed).
- 8.3. Disconnect the EVAP canister line hose.
- 8.4. Remove the fuel fill pipe clamp.
- 8.5. Place a transmission jack or other support under the fuel tank, then remove the fuel tank straps and nut.

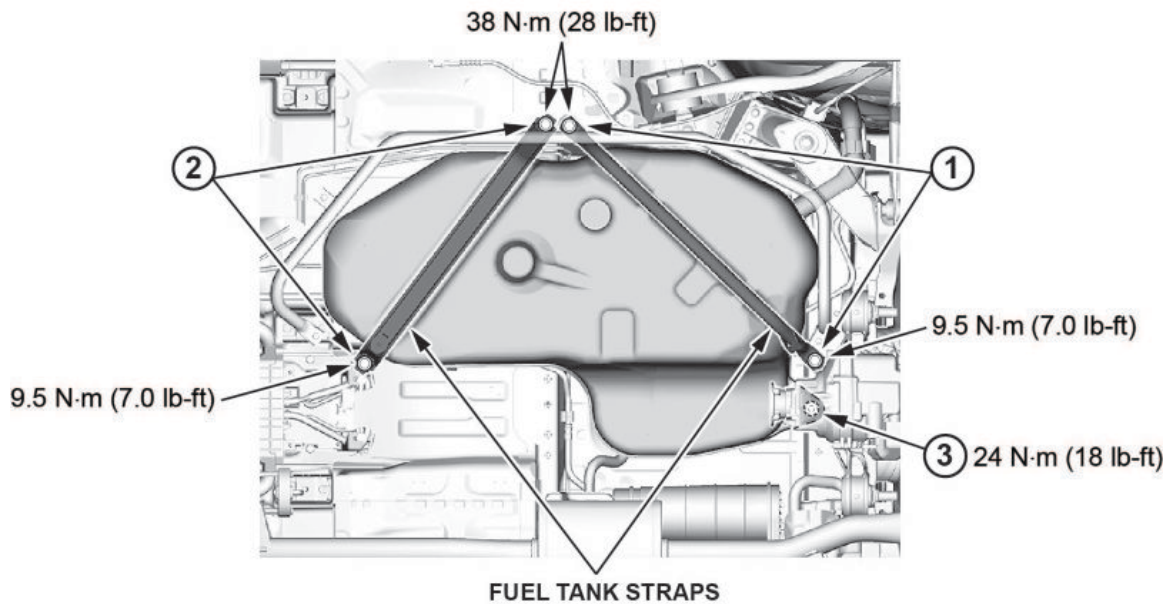
10. Install the new fuel tank; install the tank straps and bolts as shown.
