December 22, 2015

02518 Version 2

## Safety Recall: Front Passenger's Airbag Inflator Can Be Over-Pressurized

### AFFECTED VEHICLES

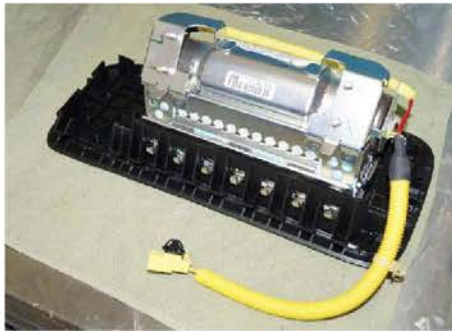
4. Place the airbag face-down on a clean shop towel as shown.

- The orientation of the airbag is critical because if the inflator is installed incorrectly, the harness will be too short when you reinstall the airbag.
- The brackets between the various models are similar but may differ from the example shown.

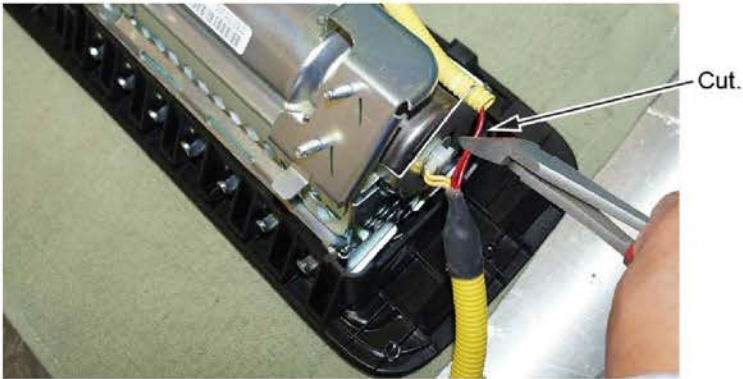
8. Short the red wires.

NOTE: **You must cut and short the wires** as indicated to prevent accidental deployment.

- Cut the red wires as shown.

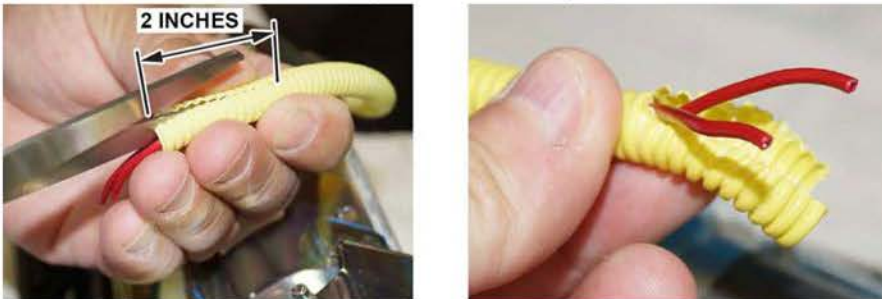
- Cut about 2 inches of the corrugated tube, then pull out the two red wires.

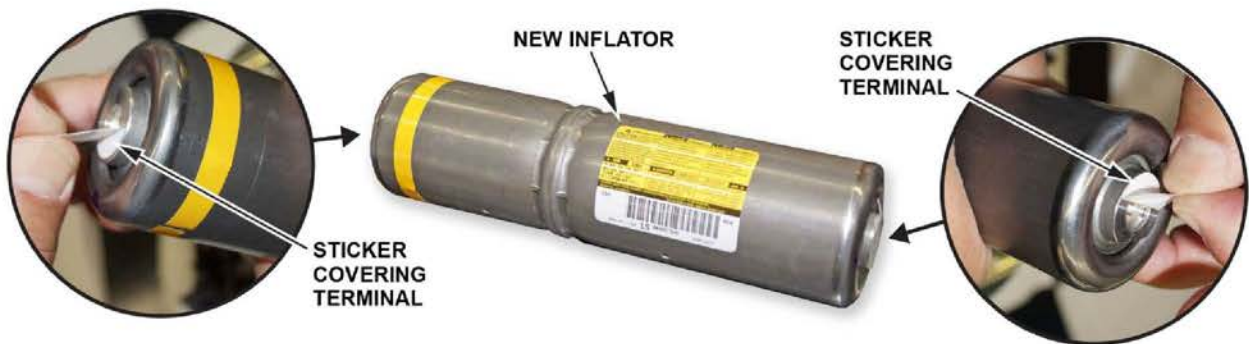
15. Remove the stickers covering the terminals on both sides of the new inflator.

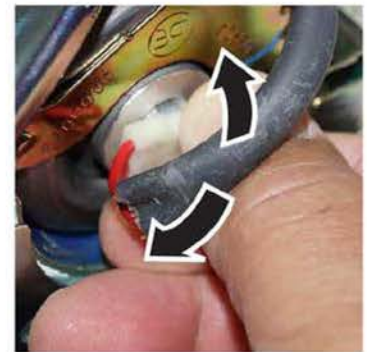
③ Wiggle the connector to make sure it's secure.

- After you hear each connector click, wiggle it to make sure it is secure.  
**NOTE: If the connector is not properly aligned, it will come out.**
