# Mission Church Complex

## Study Report

*Boston Landmarks Commission*  
Environment Department  
City of Boston

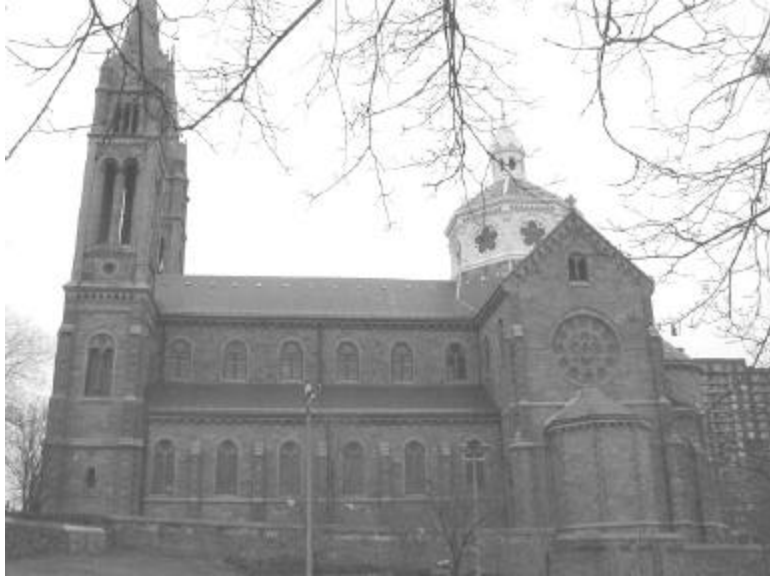
East façade of the basilica

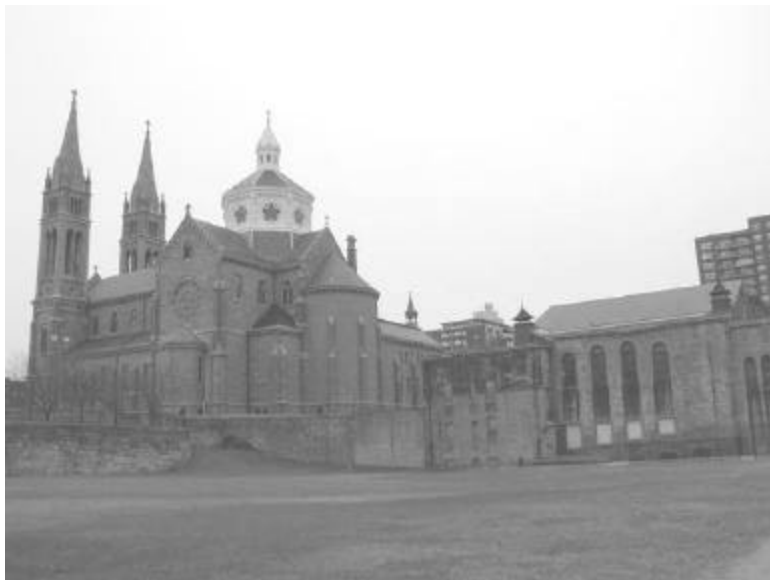
East and north facades of the basilica with the east façade of St. Alphonsus Hall

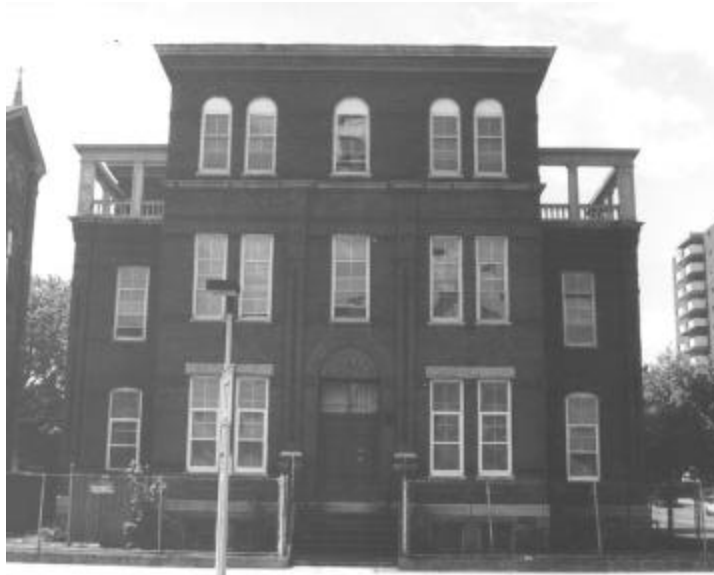
Front façade of the convent building (Smith Street)

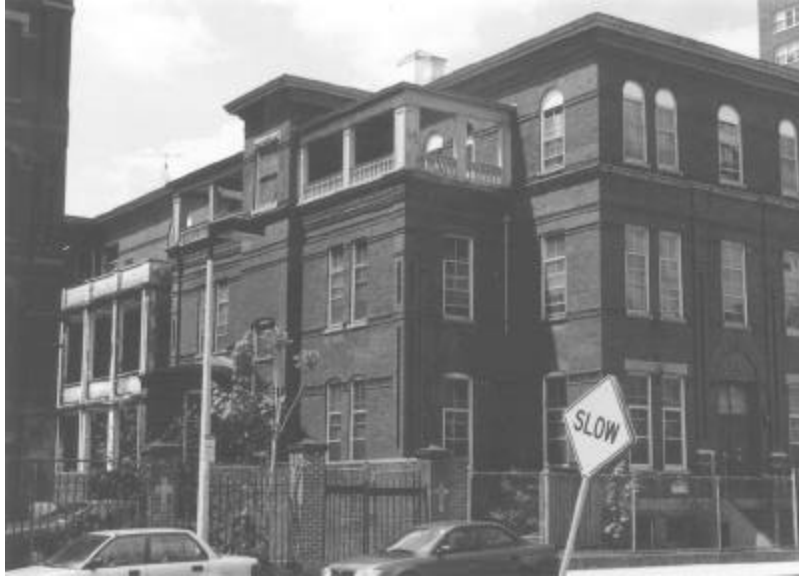
¾ view of the convent building from Smith Street

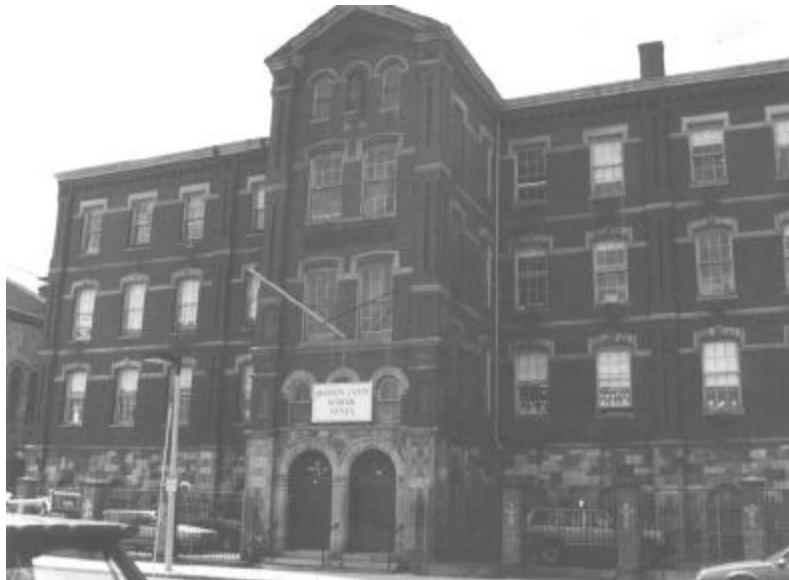
View of the Mission School from Smith Street

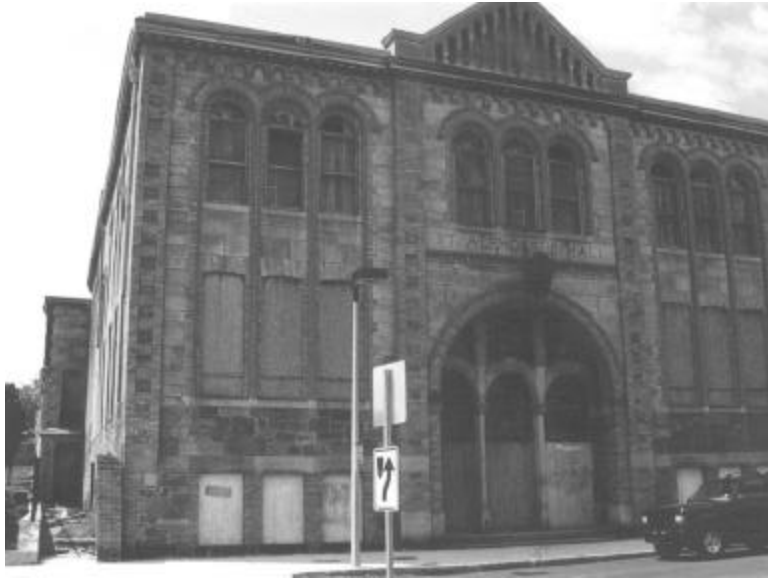
View of St. Alphonsus Hall from Smith Street

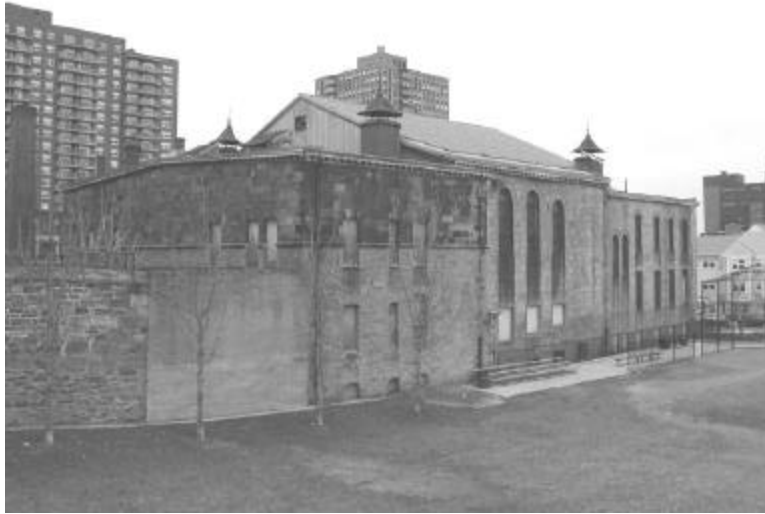
East façade and rear of St. Alphonsus Hall from the adjacent baseball field

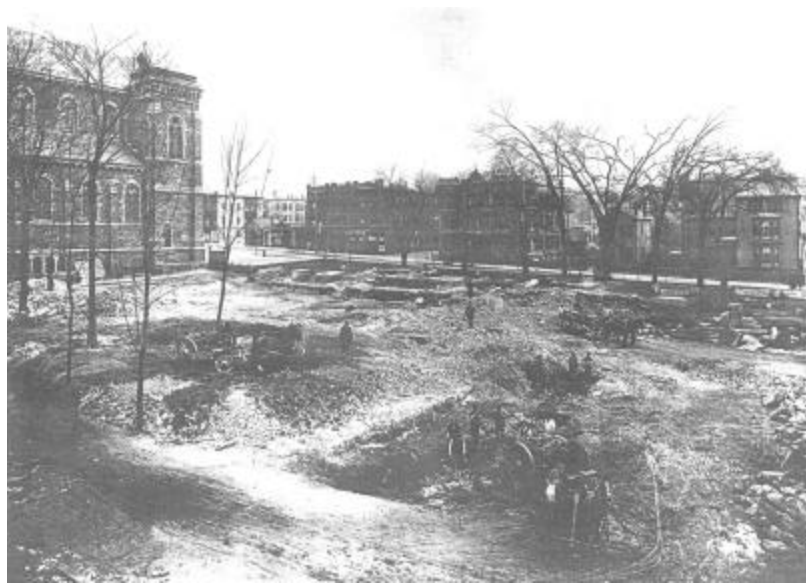
Construction of the rectory building
