ITB08-034c

VOLUNTARY RECALL CAMPAIGN 2004 – 2006 INFINITI QX56 AIR CONDITIONER CONDENSER FAN

NHTSA #: 08V-284

APPLIED VEHICLES: 2004 – 2006 QX56 (JA60)

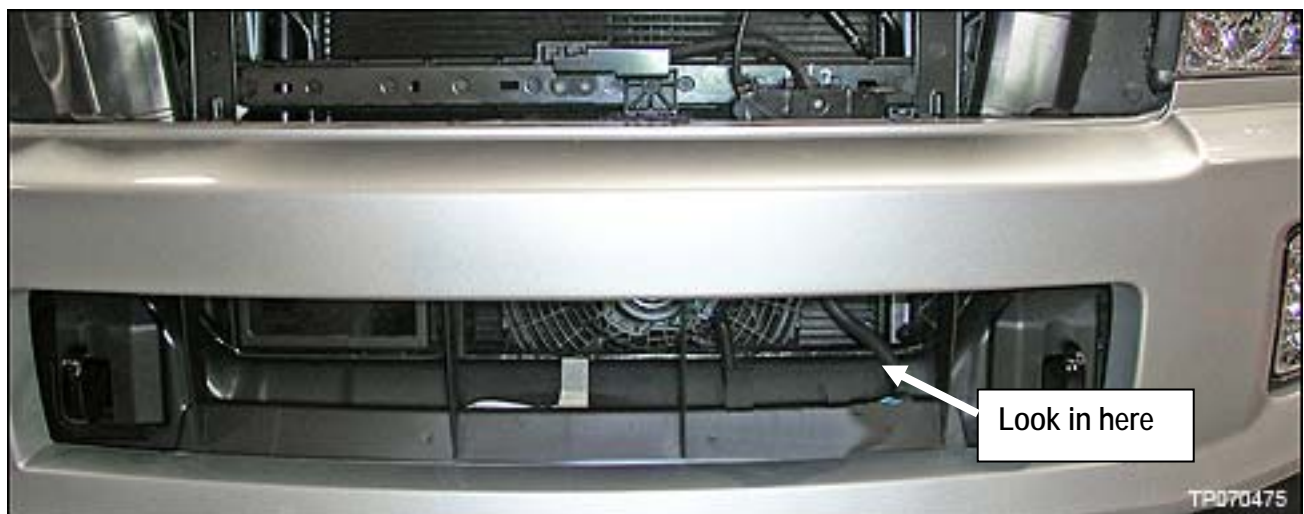
Figure A-1

1. Look in the lower area of the front fascia.

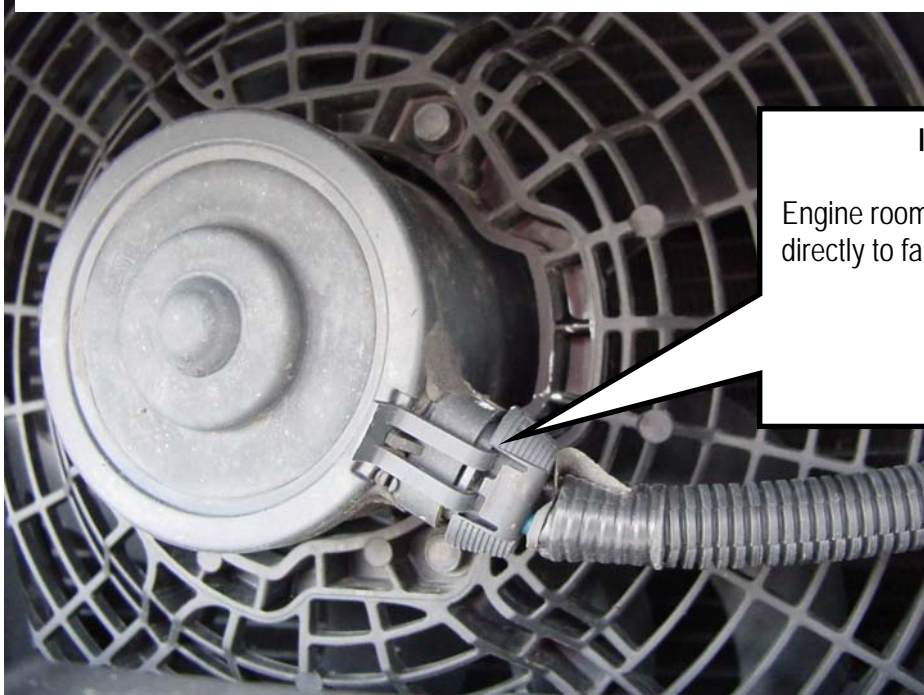
Figure A-2

Type 3 Fan - 140 watt motor

Engine room harness connects directly to fan motor.

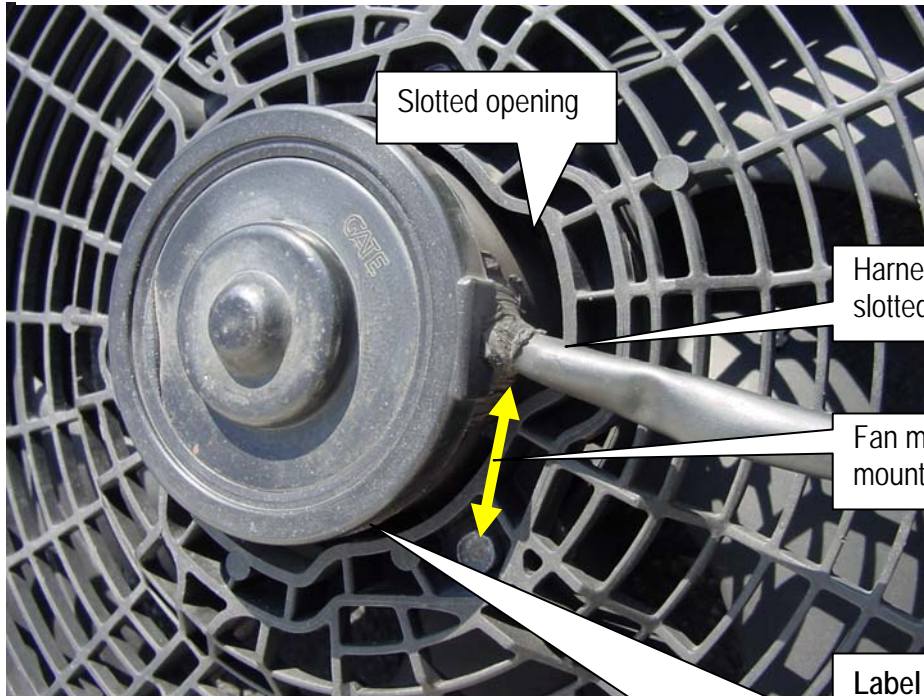
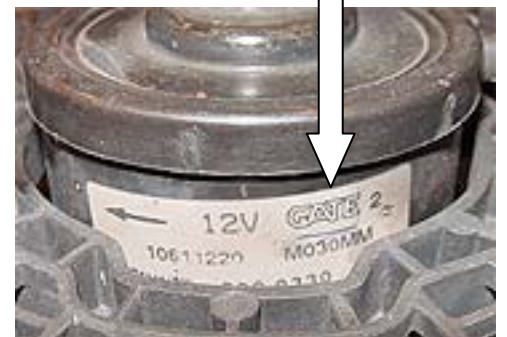
Figure A-3

Type 1 Fan - 90 watt motor

Harness goes across the lower part of the slotted opening.

Fan motor harness position is 1 1/2" from mounting bolt.

Label has the word "GATE"

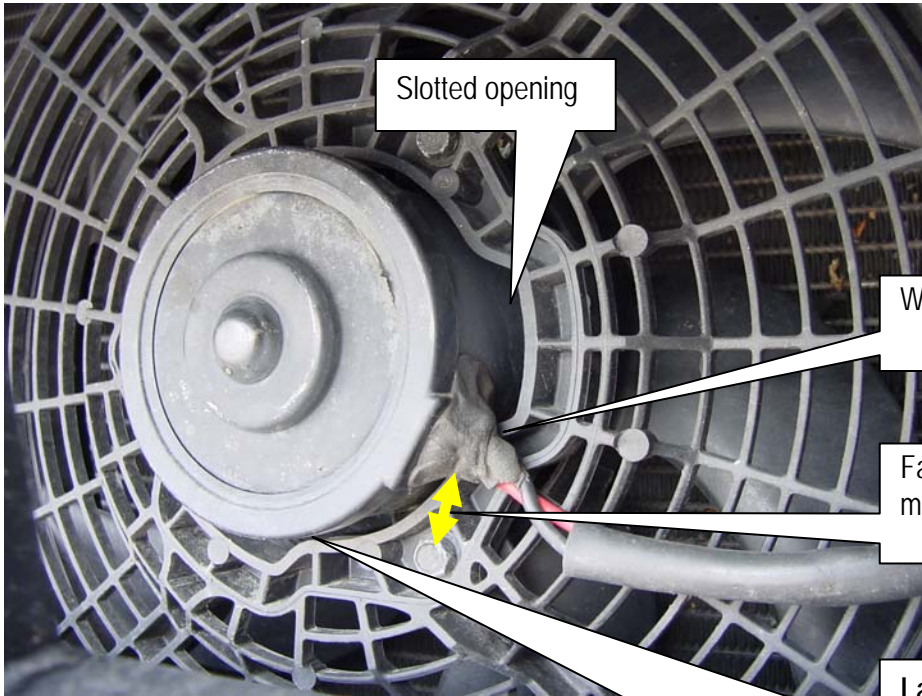
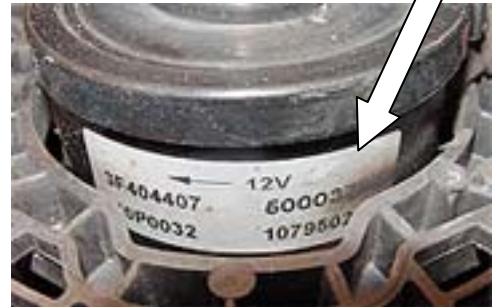
Figure A-4

Type 2 Fan - 90 watt motor
Go to Procedure B - Cooling Fan Motor Inspection

Wire harness is below slotted opening.

Fan motor harness position is 1/2" from mounting bolt.

Label does not have the word "GATE"

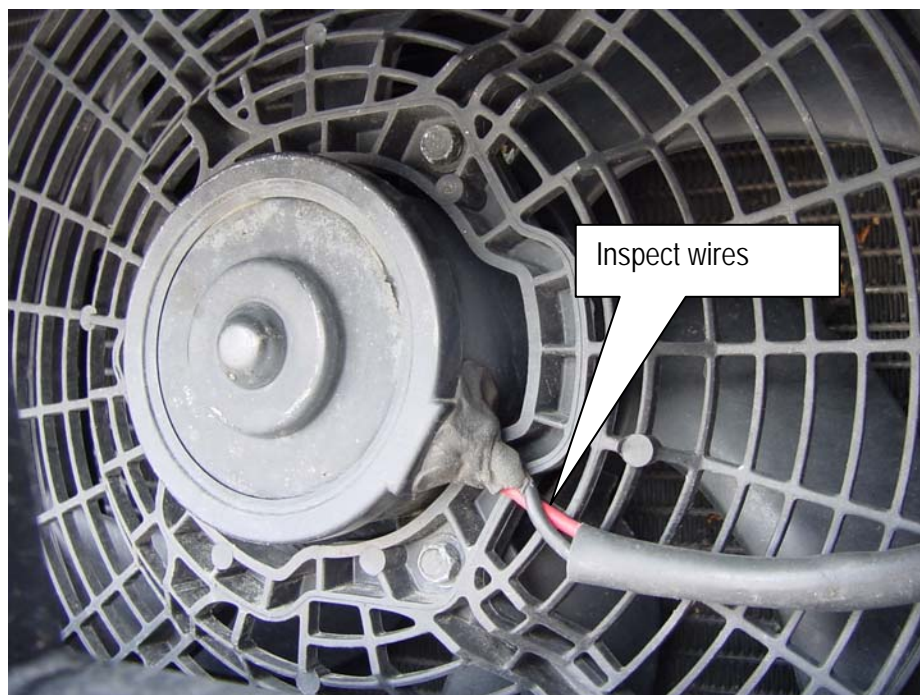
Figure B-1

1. Inspect the wires near the condenser fan motor:

- Make sure there is no damage to the wire insulation and the wires are in good condition.
- **If the wires are damaged** (cracked or missing insulation), STOP; no more testing is needed. Go to Procedure C on page 17 and replace the condenser fan assembly.

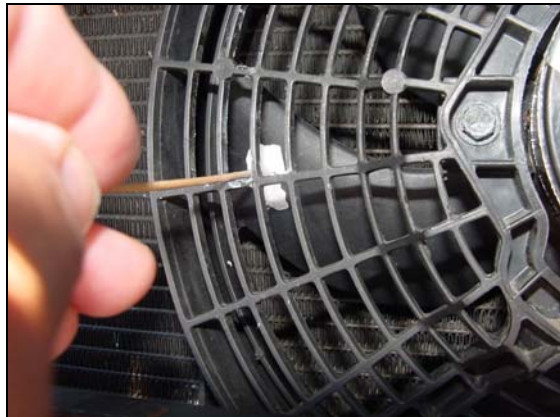
Figure B-2

4. Paint a “dime sized” area on the outer portion of one fan blade.

- Make sure the painted area is completely filled in (no unpainted spots or thin paint in the dime sized area).
- Allow the paint to dry—about 5 minutes.

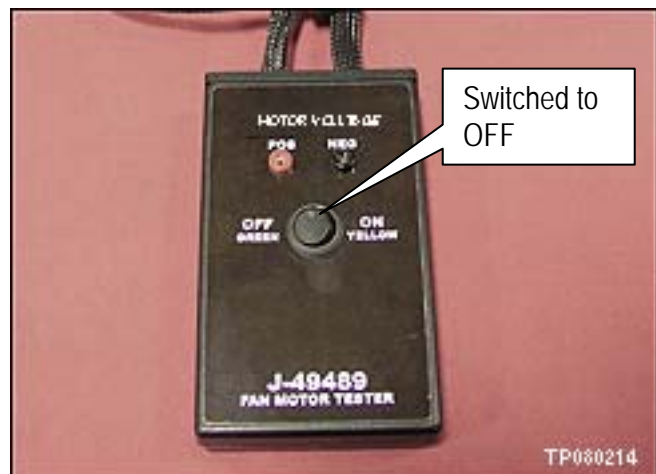
Figure B-3

5. Before connecting to the vehicle battery, make sure the Fan Motor Tester is switched OFF.

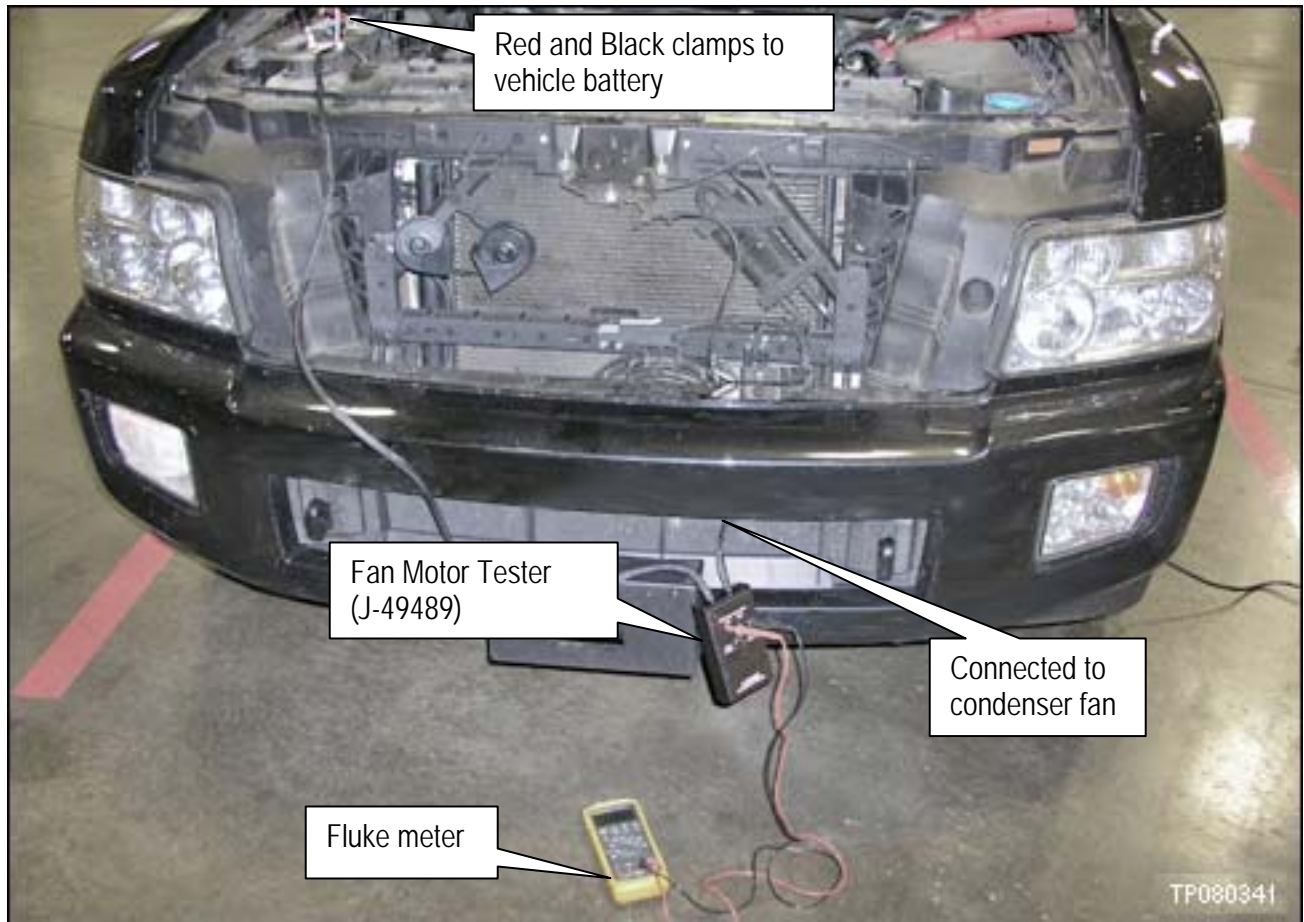
Figure B-4

6. Connect the Fan Motor Tester and the Fluke Digital Multimeter (using the fluke meter test leads) as follows (see Figure B-4):
 - Connect Fan Motor Tester harness connector to the condenser fan.
 - Connect Fan Motor Tester to the vehicle battery; Red clamp to + (positive) / Black clamp to – (negative).
 - Connect the Fluke digital multimeter to the MOTOR VOLTAGE test ports on the Fan Motor Tester; V+ red probe to POS / COM black probe to NEG.

NOTE: When connected as above with the Fan Motor Tester switched OFF, the LED on the switch will illuminate green; this indicates the tester has battery power.

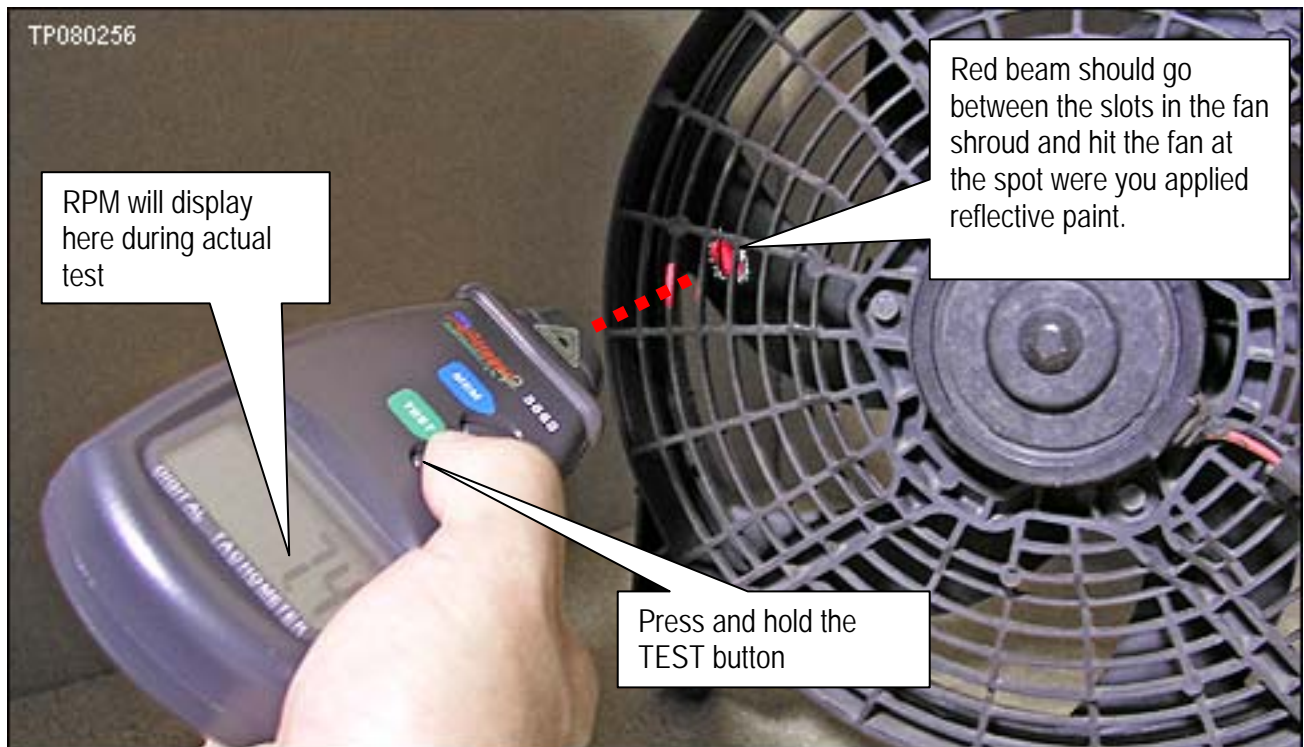
Figure B-7

3. Hold the digital tachometer about 4 inches away from the condenser fan.
4. Aim the red beam at the painted area on the fan blade.
 - The beam should be aimed between / through the slots in the fan shroud.

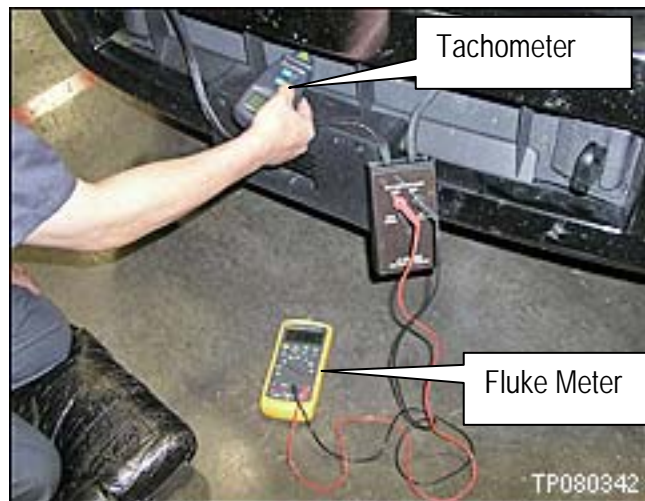
Figure B-8

b. Hold the digital tachometer about 4 inches away from the condenser fan.

c. Aim the red beam at the painted area on the fan blade.

- The beam should be aimed between / through the slots in the fan shroud.

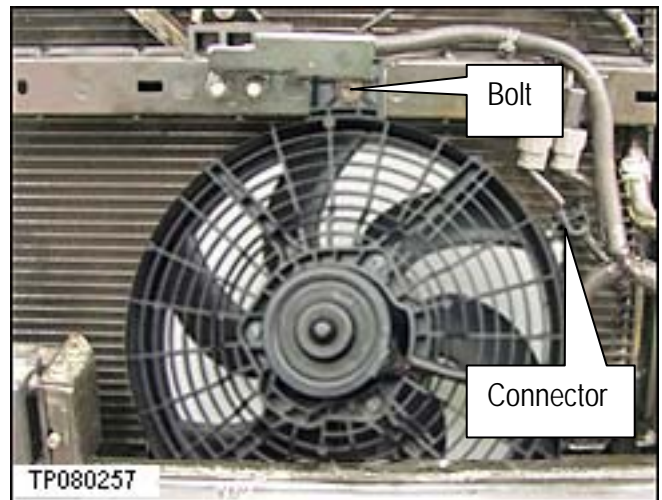
Figure C-10

14. Remove the condenser fan mounting bolt.
15. Remove the condenser fan.

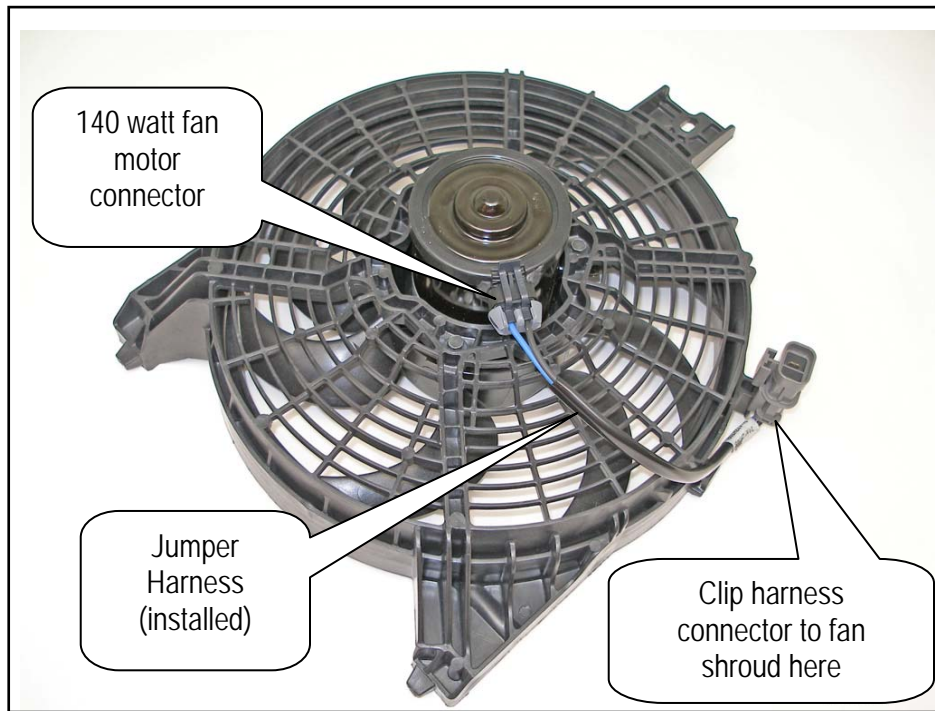
Figure C-11

Jumper harness installation on NEW 140 watt fan assembly

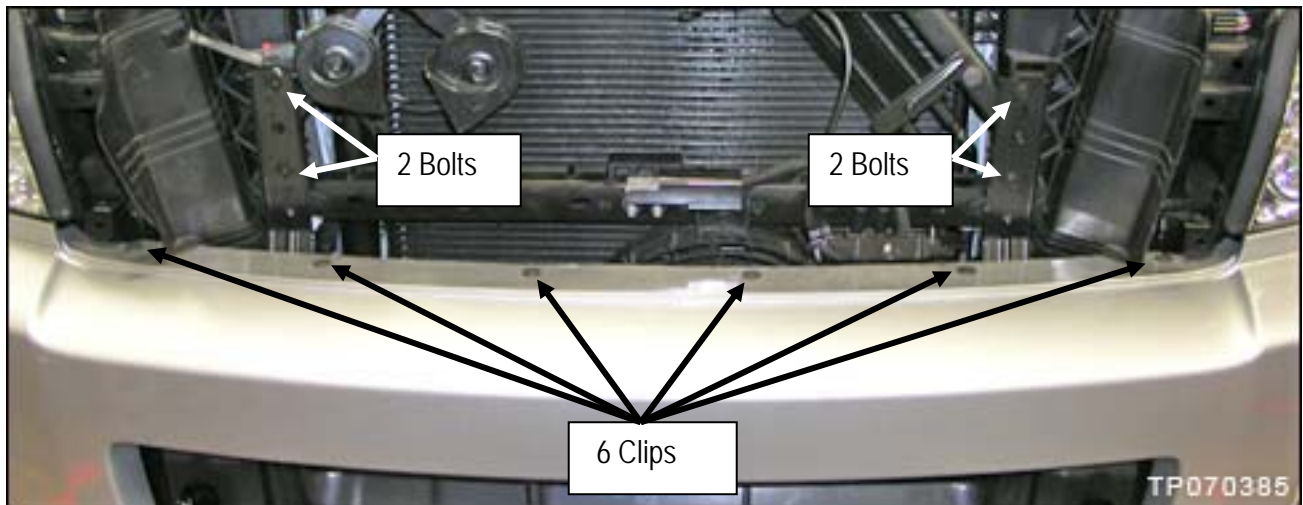
Figure C-19

25. Install 6 clips for the bumper fascia (shown below).

26. Install 4 bolts for the bumper fascia brackets (shown below).

Torque: 9.6 N.m (0.97 kg-m, 85 in-lb)

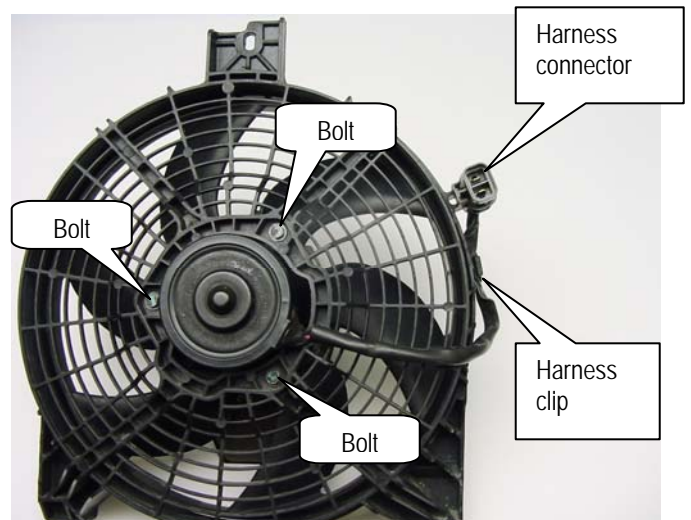
Figure D-1

1. Remove the fan motor from the shroud as follows:
 - a. Disconnect the harness connector from the shroud.
 - b. Disconnect the harness from the shroud clip.
 - c. Remove the fan motor bolts x 3.
 - Discard the bolts; they will not be reused.
 - d. Carefully separate the motor from the shroud:
Don't damage the fan harness.

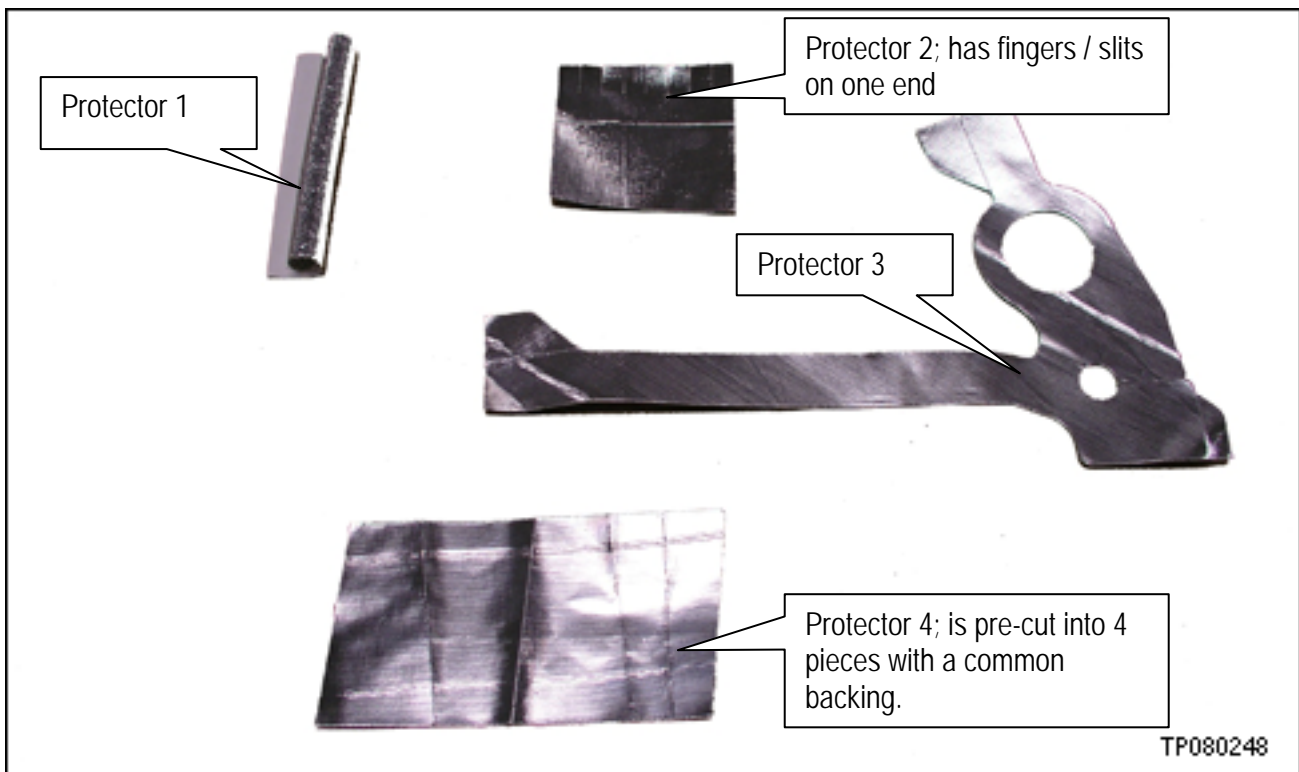
Figure D-3

In the next few steps you will be installing these four self adhesive protectors.

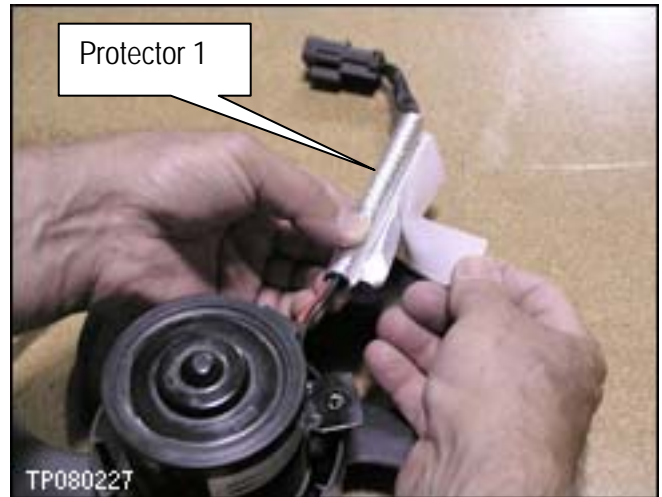
Figure D-4

3. Install **Protector 1** around the fan harness:

- Wrap / roll the protector tightly around the harness.
- While holding the protector rolled tightly, remove the adhesive backing and secure the protector.

NOTE: The protector should slide on the harness.

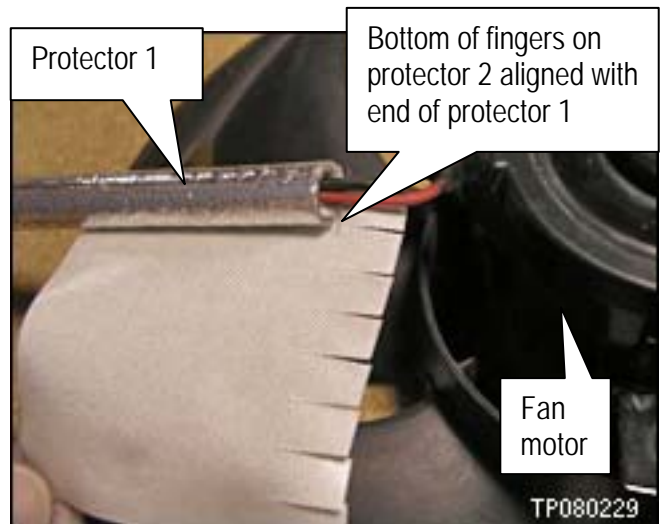
Figure D-5

4. Remove the adhesive backing from **Protector 2** and install it around protector 1:

- Fingers / slits on protector 2 must be facing the fan motor.
- Align the bottom of protector 2 fingers with the end of protector 1.

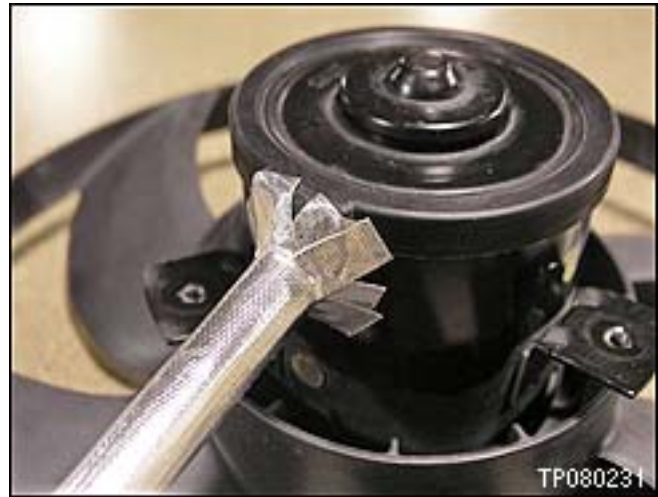
Figure D-7

5. Slide protector 2 against the fan motor and press / stick the fingers to the fan motor as shown.
 - Make sure to press and smooth the fingers so they are completely stuck to the fan motor.

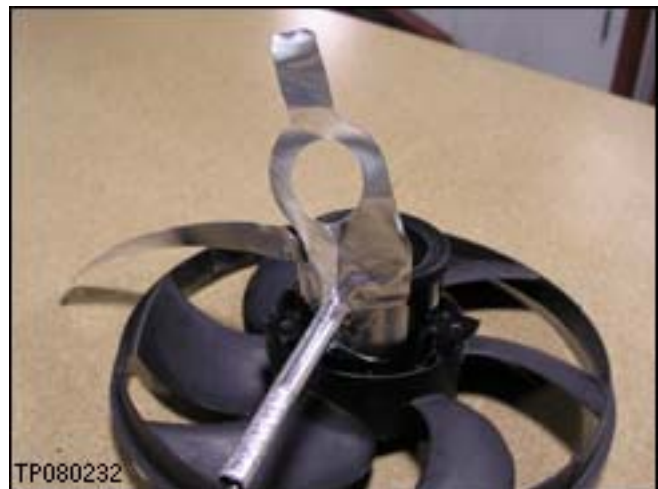
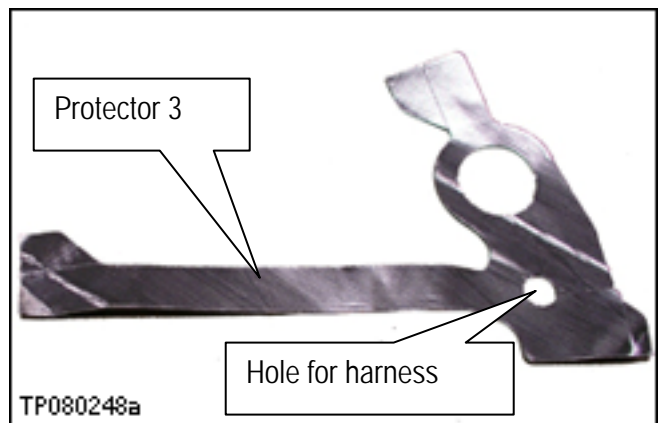
Figure D-8

6. Remove the adhesive backing from **Protector 3** and stick it to the fan motor as shown.
 - Make sure the harness is routed through the harness hole in Protector 3. (Refer to Figure D-8A.)

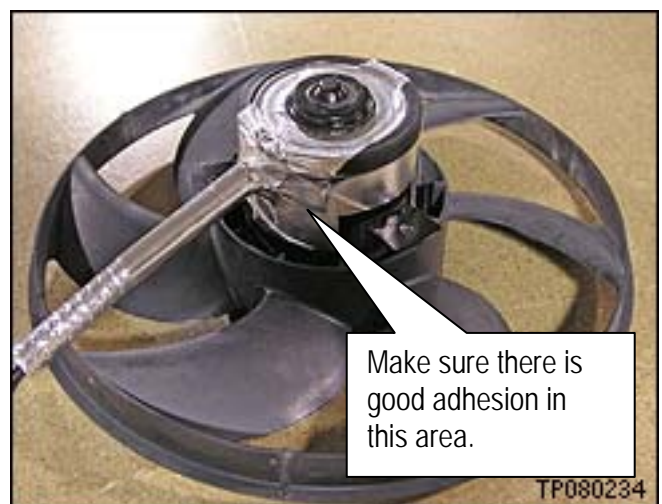
Figure D-11

9. Press and smooth all parts of protector 3. Make sure it is completely stuck to the fan motor.
 - Pay special attention to the area shown in Figure D-11. Make sure there is good adhesion in this area.

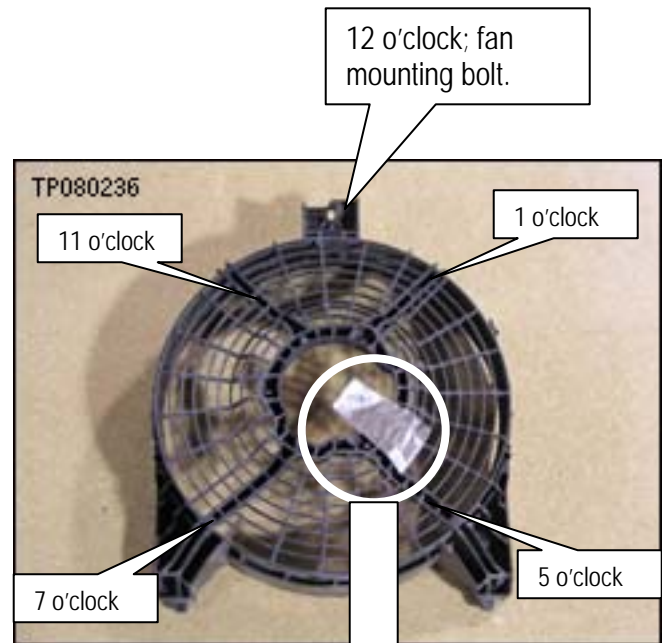
Figure D-12

10. Thoroughly clean all dirt and debris from the fan shroud between the 1 o'clock and 5 o'clock ribs (see Figure D-12).

11. Install Protector 4 on the fan shroud.

- Remove 1 of the 4 sections from protector 4 adhesive backing.
- Stick the 1st section next to the 5 o'clock support rib.

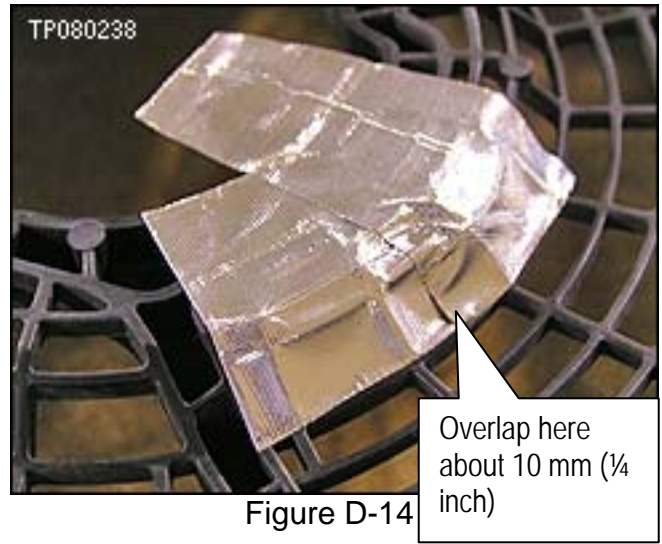
Figure D-14

- c. Stick the 2nd piece of protector 4 on the fan shroud as shown.
- Overlap the 2nd piece on top of the 1st piece at the spot shown.
 - Overlap about 10 mm (¼ inch) but not less than 5 mm (1/8 inch).
 - Fold and stick the protector under the shroud.

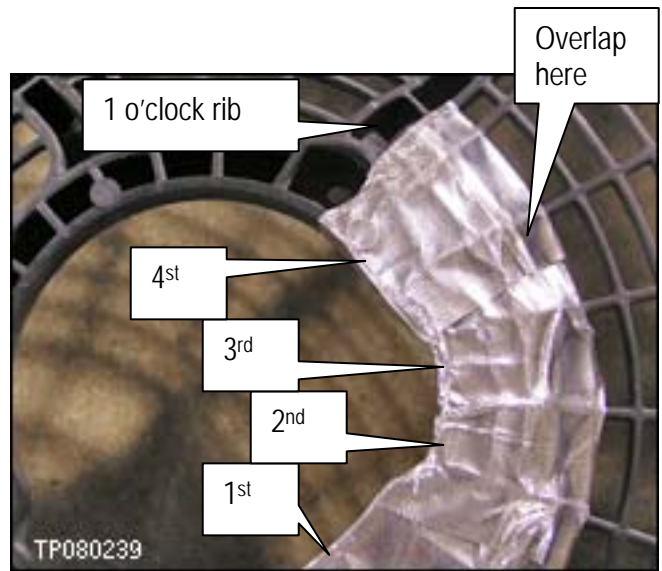
Figure D-15

- e. Install the 4th piece of Protector 4 as shown.
- Align the protector along the 1 o'clock rib as shown.
 - Don't cover up the bolt hole.
 - Overlap the 4th piece on top of the 3rd piece at the spot shown.
 - Overlap must be at least 5 mm (1/8 inch).
 - Fold and stick the protector under the shroud.

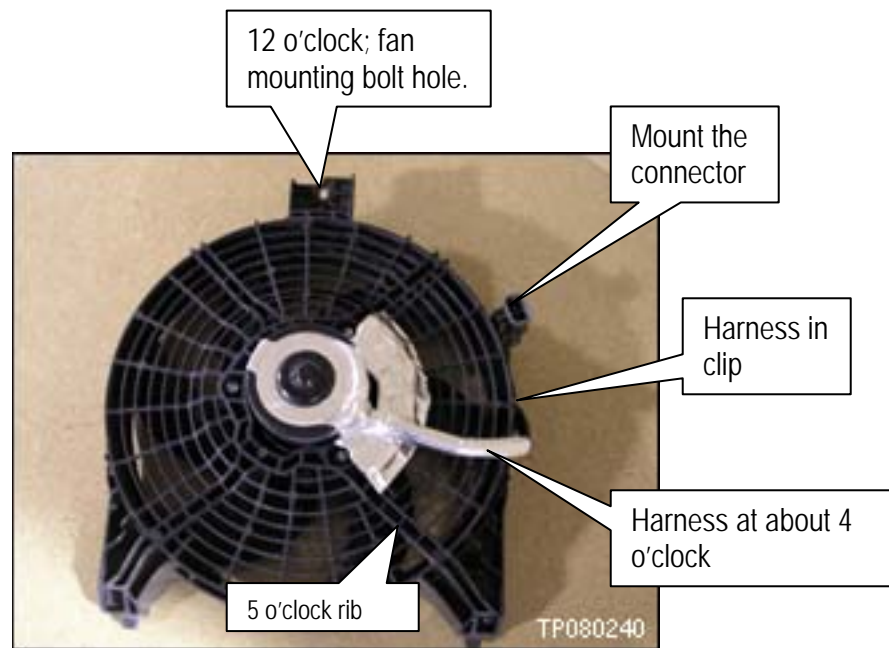
Figure D-16

13. Install the motor in the shroud with the harness in the correct location (about 4 o'clock) as shown in Figure D-16.

- Use new bolts from the Fan Protector Kit. Bolt torque: 4.5 N.m (0.45, kg-m, **40 in-lb**).
- Mount the harness connector and clip the harness in place.

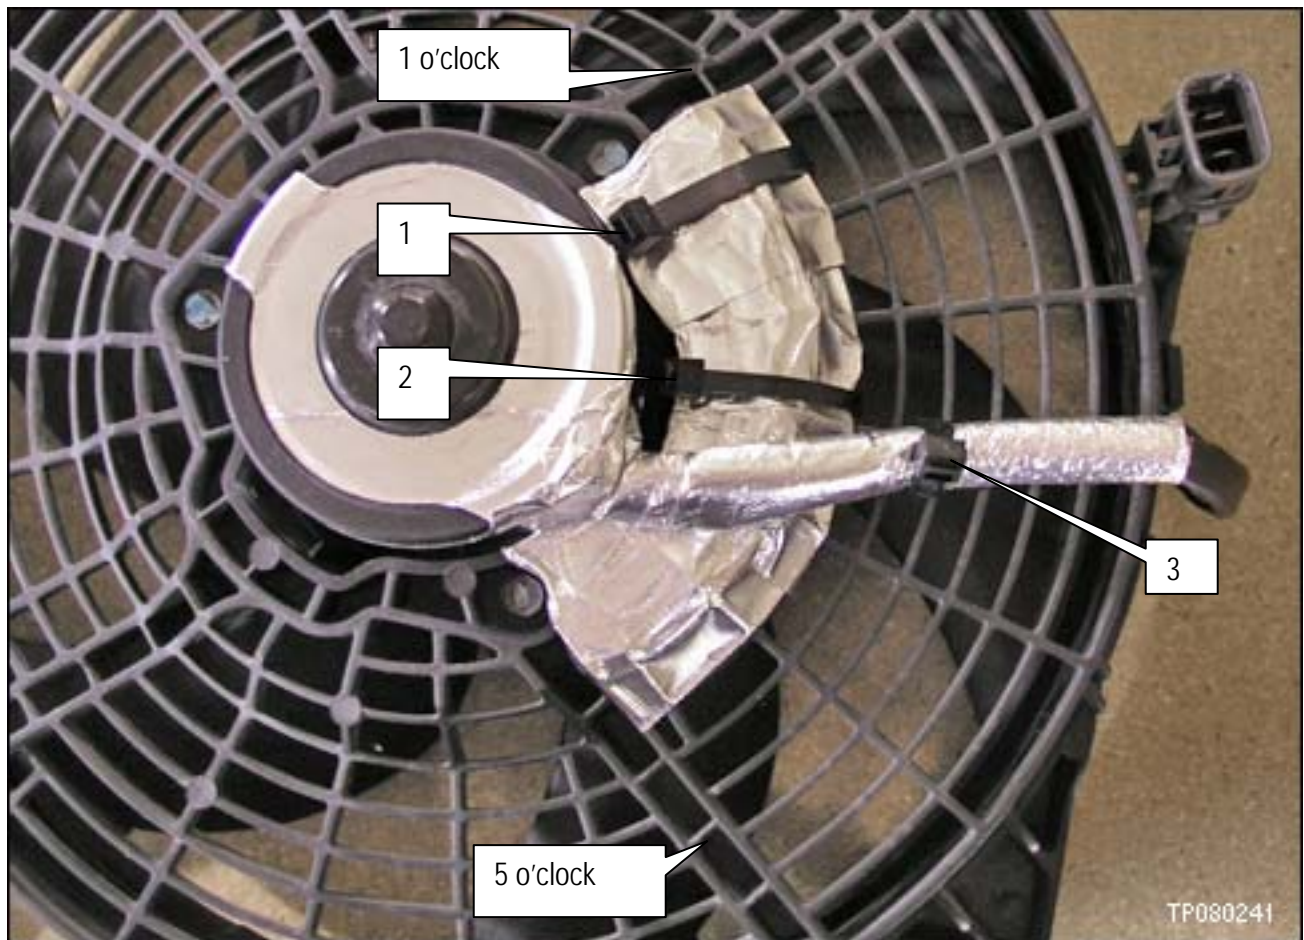
Figure D-17

14. Attach 3 tie-wraps as shown in Figure D-17.

- Use 7½ inch (19.5 cm) tie-wraps from the protector kit.
- Use the large 1 o'clock and 5 o'clock ribs for reference.
- **Pay close attention to the tie wrap locations.** Count the slots in the fan shroud to confirm correct tie-wrap locations.

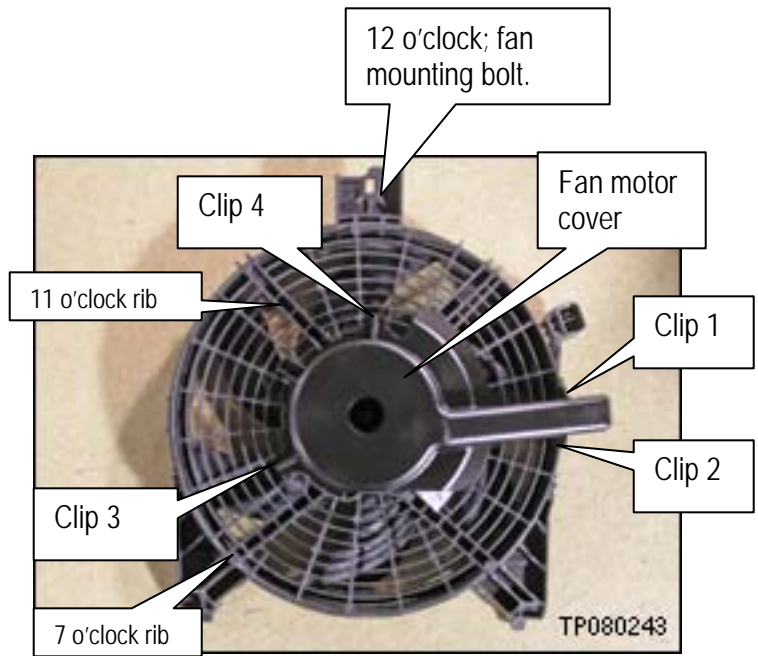
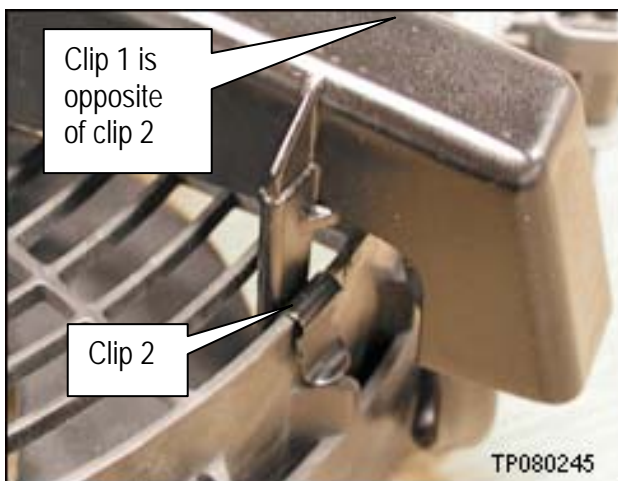
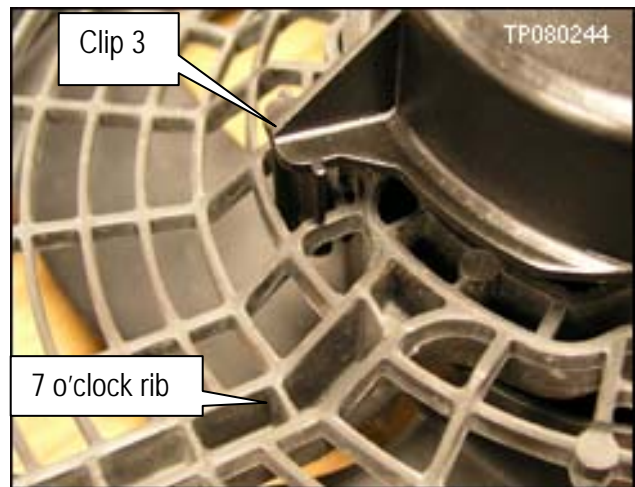
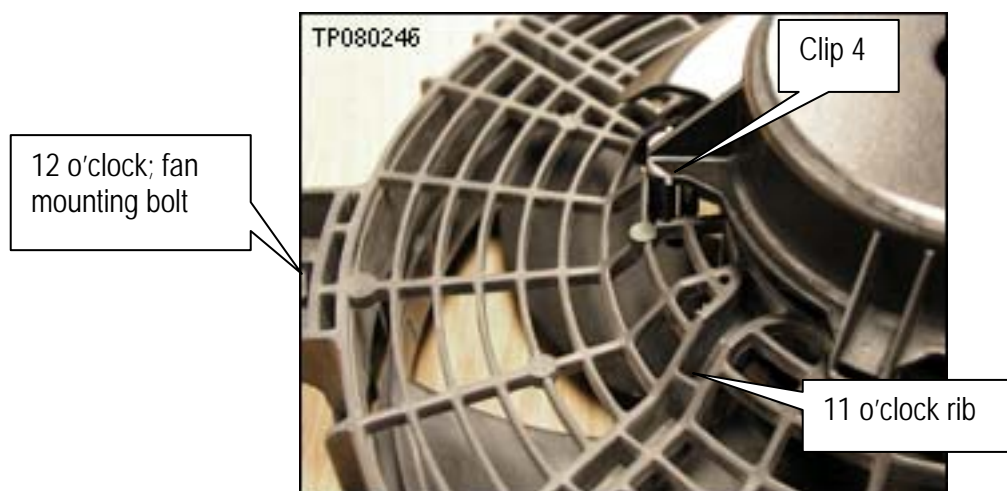
15. Install the fan motor cover:

- Make sure the 4 clips are installed in the correct locations.
- Refer to Figures D-18 through D-21 for clip locations.
- Use the large 7 o'clock and 11 o'clock ribs for reference.
- Count the slots in the fan shroud to confirm locations for clips 3 and 4.

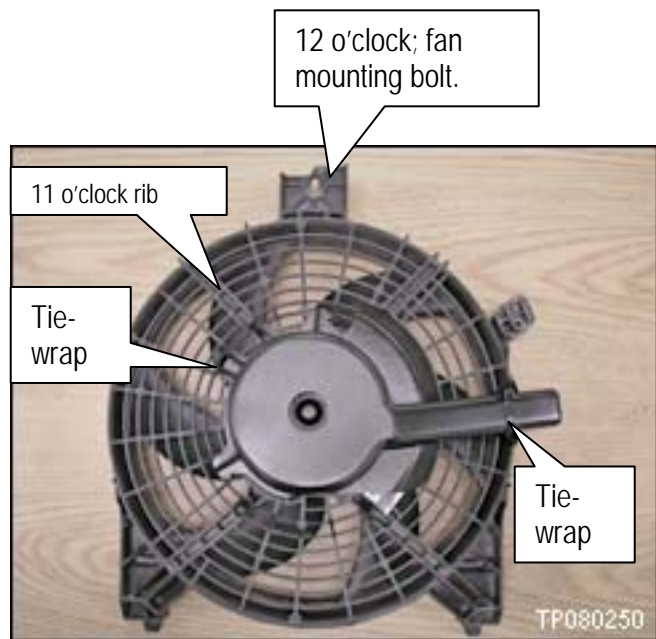
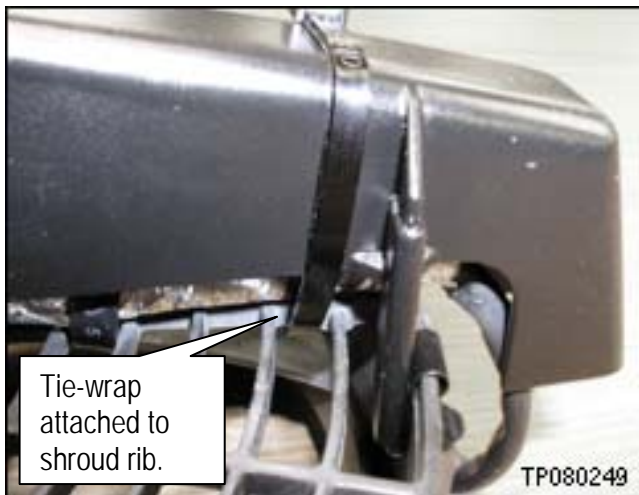
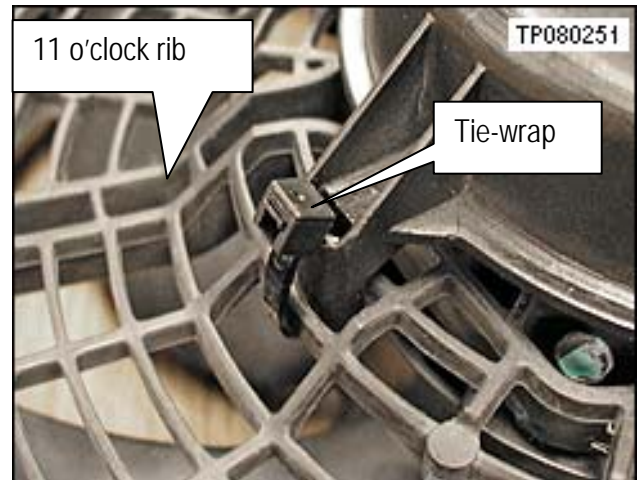
16. Install 2 tie-wraps on the fan motor cover.
- Use 11 inch (28 cm) tie-wraps from the protector kit.
 - Refer to Figures D-22 through D-24 for tie-wrap locations.
 - Use the large 11 o'clock rib for reference.
 - Count the slots in the fan shroud to confirm locations as needed.

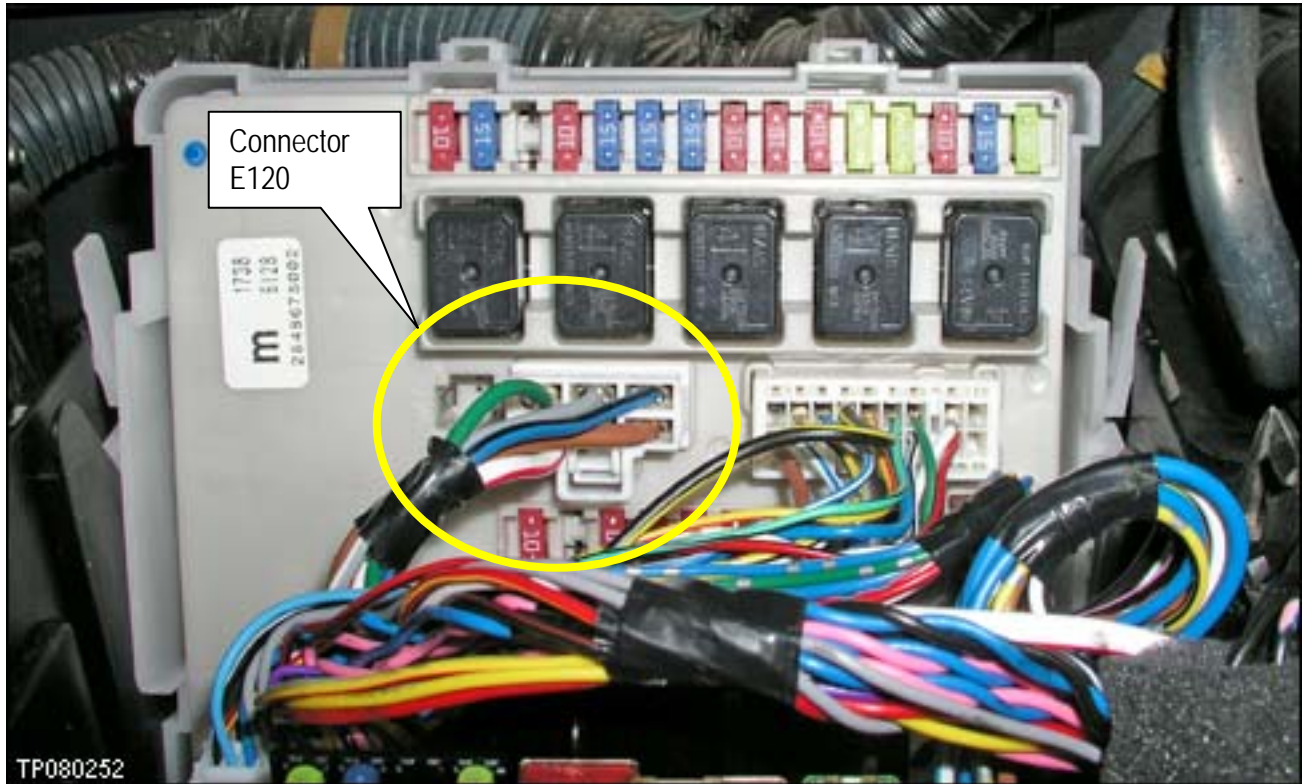
Figure E-3

3. Disconnect the white connector circled in Figure E-3.

- This is connector E120.
- This connector has 6 terminal slots with only 5 filled.

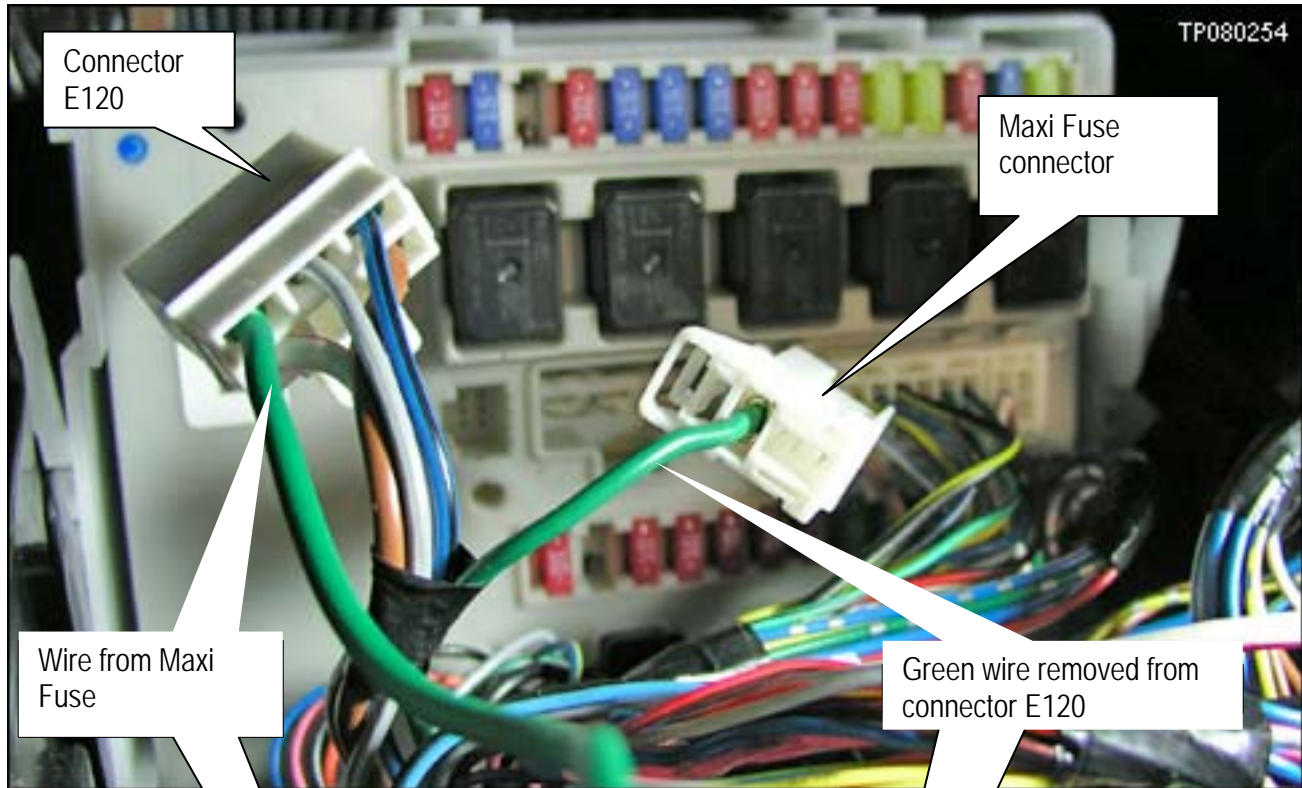
Figure E-5

5. Take the wire you removed from connector E120 and put it into the Maxi Fuse connector. Make sure to put it in the correct slot as shown in Figure E-5.
6. Insert the wire from the Maxi Fuse into the slot of connector E120 (see Figure E-5).

- The terminals will not snap in upside down.
- If the terminal won't snap-in, you are trying to put it in upside down; turn it over.

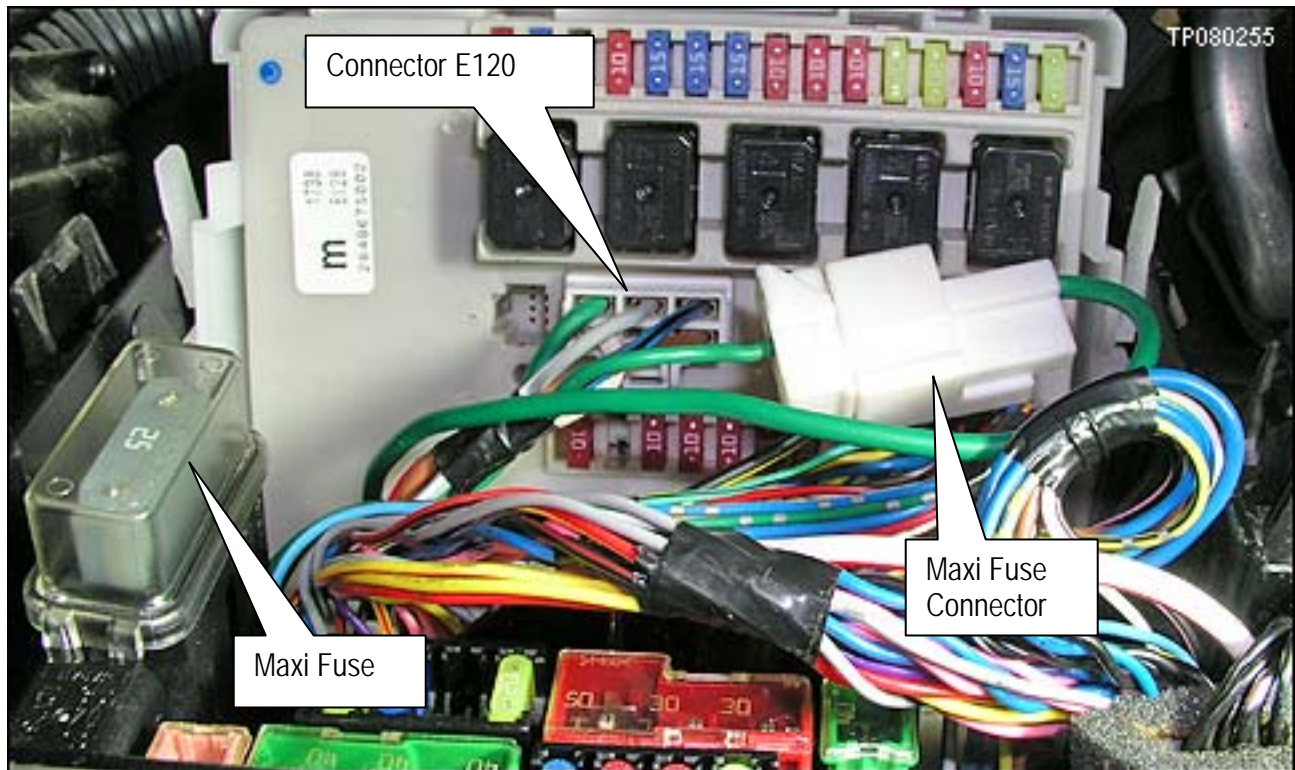
Figure E-6

7. Reconnect connector E120.
8. Connect the Maxi Fuse connector.
9. Position the Maxi Fuse, wires, and connector into the IPDM E/R box as shown in Figure E-6.
